**Climate Proofing Housing Landscapes:  
Interim Monitoring Report**

**August 2015 to May 2016**

**Authors: Connop, S. and Clough, J.**

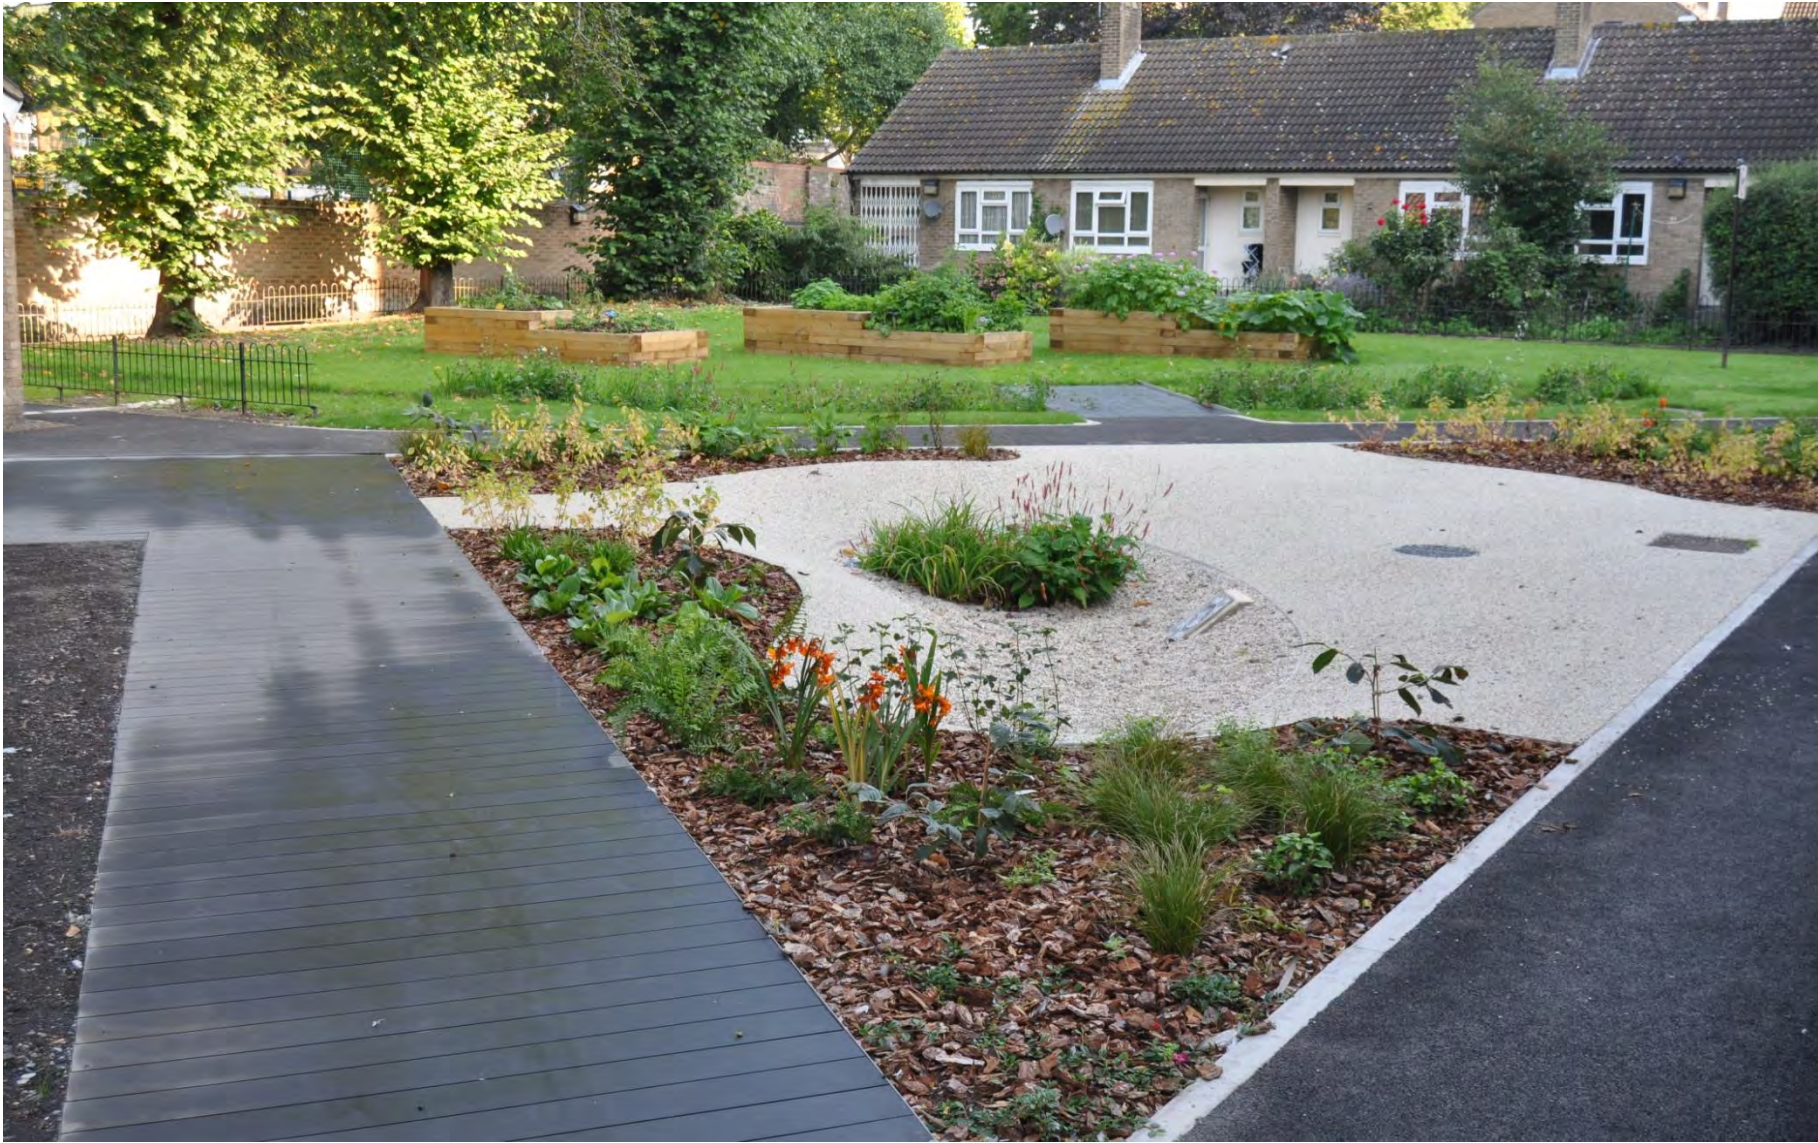
**Figure 1. Green infrastructure retrofit at Queen Caroline Estate, London Borough of Hammersmith & Fulham. Raised planters, permeable pathways, ornamental planting, pollinator-friendly swales and detention basins.**

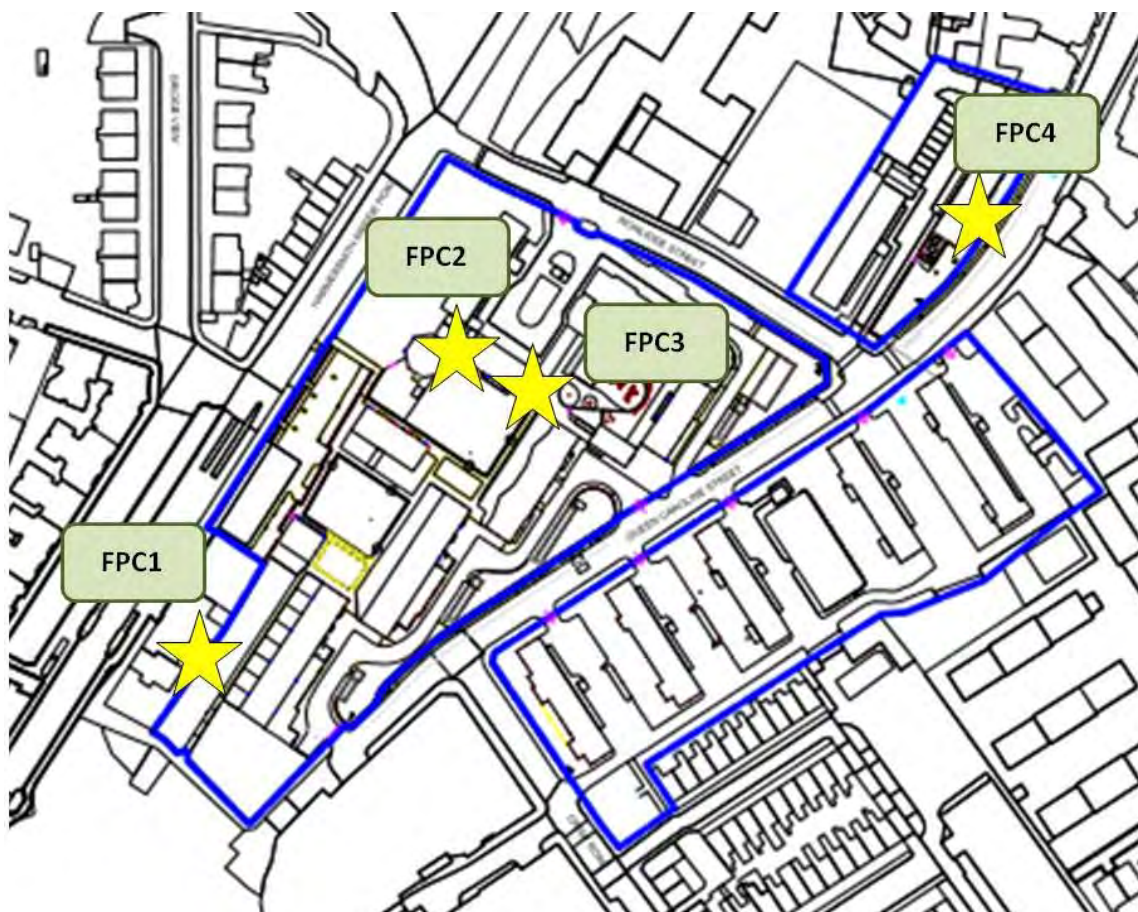
**Figure 2. Location of fixed-point camera at Richard Knight House, London Borough of Hammersmith & Fulham. Yellow stars represent the location of the fixed point cameras FPC1 to FPC4.**

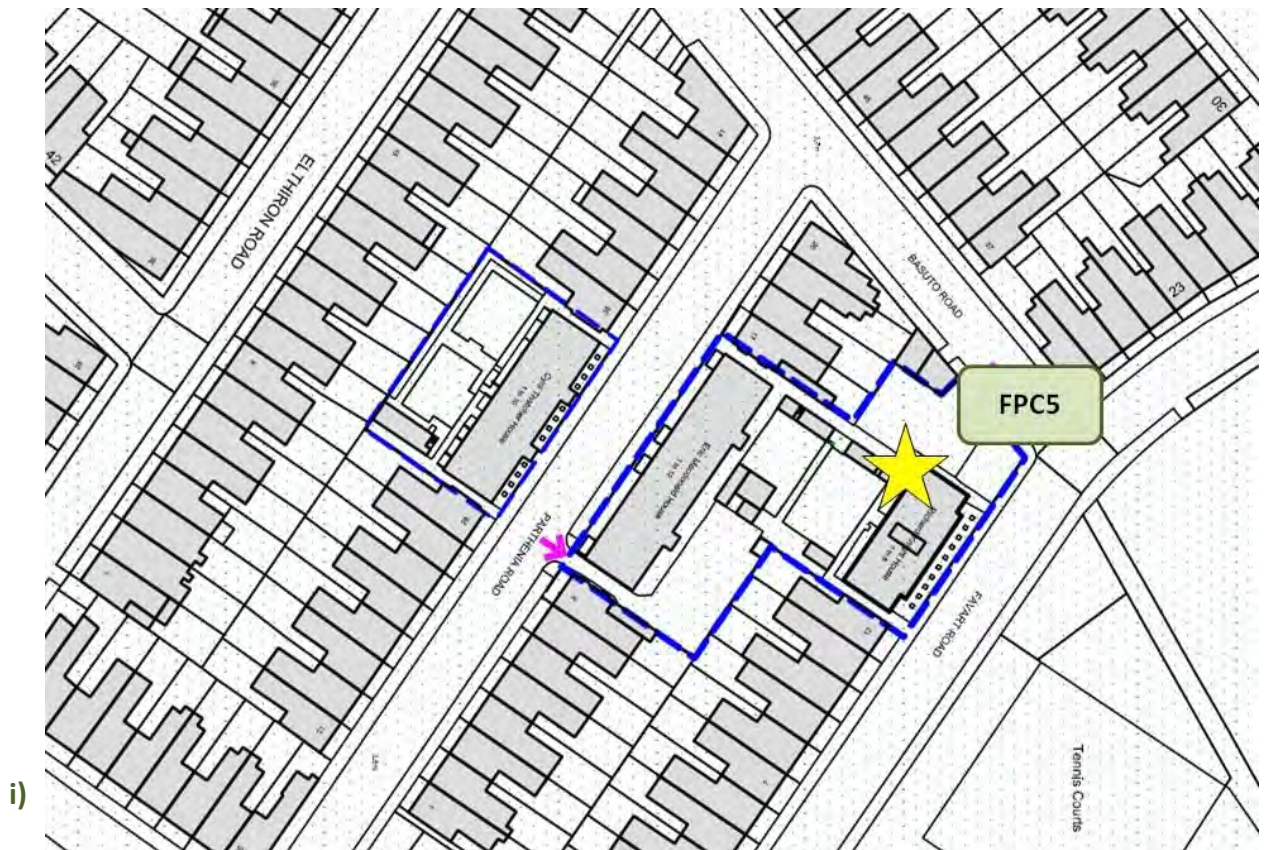
**Figure 6. Location of fixed-point camera at Richard Knight House, London Borough of Hammersmith & Fulham. i) Yellow stars represent location of camera ii) Red arrows represent direction of field of view.**

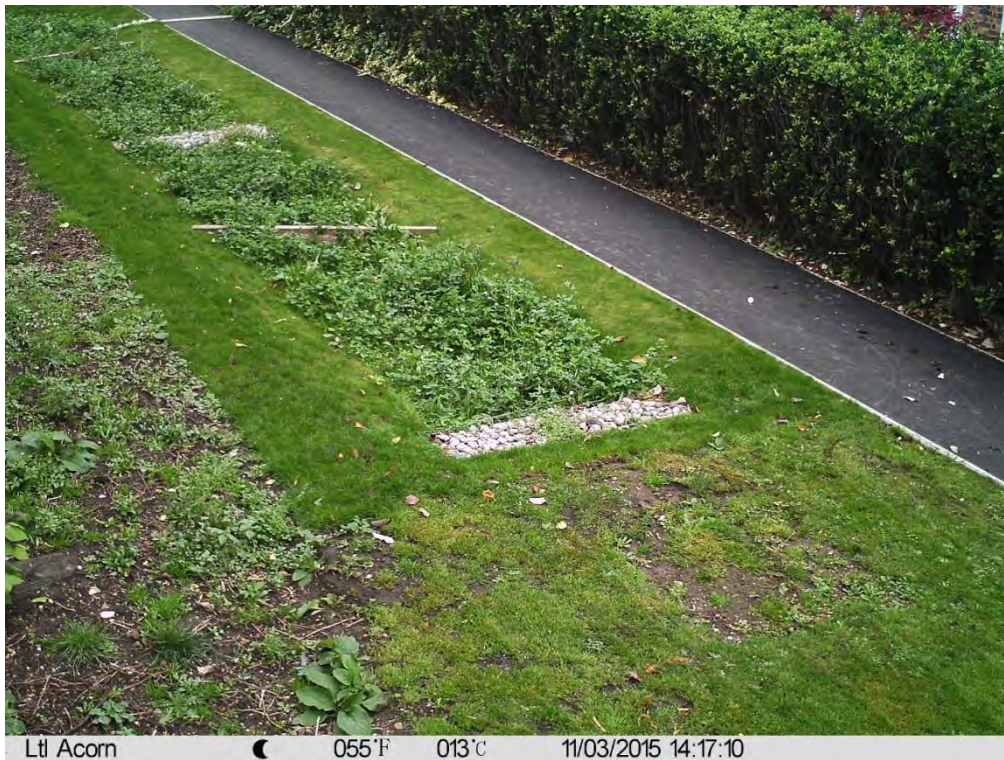
**Figure 7. Field of view of fixed-point camera (FPC1) at the rear of Alexandra House, Queen Caroline Estate, London Borough of Hammersmith & Fulham. Field of view orientated to capture the lower end of the swale to monitor infiltration rates and storage capacity exceedance.**

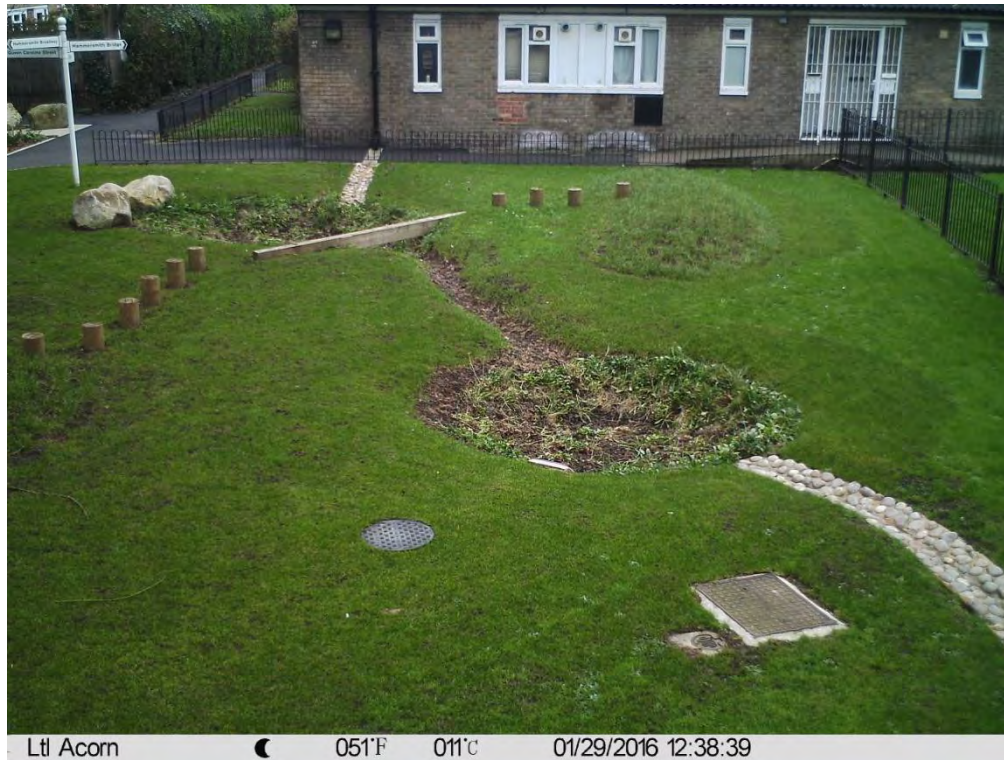
**Figure 8. Field of view of fixed-point camera (FPC2) at the rear of Adella House, Queen Caroline Estate, London Borough of Hammersmith & Fulham. Field of view orientated to capture the lower basin to monitor infiltration rates and storage capacity exceedance.**

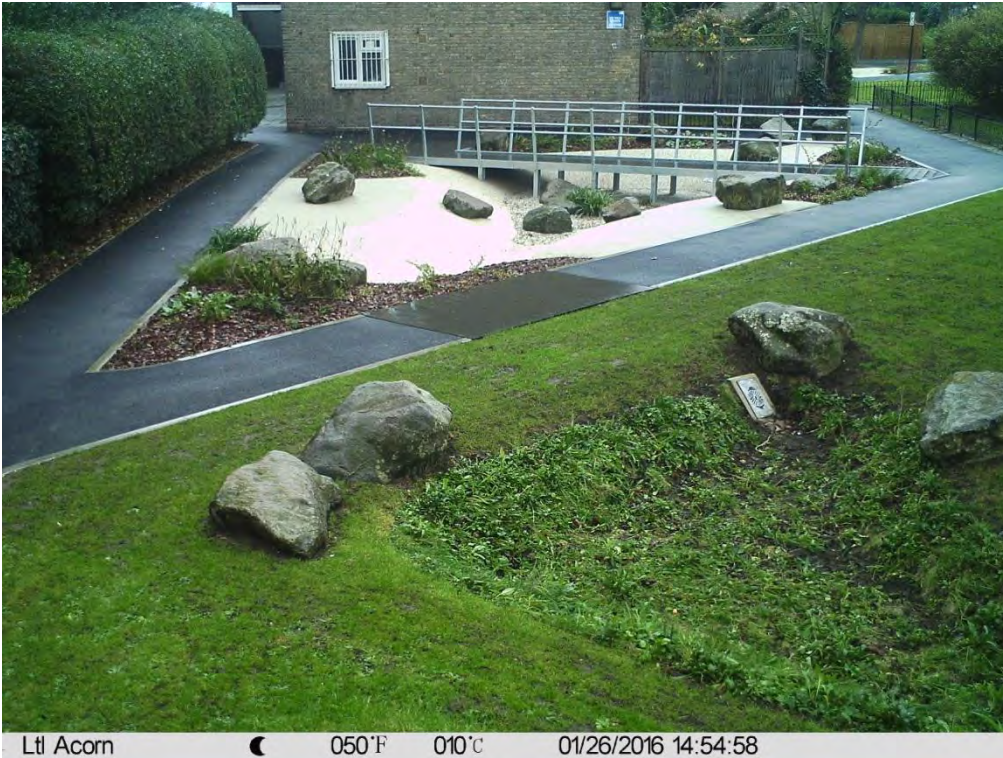
**Figure 9.** Field of view of fixed-point camera (FPC3) at the rear of Adella House, Queen Caroline Estate, London Borough of Hammersmith & Fulham. Field of view orientated to capture two basins to monitor infiltration rates and storage capacity exceedance.

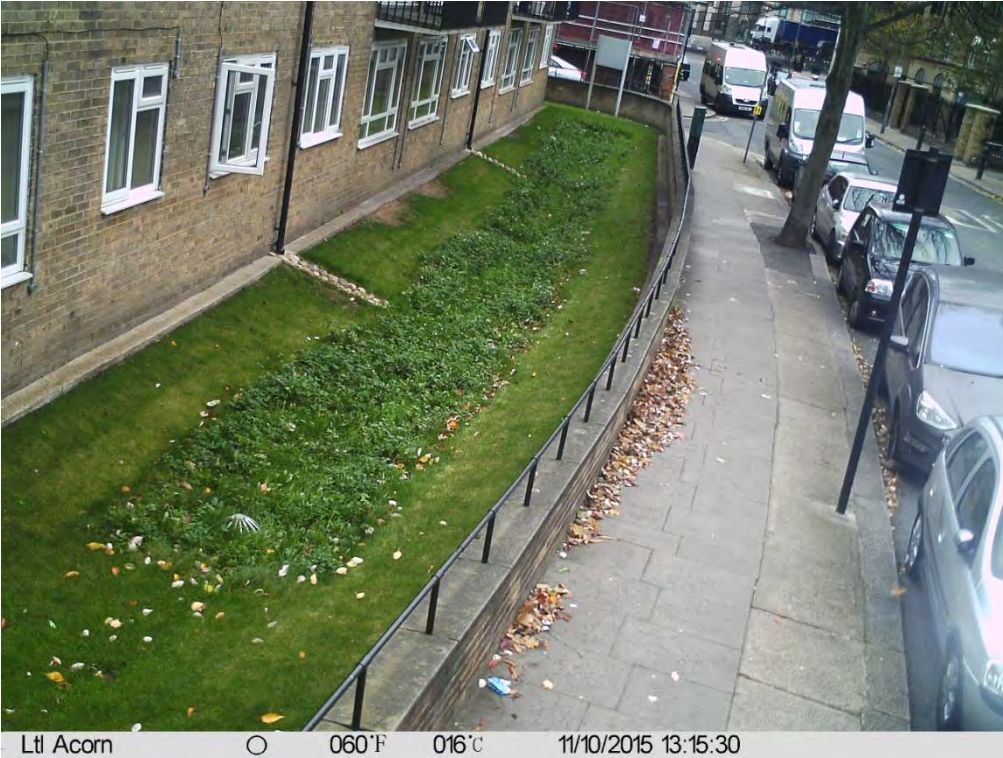
**Figure 10.** Field of view of fixed-point camera (FPC4) in front of Beatrice House, Queen Caroline Estate, London Borough of Hammersmith & Fulham. Field of view orientated to capture the swale whole to monitor infiltration rates and storage capacity exceedance.

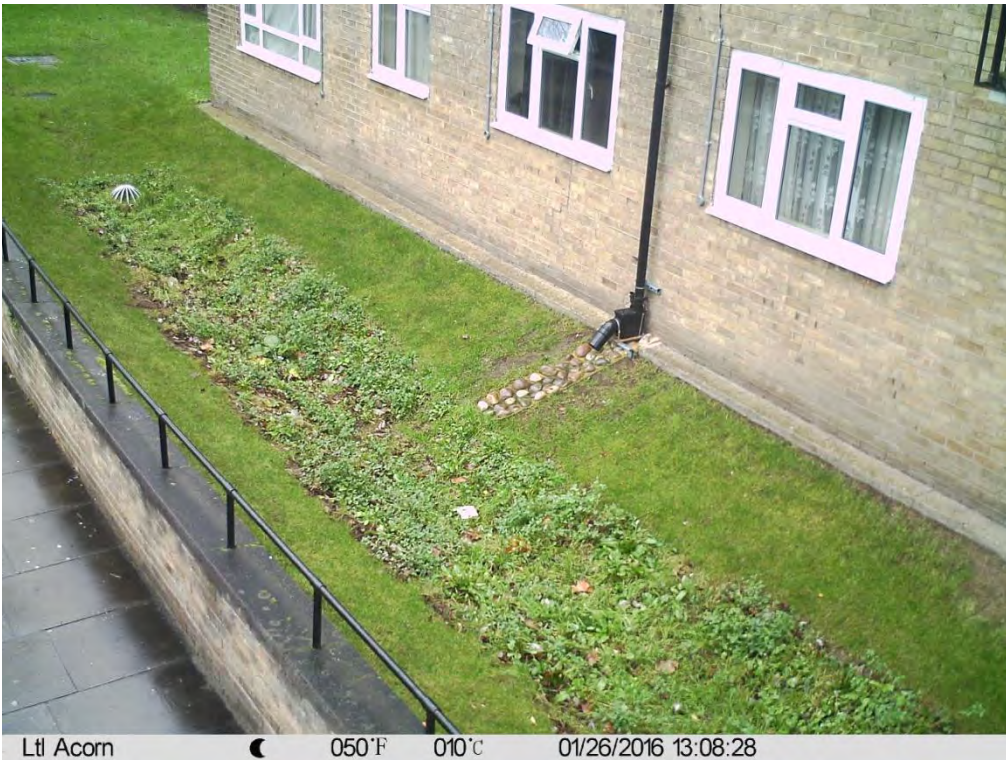
**Figure 11. Second field of view of fixed-point camera (FPC4) in front of Beatrice House, Queen Caroline Estate, London Borough of Hammersmith & Fulham.** Camera position had to be moved approximately 2 months into monitoring due to a tree removal order being posted on the original vantage point. Field of view orientated to capture the lower end of the swale to monitor infiltration rates and storage capacity exceedance.

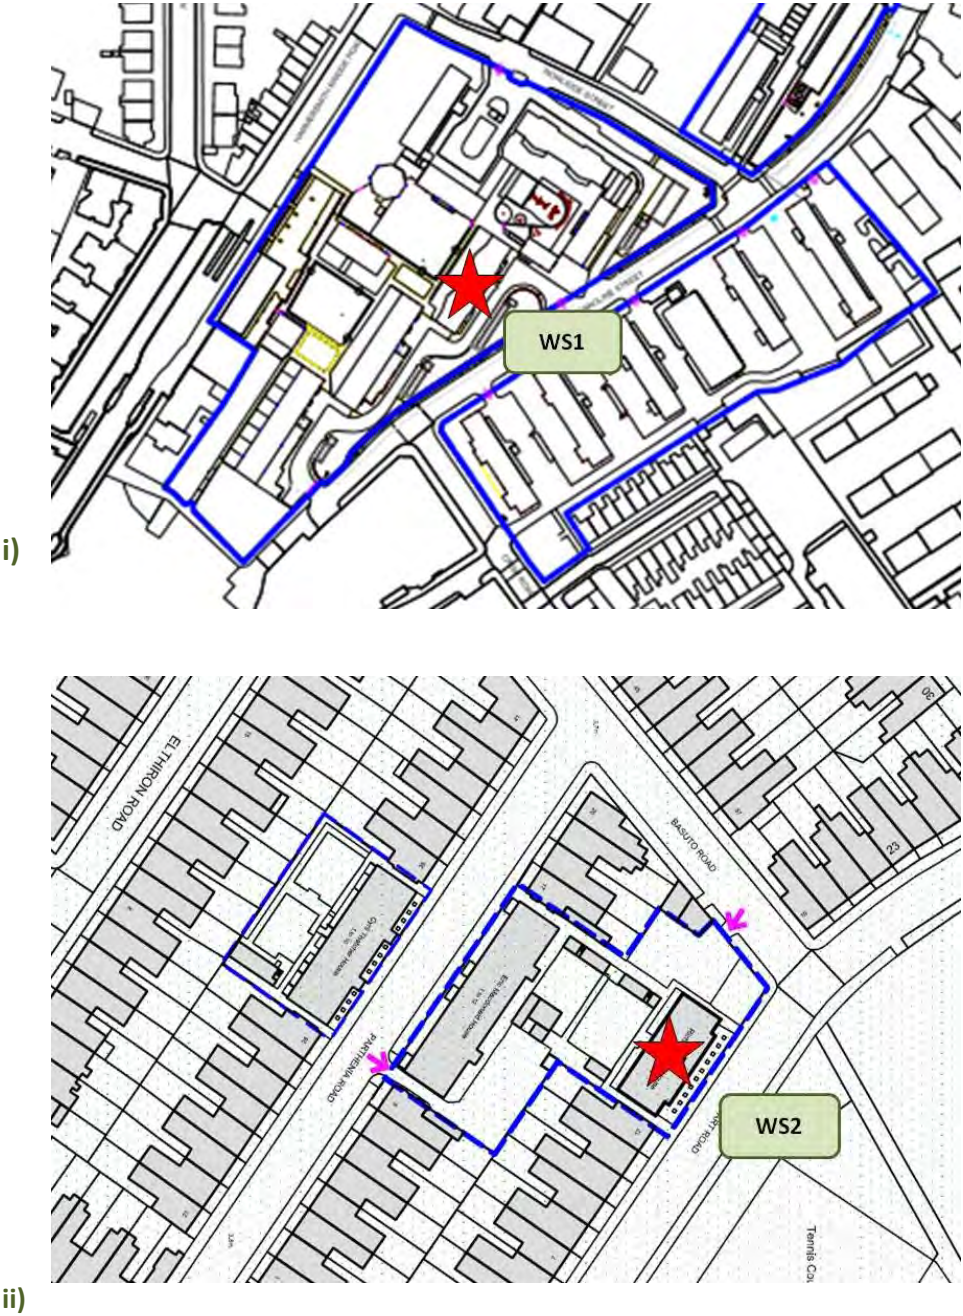
**Figure 13. Location of weather stations at i) Queen Caroline Estate (WS1) and ii) Richard Knight House (WS2), London Borough of Hammersmith & Fulham.**

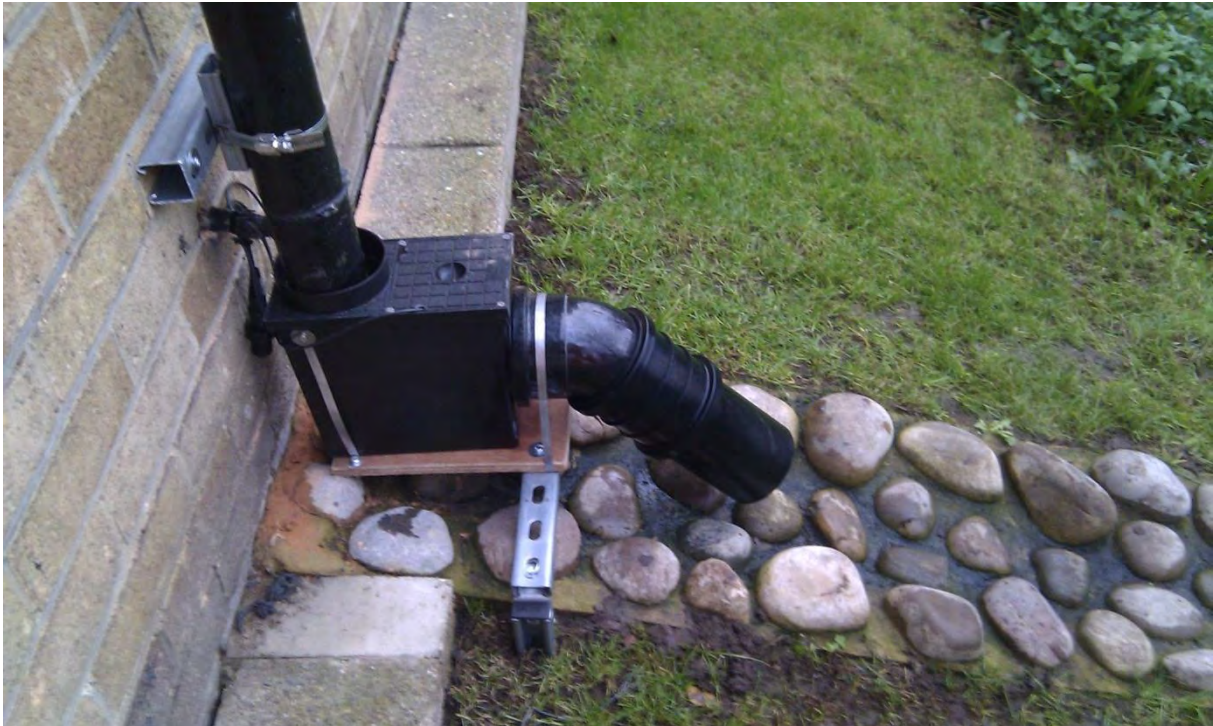
A series of flowmeters and a pressure sensor have also been installed at Queen Caroline Estate to monitor the fine performance of a selection of the retrofitted green infrastructure components. This included a series of 3001 LT Levelloggers installed into bespoke calibrated v-notch weir controlled release boxes with direct read cables to enable data download (Figure 15) and an additional pressure sensor level logger buried to measure the depth of water and infiltration times in a water retention feature (Figure 16). Of these, three level loggers with v-notches were installed at the base of downpipes on three of the pram shed roofs retrofitted with small-scale green roofs (Figure 17). The other two Levelloggers with v-notch weirs were installed on the downpipes taking water from Beatrice House and feeding it into the neighbouring swale (Figure 18). The final pressure sensor was buried in the base of this swale to measure the volume of water accumulating from the Beatrice House roof and the time for any accumulating water to infiltrate following large rain events (Figure 18). An additional barologger was installed at UEL to act as an atmospheric pressure control.

**Figure 15. V-notch and levellogger installed at Beatrice House, Queen Caroline Estate, London Borough of Hammersmith & Fulham.**

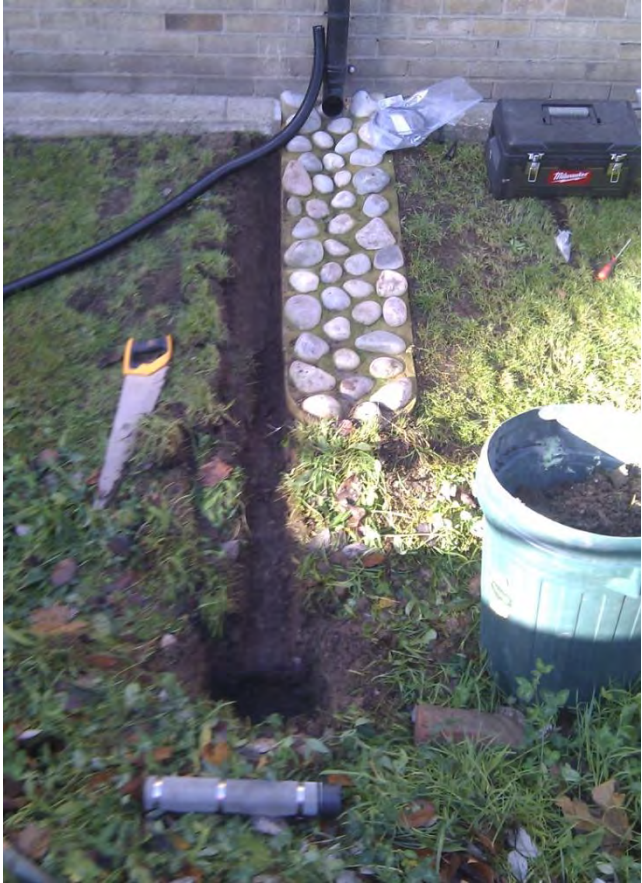
**Figure 16. Pressure sensor buried beneath swale behind Beatrice House, Queen Caroline Estate, London Borough of Hammersmith & Fulham.**

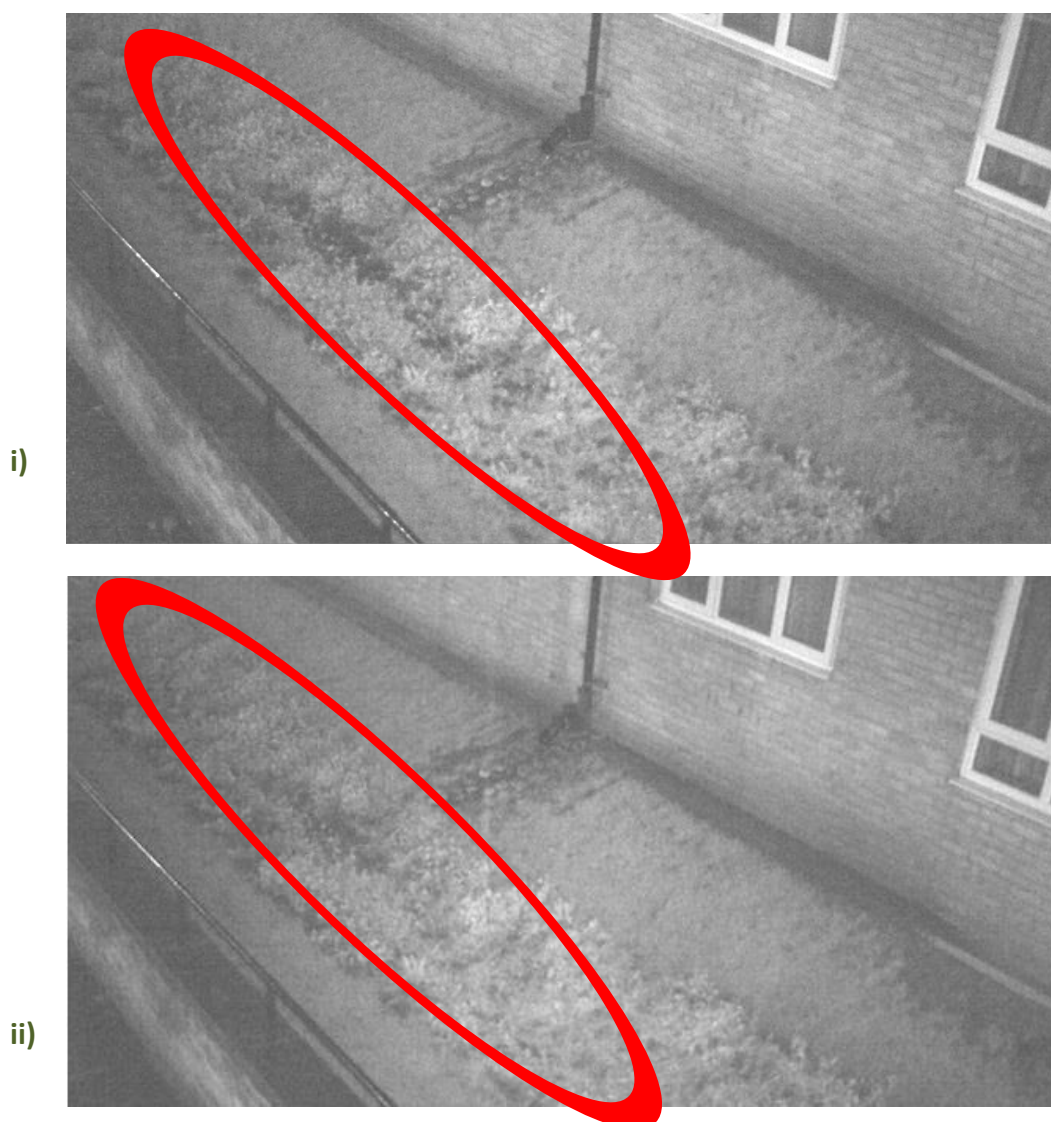
A complete collection of the images from the Beatrice swale during the heaviest rain event recorded since the monitoring equipment was installed (from 01:00 to 03:15 on the 11th January 2016) are presented in Appendix A. They demonstrate that the swale was able to retain and attenuate all of the rainfall that fell directly onto the area and that which was diverted from the roofs of Beatrice House. The images also demonstrate that at around 02:05 there was obvious standing water within the swale, but that this had reduced again by the time of the next image at 02:20 indicating that the swale was releasing water by infiltration and/or conveyance (Figure 22).

**Figure 22. Time-lapse camera images from Beatrice House swale (FPC4).** Images show i) evidence of swale filling during period of highest rain intensity 2am to 2:30am on 11/01/2016 [3.6 mm of rain at maximum intensity of 57.6 mm/hr] and ii) evidence of infiltration/conveyance by the time of the next time-lapse photo (~15 minutes later).

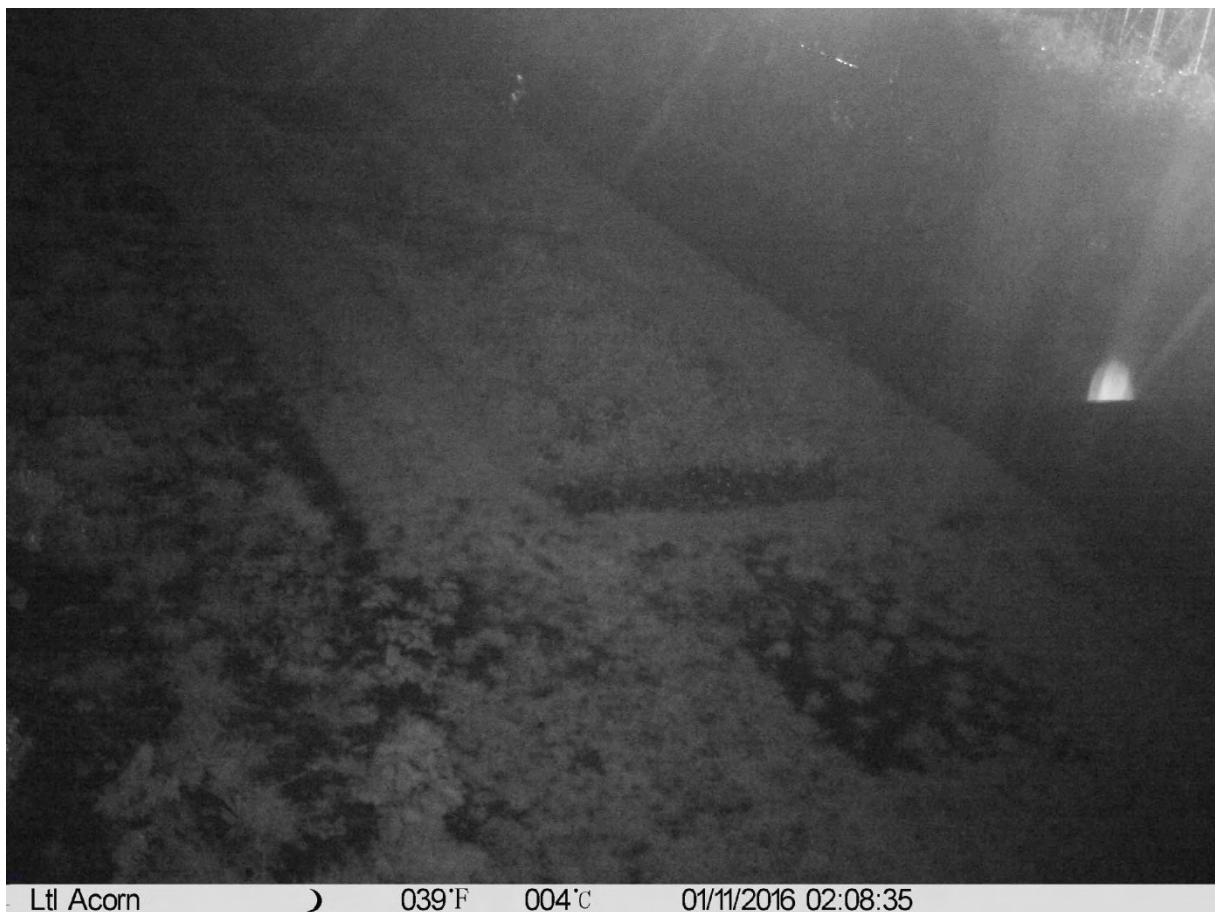
Images showing the performance of the Alexandra House swale for the same rain event are presented in Appendix A2. The swale was designed to take stormwater from the surrounding ground level permeable and hardstanding areas and from the roof of the neighbouring Alexandra House. Whilst the fixed point photos showed evidence of the intensity of the rain event in relation to pooling on the ground, there was no evidence of any substantial filling of the swale. This was the case even during the most intense period of rainfall (Figure 23). This indicated that the swale was performing as expected for this rain event. It is important to note at this point, however, that lack of maintenance of the guttering on Alexandra House might mean that not all of the rain falling on the areas of the roof that should be diverted to the swale is actually reaching the swale.

**Figure 23. Time-lapse camera images from Alexandra House swale (FPC1).** Image shows no evidence of swale filling excessively during period of highest rain intensity 2am to 2:30am on 11/01/2016 [3.6 mm of rain at maximum intensity of 57.6 mm/hr].

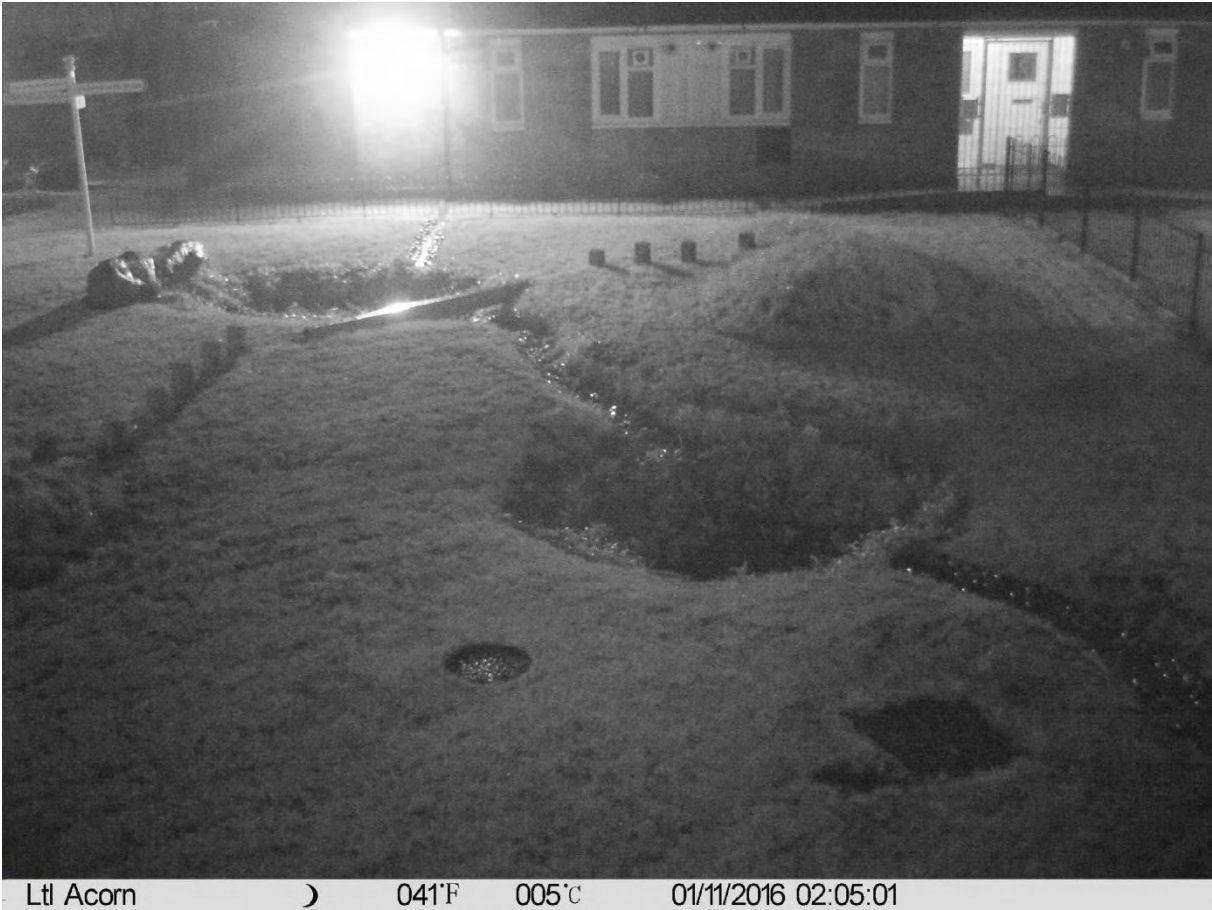
Images showing the performance of the Community Hall and Sofia House grass basins for the same rain event are presented in Appendix A3. The basins were designed to take stormwater from the surrounding ground level permeable and hardstanding areas and from the roof of the neighbouring Community Hall and Sophia House. Whilst the fixed point photos showed evidence of the intensity of the rain event in relation to pooling on the ground, there was no evidence of any substantial filling of the basins. This was the case even during the most intense period of rainfall (Figure 24). This indicated that the basins were performing as expected for this rain event.

**Figure 24. Time-lapse camera images from Community Hall and Sophia House basins (FPC2).** Image shows no evidence of basins filling excessively during period of highest rain intensity 2am to 2:30am on 11/01/2016 [3.6 mm of rain at maximum intensity of 57.6 mm/hr].

In the Community Hall basin there was evidence of substantial pooling during the heaviest rainfall period of this rain event. However, the pooling was not observed reaching the height of the overflow. It is proposed that rain simulation of a 1 in 100 year rain event is performed to assess the volume of this retention basin compared to the original design to ensure that it was profiled correctly.

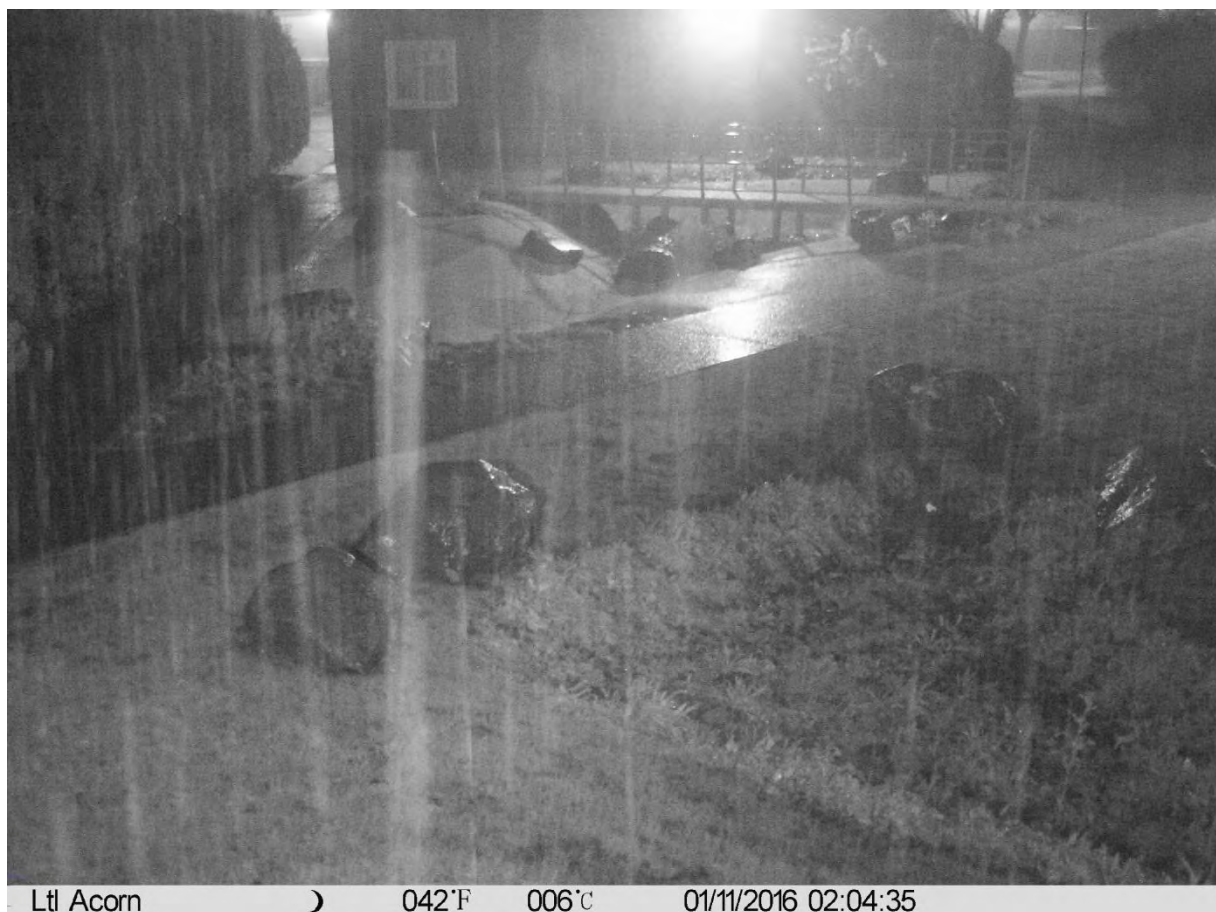
Images showing the performance of the Adella House grass basin and Adella House stoney basin for the same rain event are presented in Appendix A4. The basins were designed to take stormwater from the surrounding ground level permeable and hardstanding areas and from the roof of Adella House. Whilst the fixed point photos showed evidence of the intensity of the rain event in relation to pooling on the ground, there was no evidence of any substantial filling of the basins. This was the case even during the most intense period of rainfall (Figure 25). This indicated that the basins were performing as expected for this rain event. It is important to note at this point, however, that lack of maintenance of the guttering on Adella House might mean that not all of the rain falling on the areas of the roof that should be diverted to the basins is actually reaching the basins.

**Figure 25. Time-lapse camera images from Adella House grass basin and Adella House stoney basin (FPC3).** Image shows no evidence of basins filling excessively during period of highest rain intensity 2am to 2:30am on 11/01/2016 [3.6 mm of rain at maximum intensity of 57.6 mm/hr].

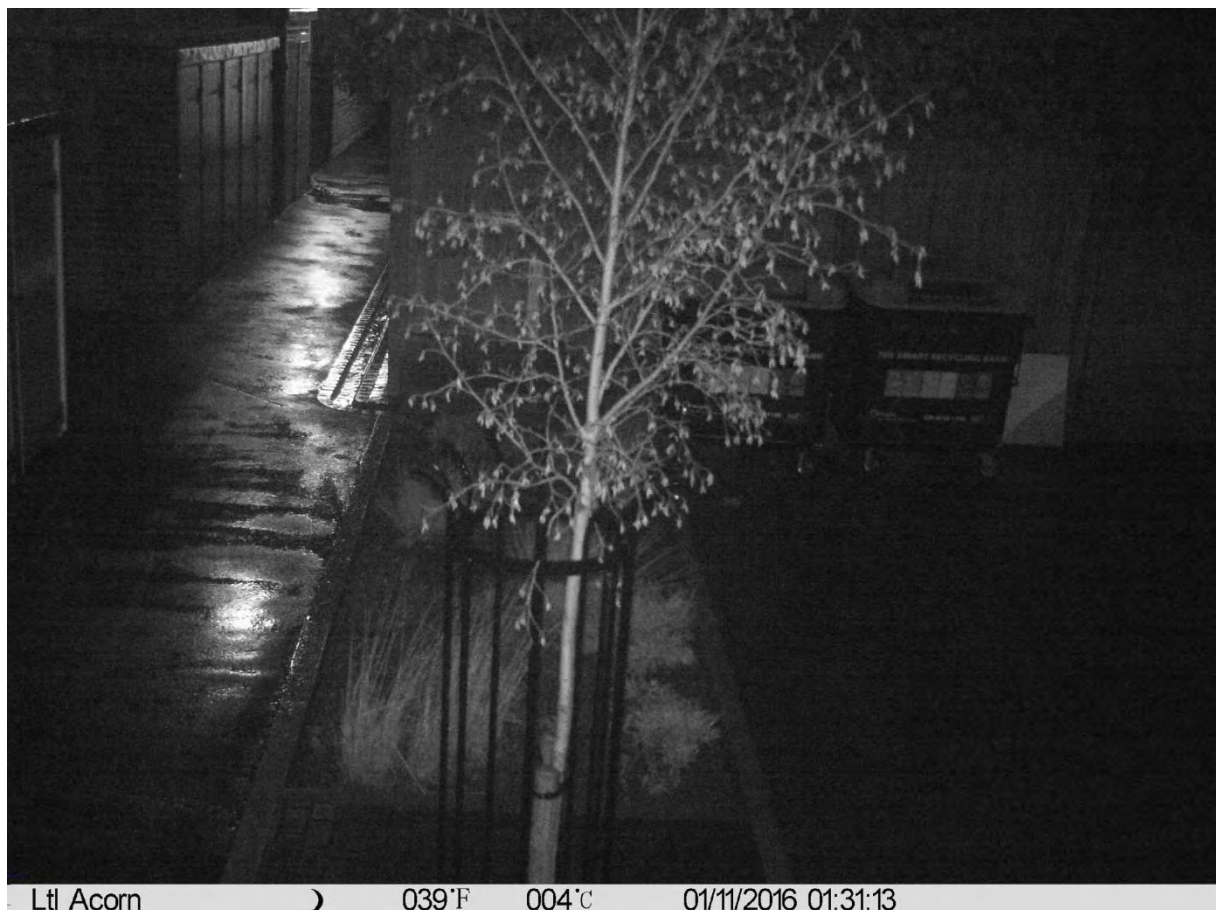
Images showing the performance of the Richard Knight House rain garden for the rain event on 11th January 2016 are presented in Appendix A5. The basins were designed to take stormwater from the ground level permeable and hardstanding areas surrounding the rain garden, from the green roofs on the pram sheds and from the roof of a neighbouring house. Whilst the fixed point photos showed evidence of the intensity of the rain event in relation to pooling on the ground, there was no evidence of any substantial filling of the basins. This was the case even during the most intense period of rainfall (Figure 27). This indicated that the basins were performing as expected for this rain event.

**Figure 27. Time-lapse camera images from Richard Knight House rain garden (FPC5).** Image shows no evidence of rain garden filling excessively during period of highest rain intensity 1:30am to 2:00am on 11/01/2016 [2.4 mm of rain at maximum intensity of 29.8 mm/hr].

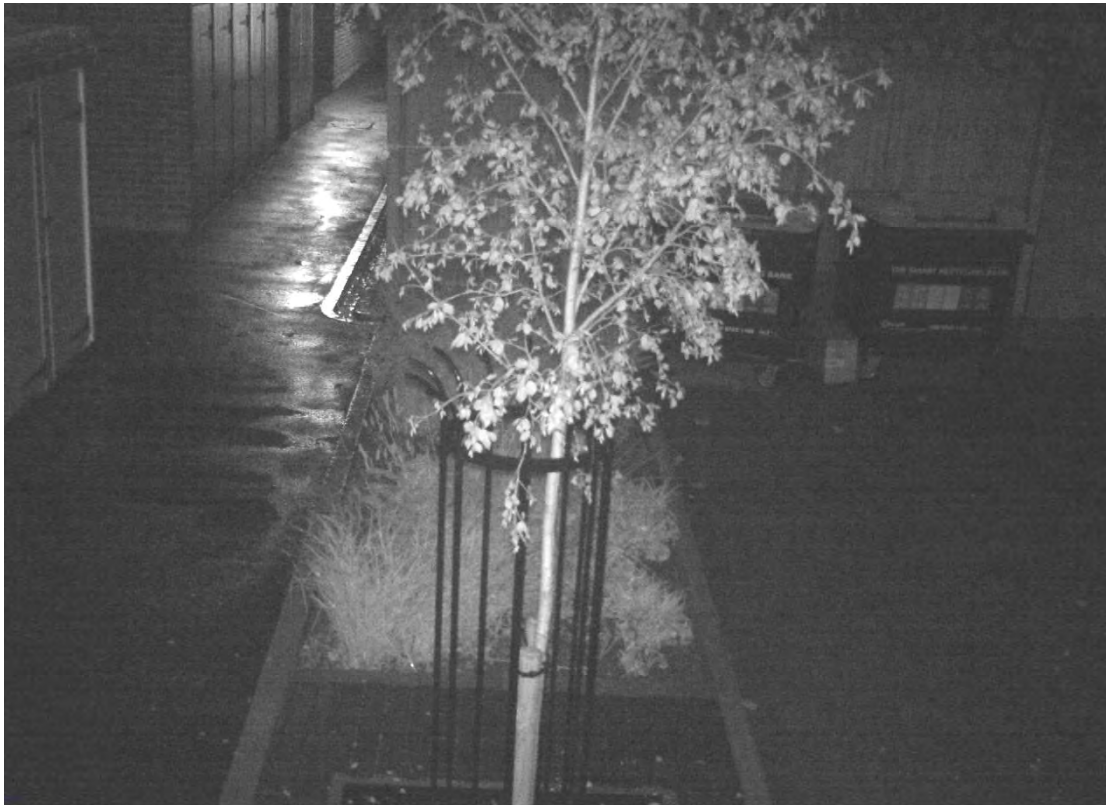
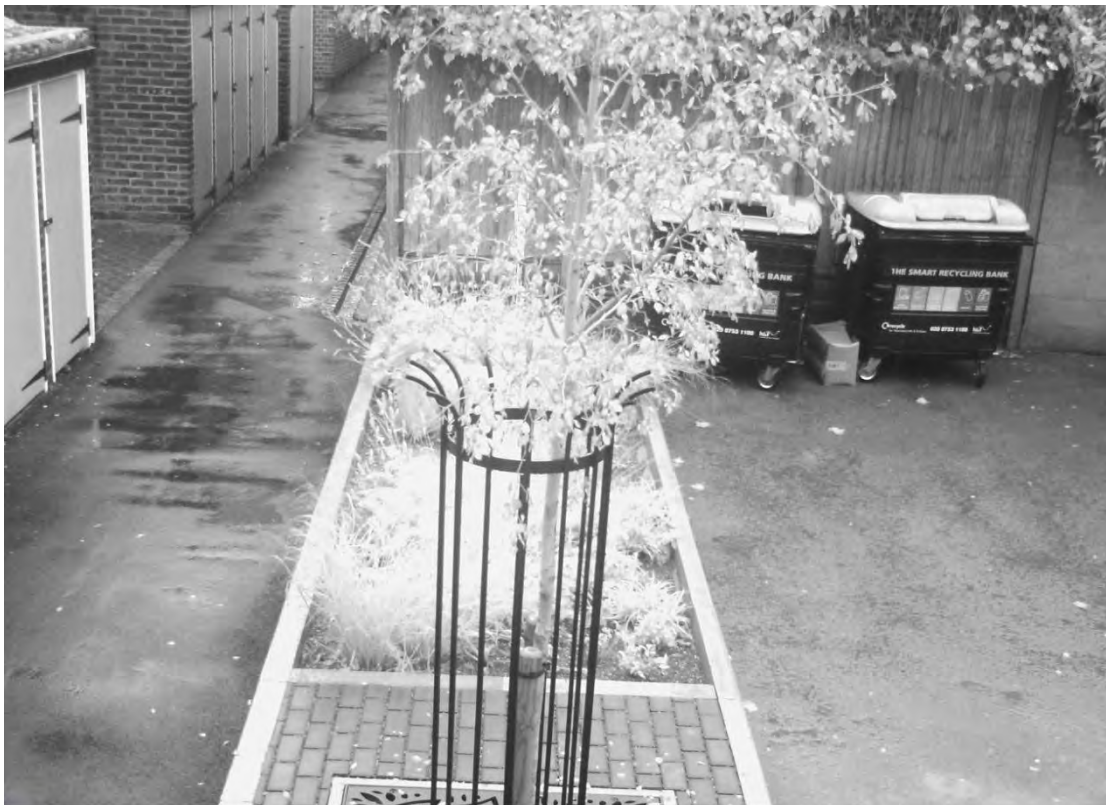
Despite this intense and substantial nature of the rainfall over a short period, the time-lapse camera images revealed no evidence of excessive filling of the Richard Knight House rain garden (Figure 29).

**Figure 29. Time-lapse camera images from Richard Knight House rain garden (FPC5).** Images show i) rain garden during the period of rain building up to the highest rain intensity and ii) following the period of highest intensity.

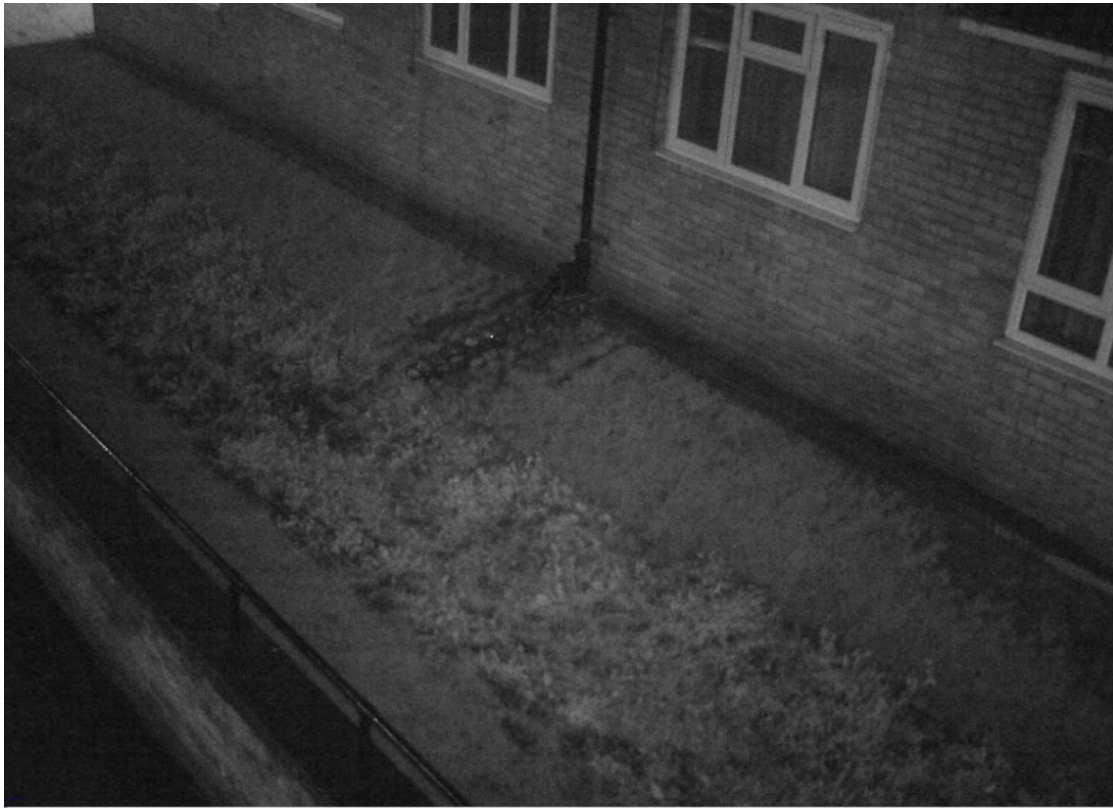
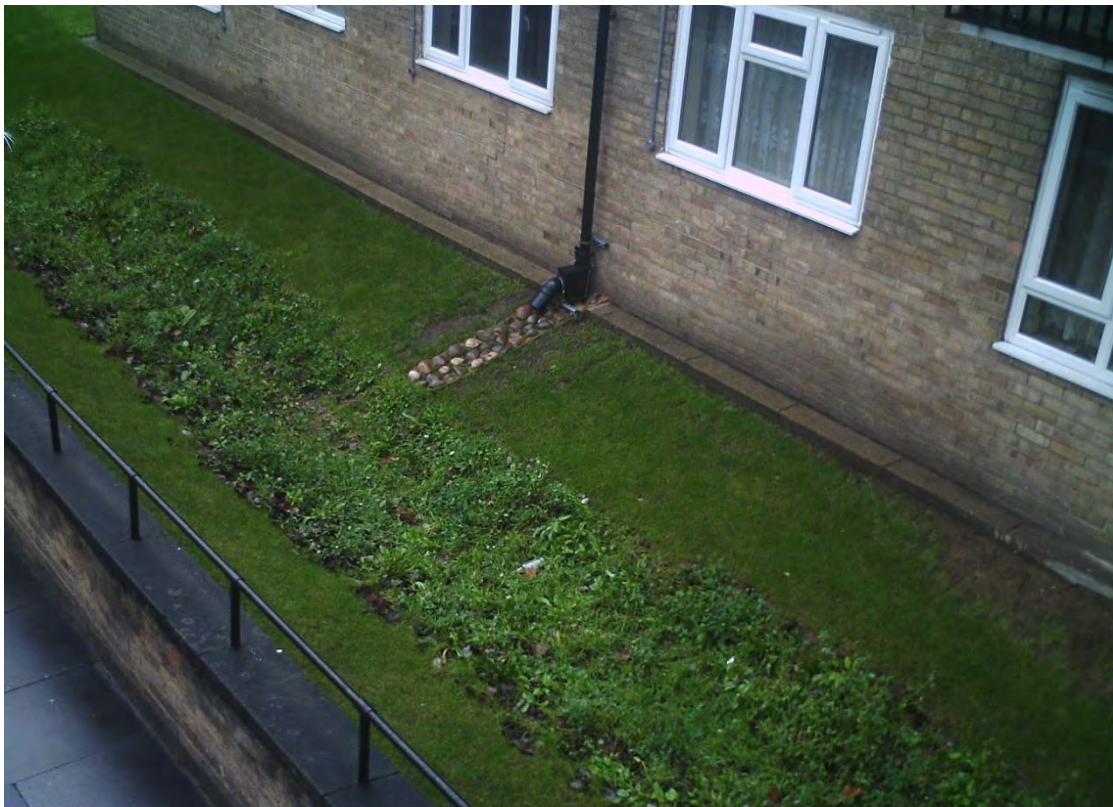
**Figure 31. Time-lapse camera images from Beatrice House swale (FPC4).** Images show no sign of excessive pooling in the swale i) following the period of intense rainfall or ii) towards the end of the rain event during daylight.
