**Climate Proofing Housing Landscapes:  
Interim Monitoring Report**

**August 2015 to May 2016**

**Authors: Connop, S. and Clough, J.**

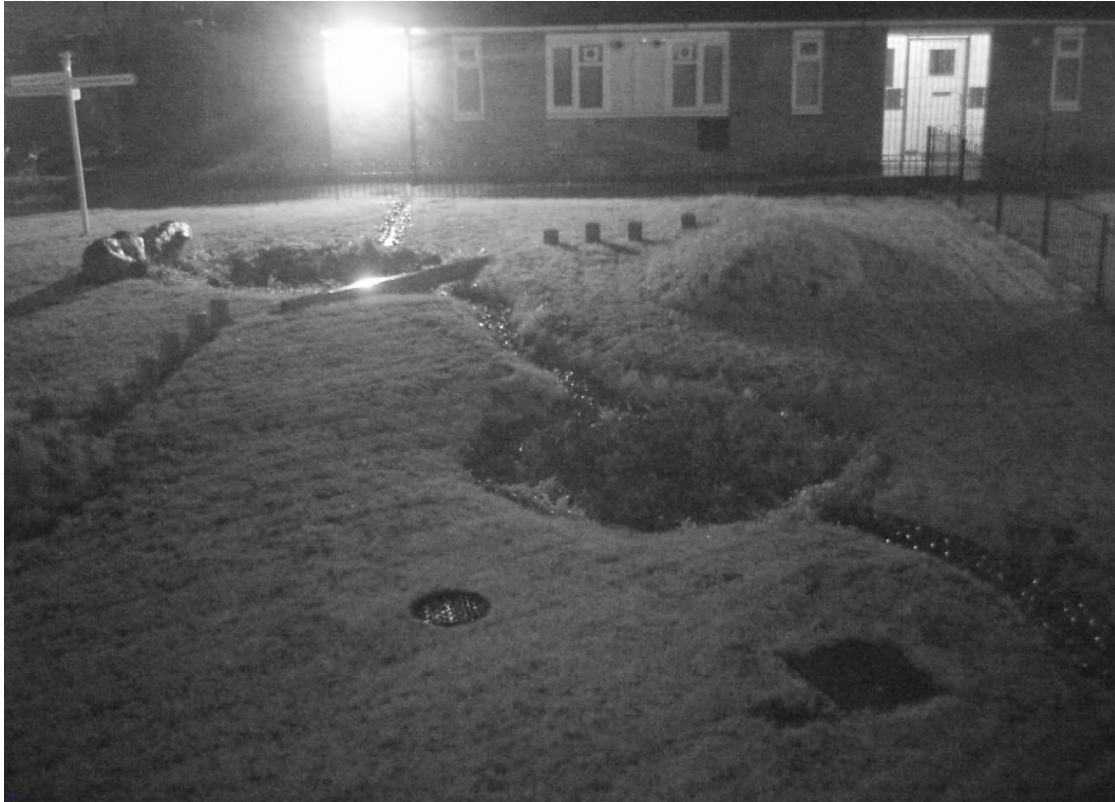
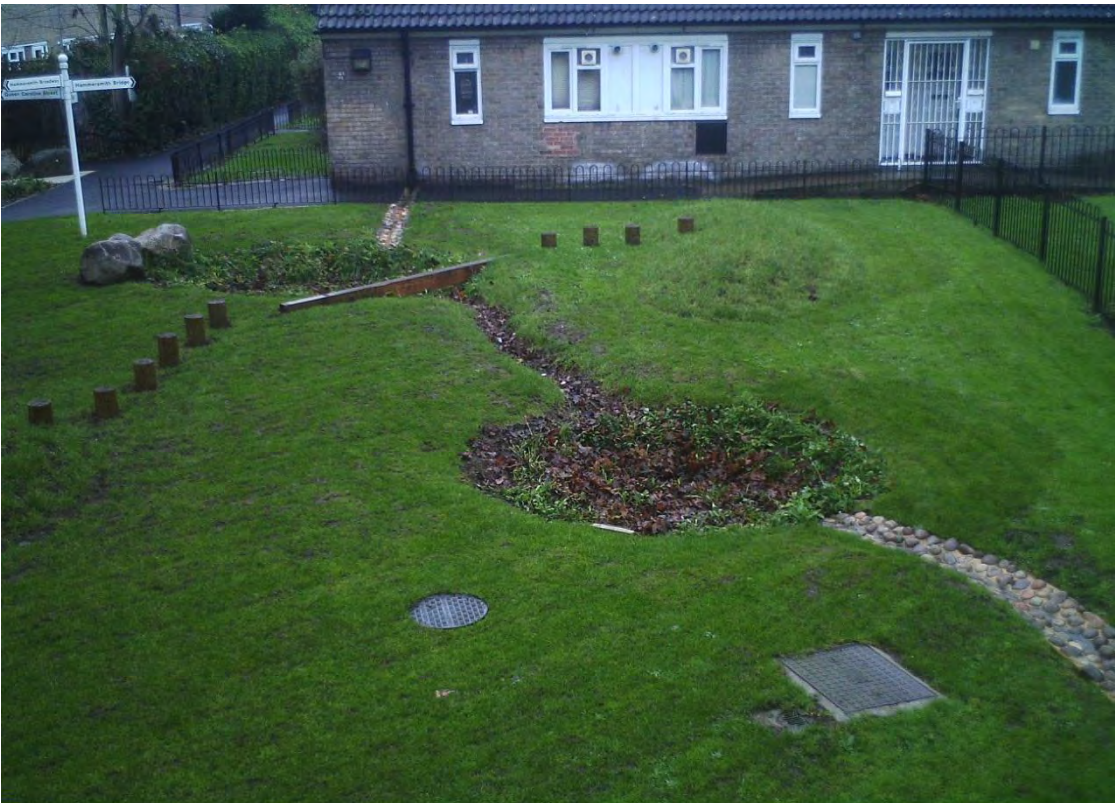
**Figure 32. Time-lapse camera images from Adella House basin (FPC2).** Images show no sign of excessive pooling in the basin i) following the period of intense rainfall or ii) towards the end of the rain event during daylight.

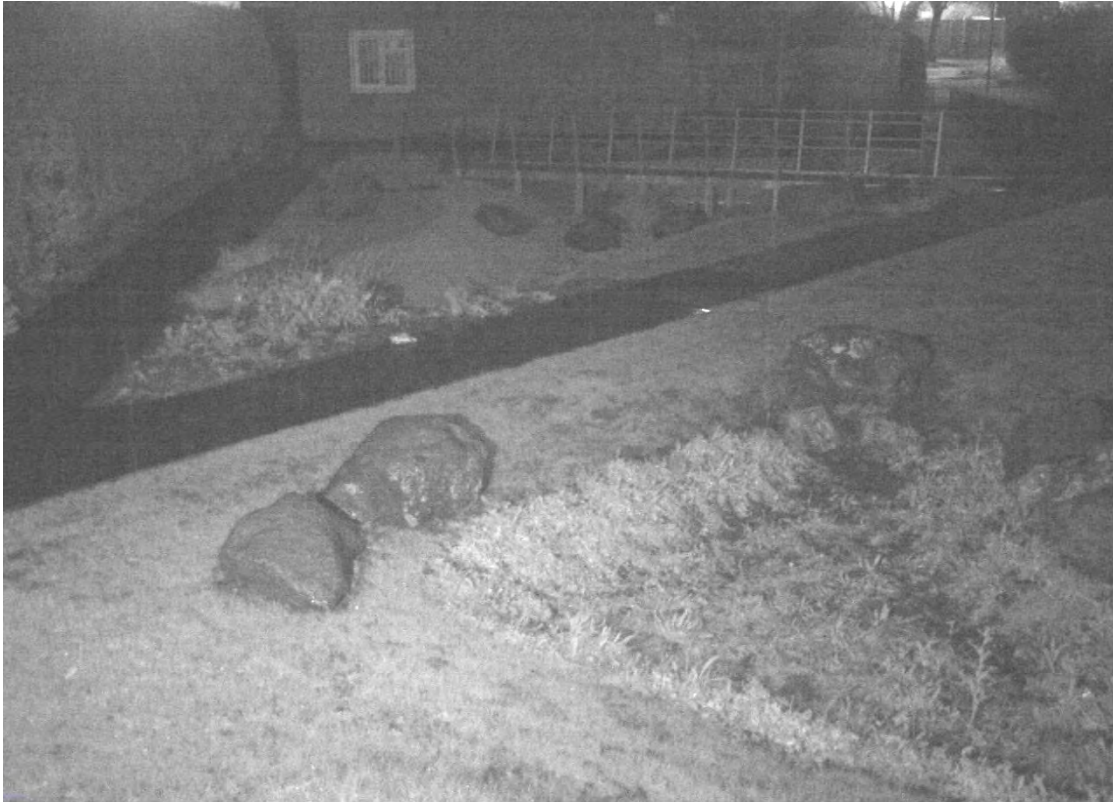
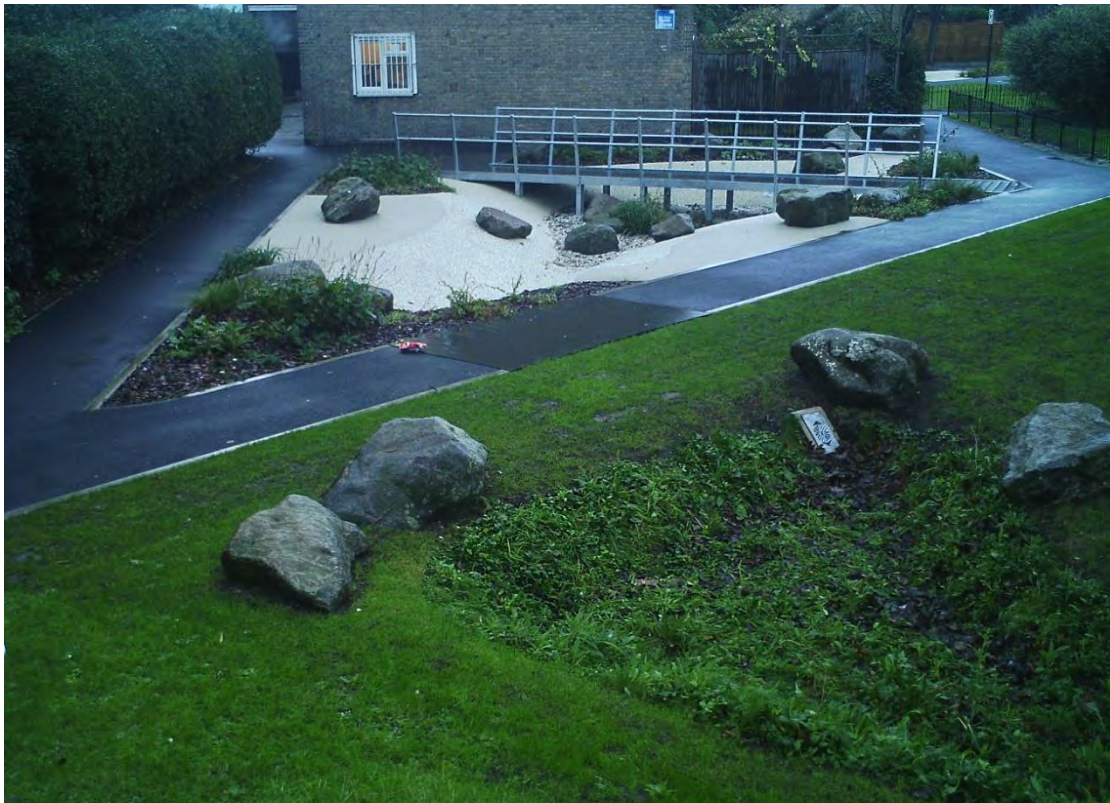
**Figure 33. Time-lapse camera images from Adella House basin (FPC3).** Images show no sign of excessive pooling in the basin i) following the period of intense rainfall or ii) towards the end of the rain event during daylight.

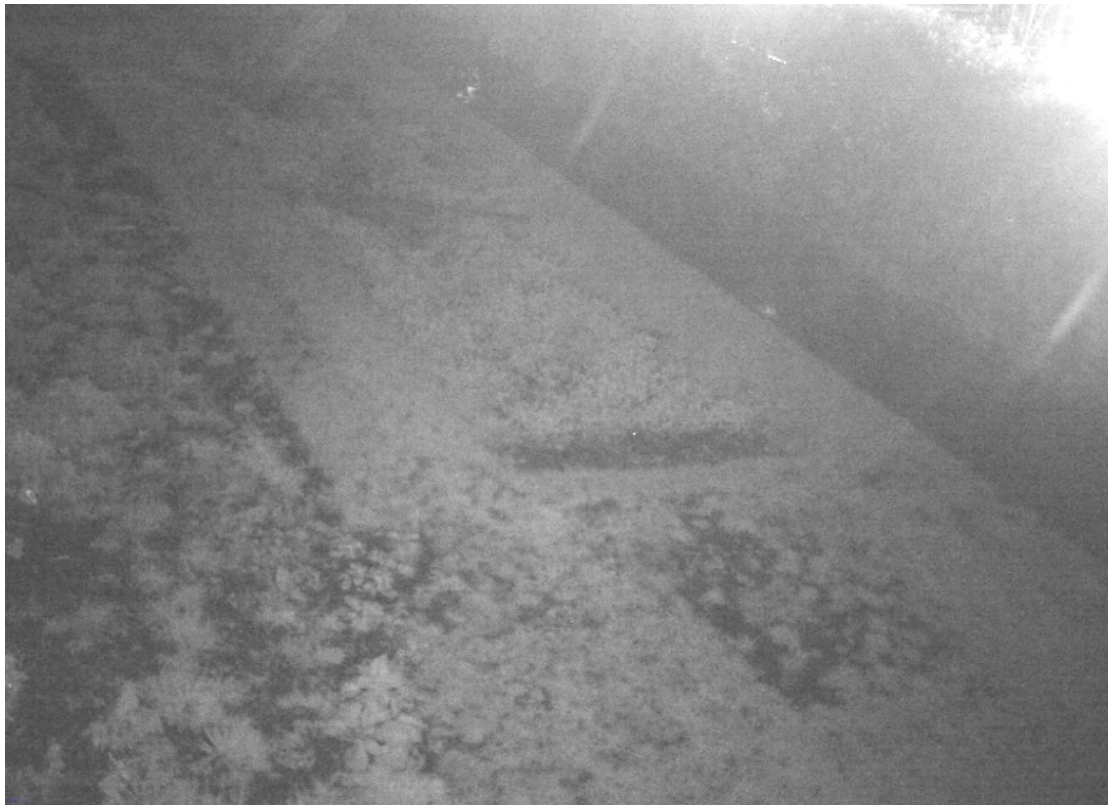
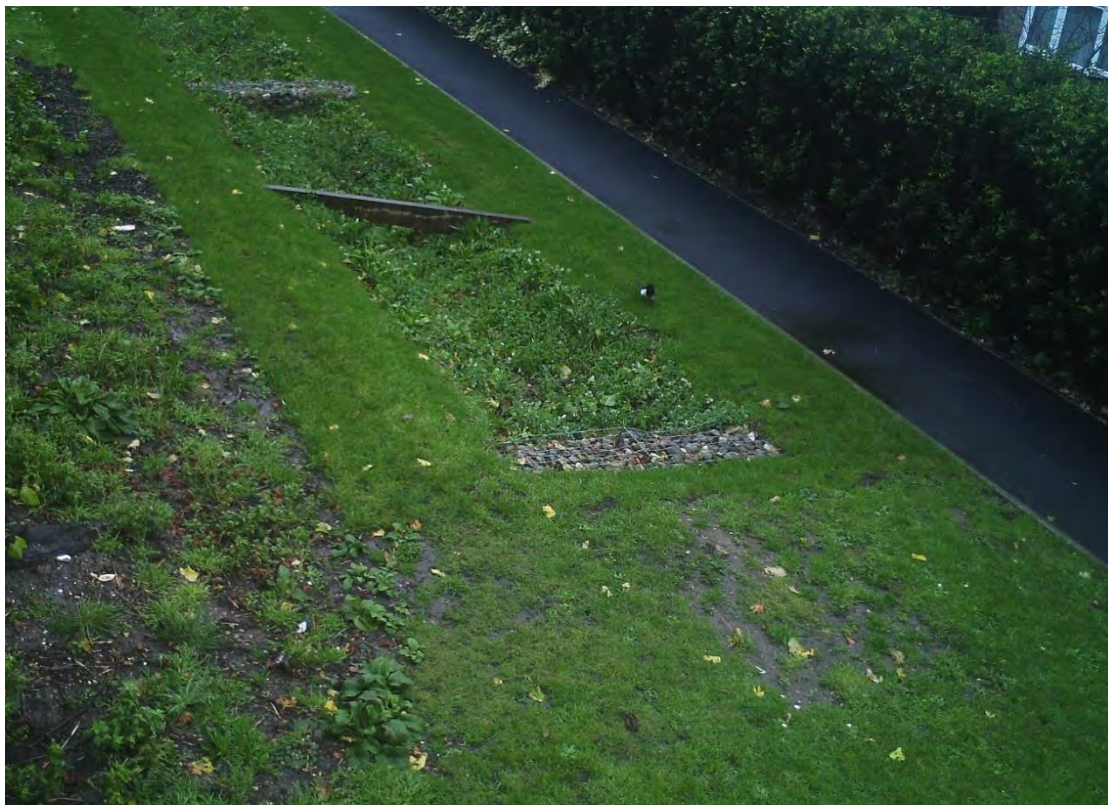
**Figure 34. Time-lapse camera images from Alexandra House swale (FPC1).** Images show no sign of excessive pooling in the swale i) following the period of intense rainfall or ii) towards the end of the rain event during daylight.

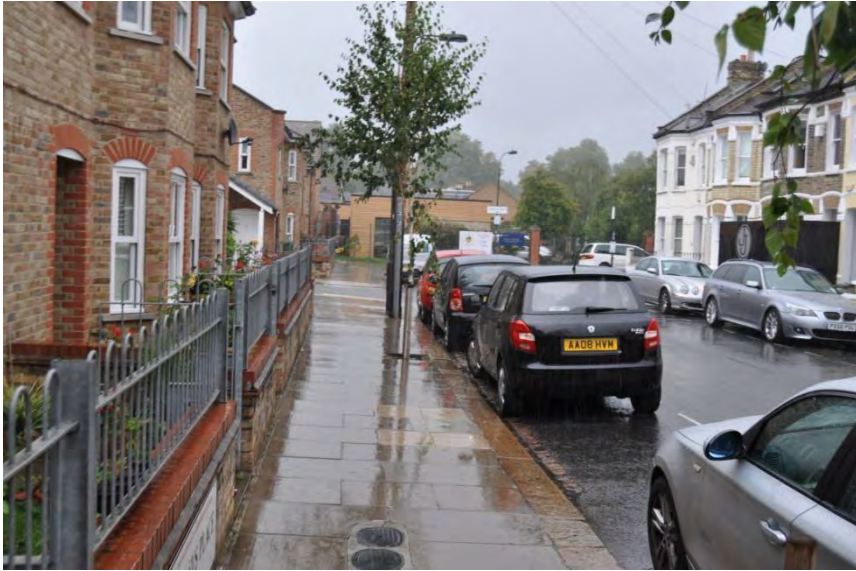
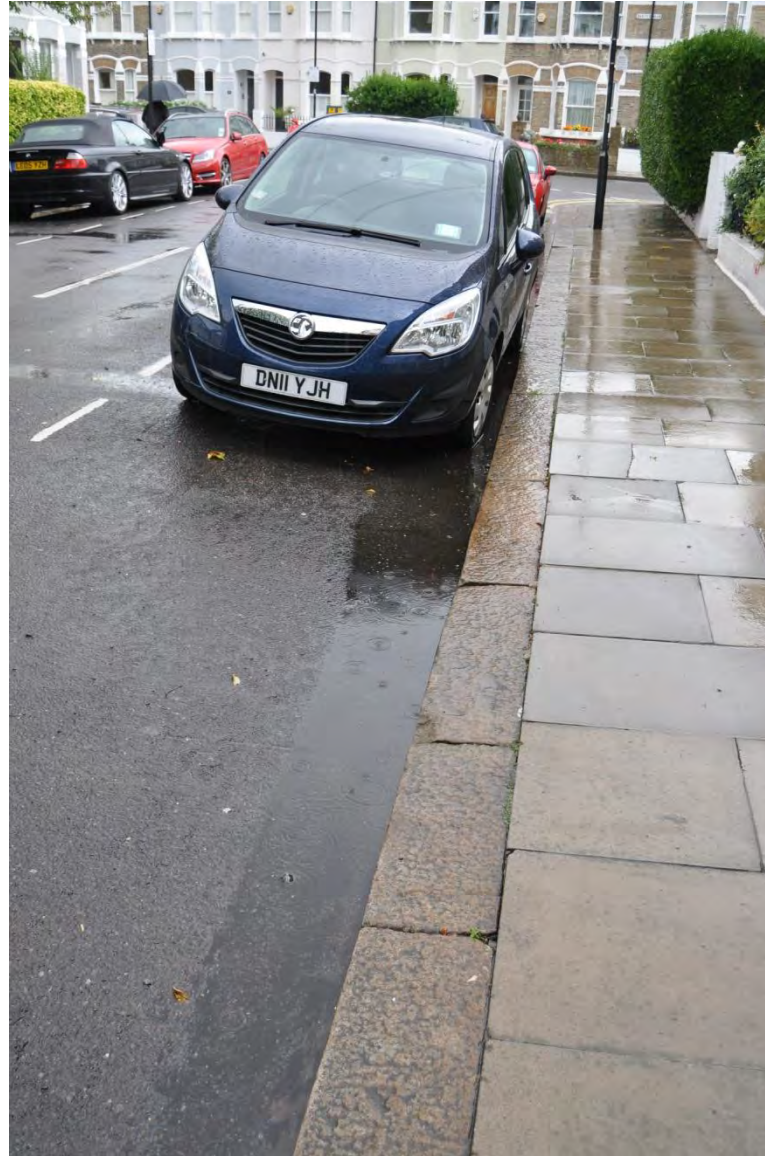
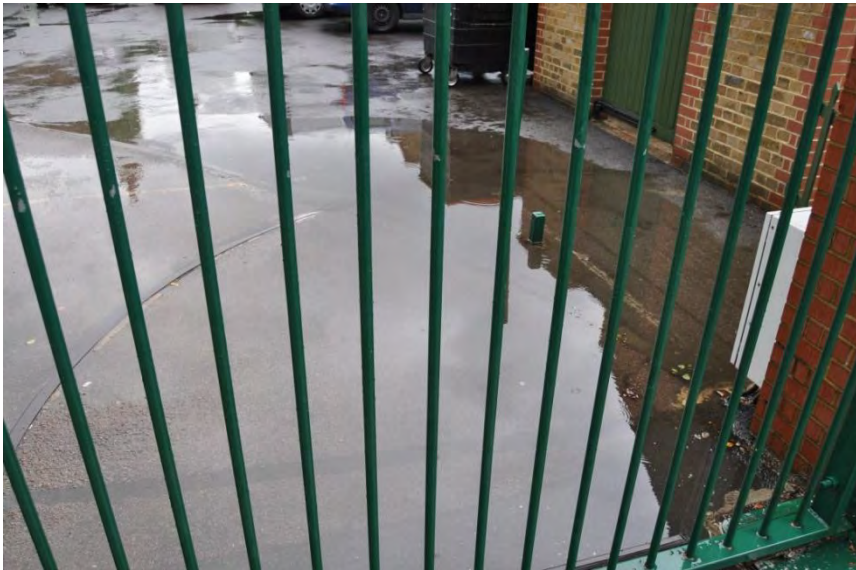
Figure 35. Images from hard standing areas around Richard Knight House during a heavy rain event on the 24th August 2015.

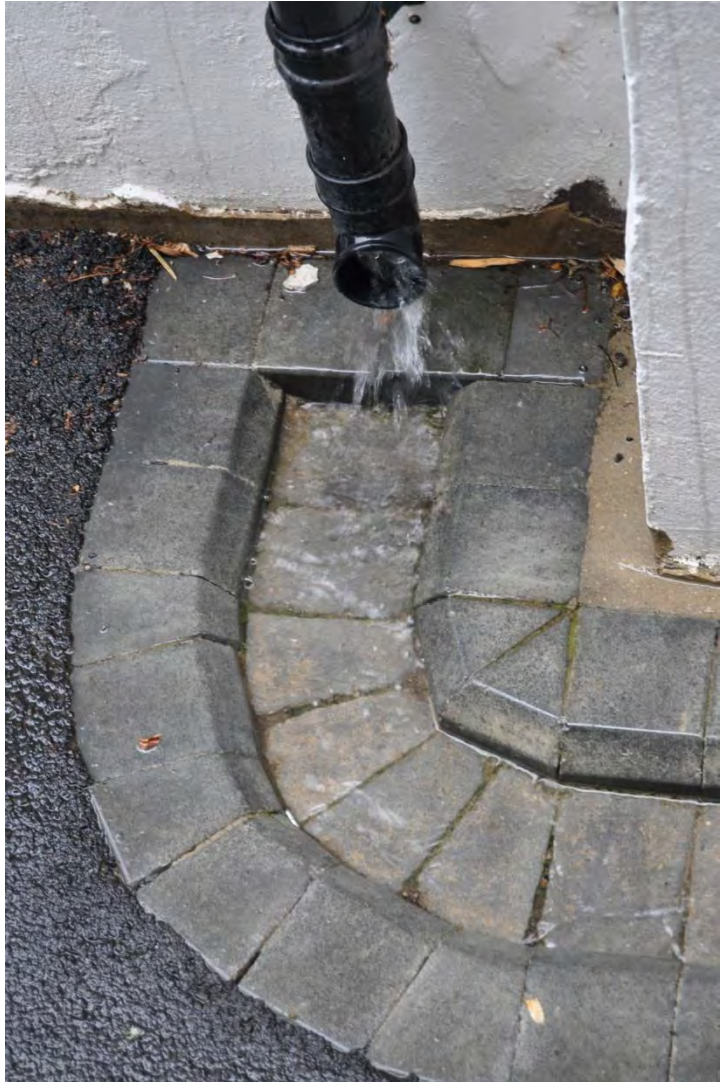
**Figure 36. Water being channelled from roof level to the rain garden at Richard Knight House during a heavy rain event on the 24th August 2015.**

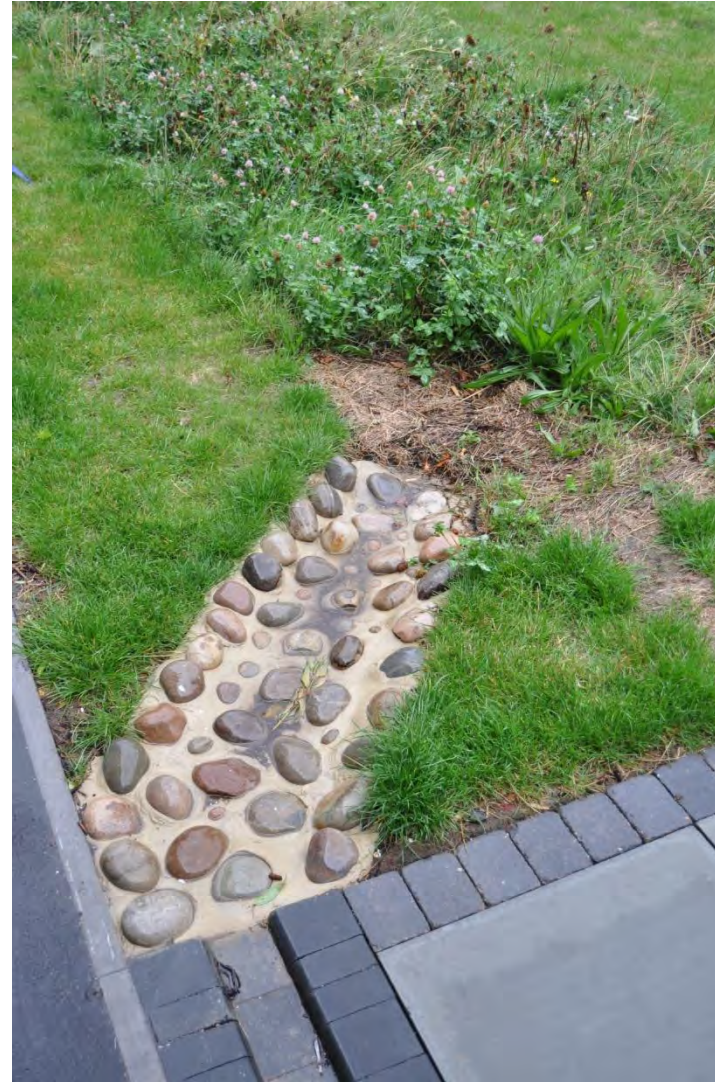
**Figure 37. Water being channelled from ground-level hard standing to a swale at Richard Knight House during a heavy rain event on the 24th August 2015.**

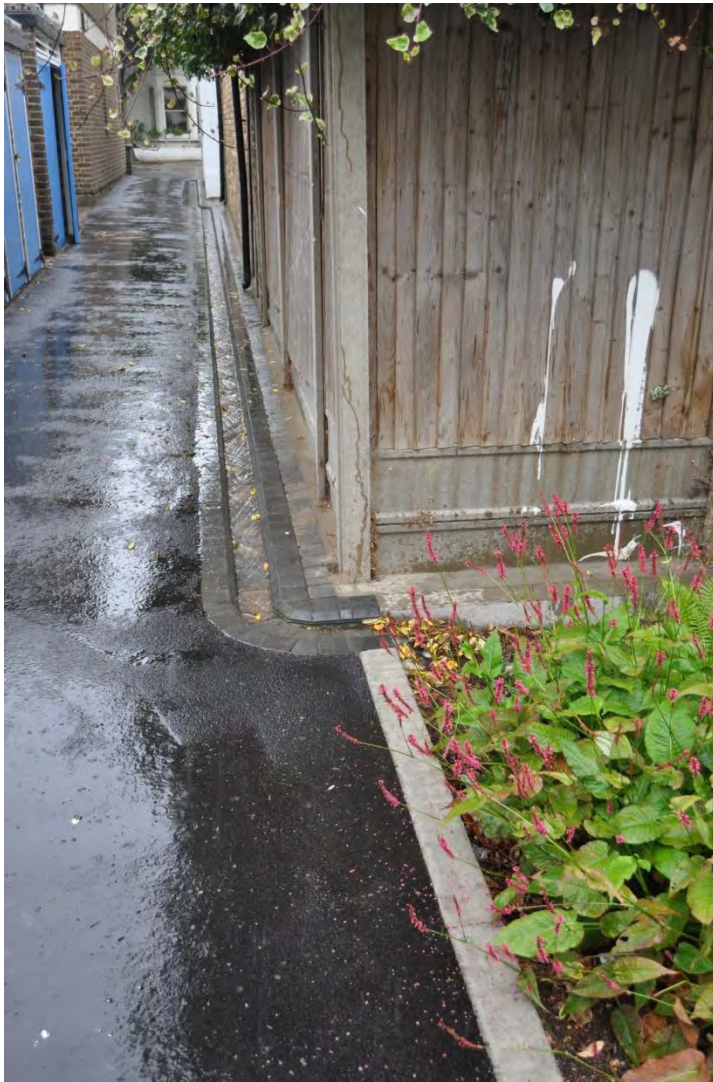
In the Richard Knight House rain garden there was a small amount of pooling observed at the point where the channel bringing water from surrounding roofs and the ground-level hardstanding entered the rain garden. However, there was no evidence that this pooling was persisting and, with no evidence of pooling further down the rain garden, it appeared that the rain entering the rain garden was infiltrating as designed. There was also no evidence of rain entering the Richard Knight House control flow chamber from the rain garden under-drain for this rain event.

**Figure 38. Water from roof level and ground-level hard standing being channelled into the rain garden at Richard Knight House during a heavy rain event on the 24th August 2015.**

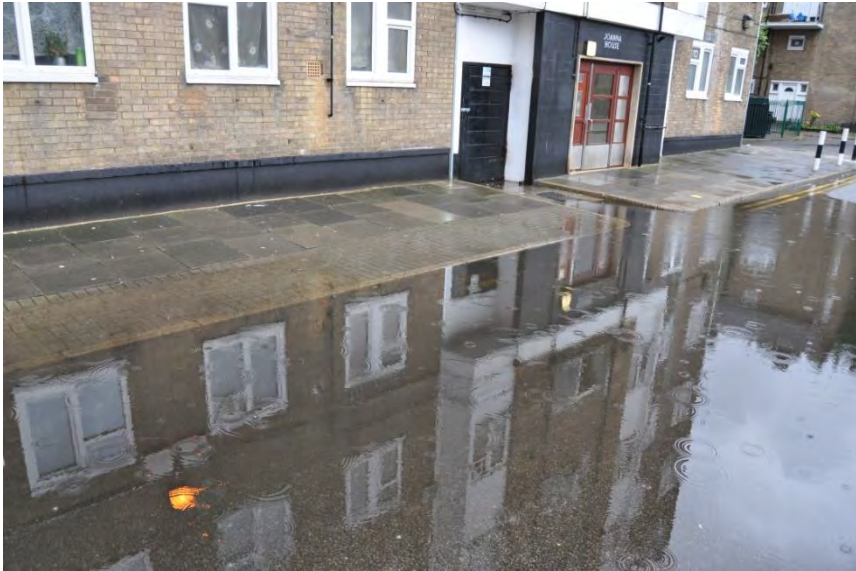
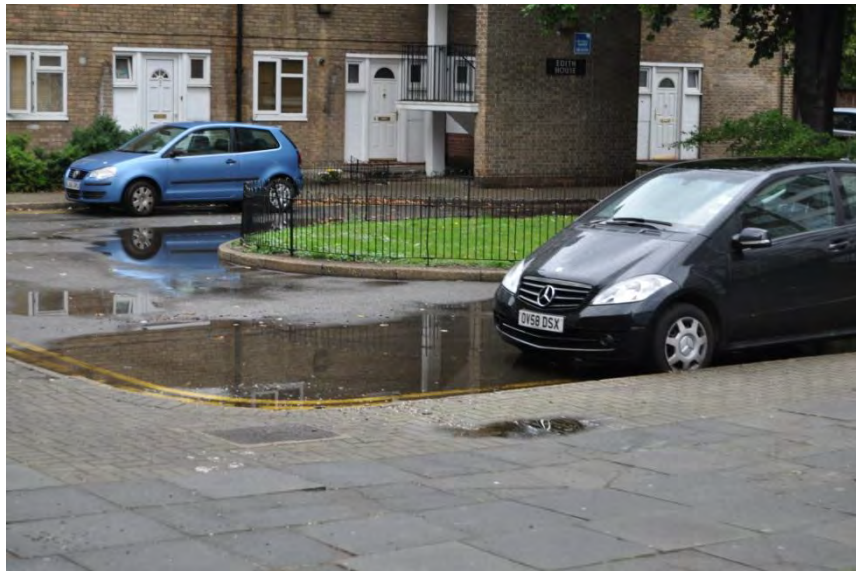
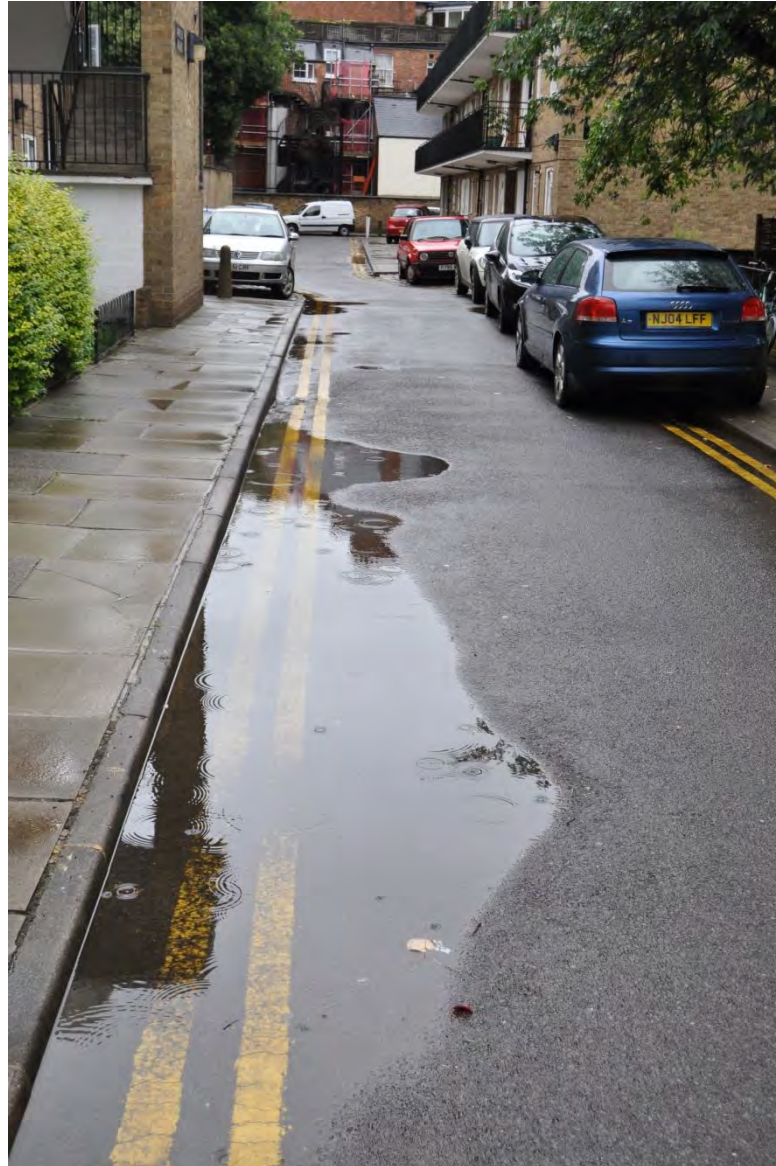
Figure 40. Images from hard standing areas around Queen Caroline Estate during a heavy rain event on the 24th August 2015.

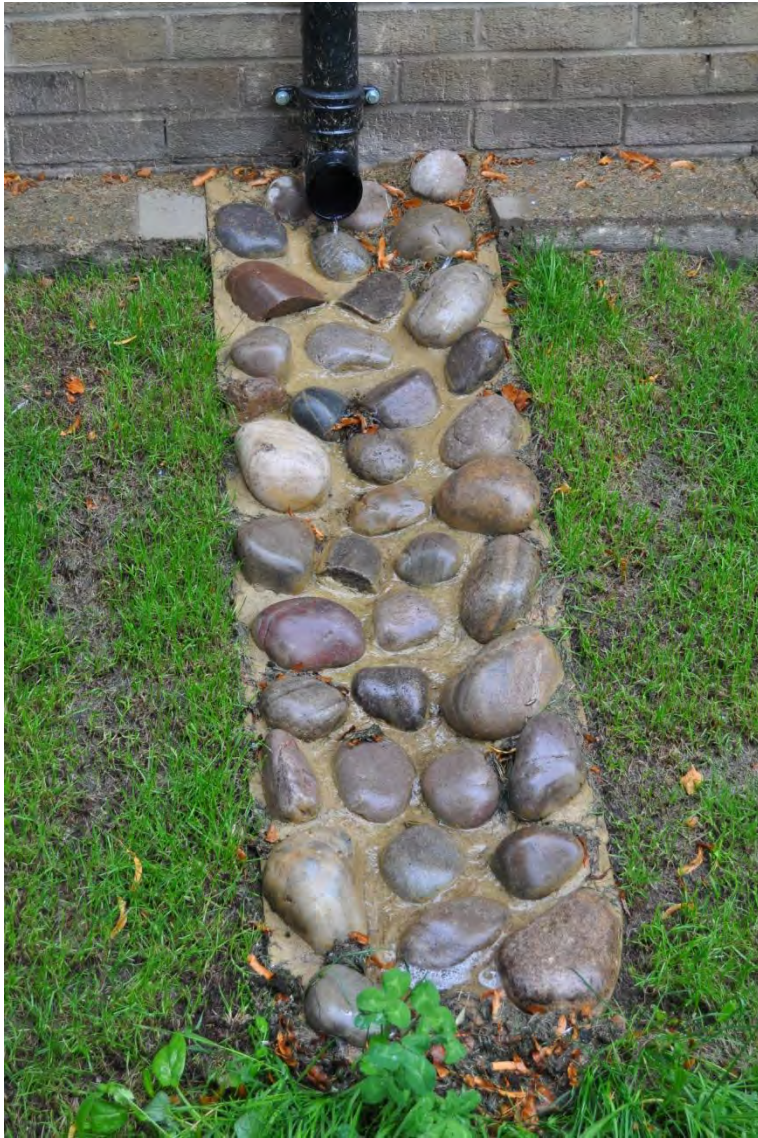
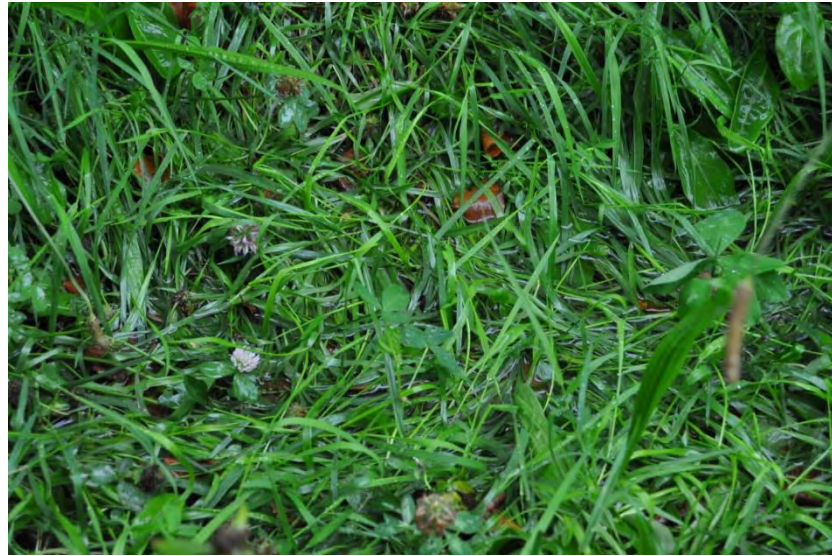
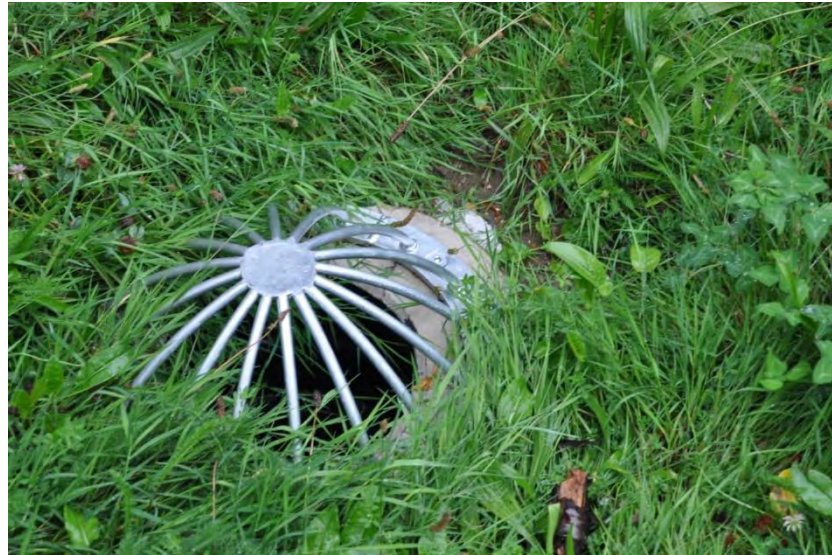
**Figure 41. Beatrice House swale during a heavy rain event on the 24th August 2015.** Images show i) water from Beatrice House roof being channelled into the swale; ii) pooling at the base of the swale; iii) no pooling around the outlet indicating all rainfall stored and infiltrated.

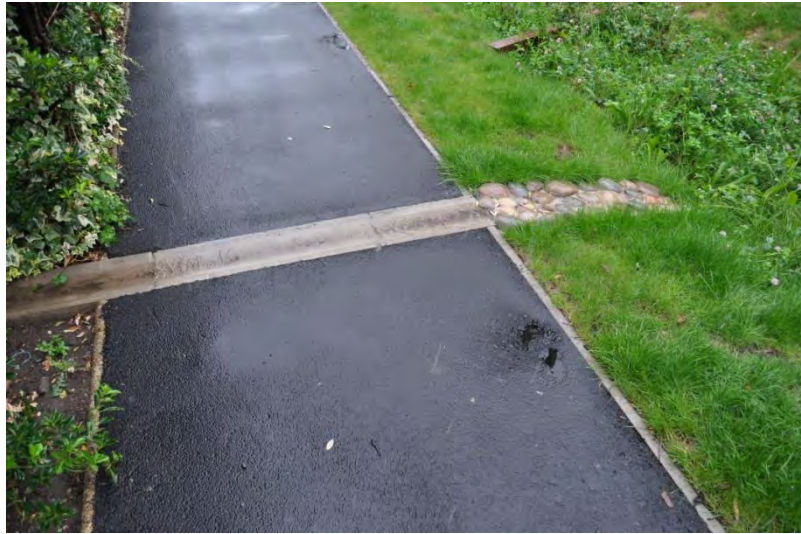
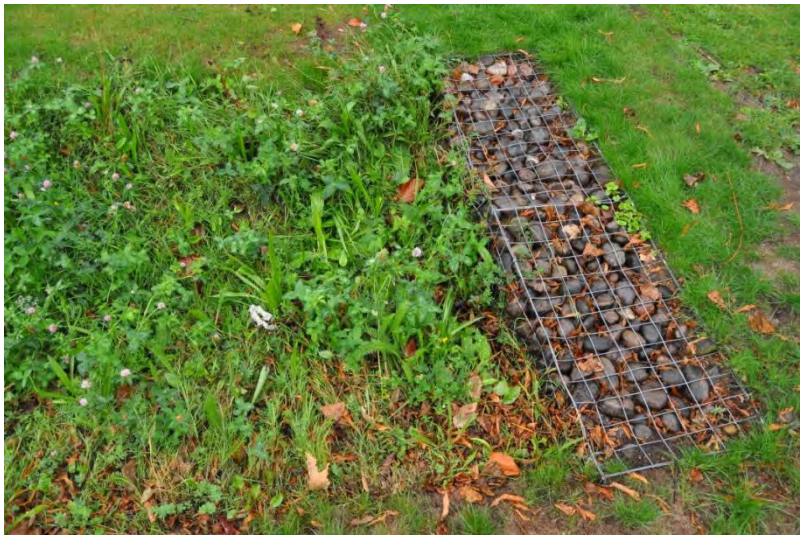
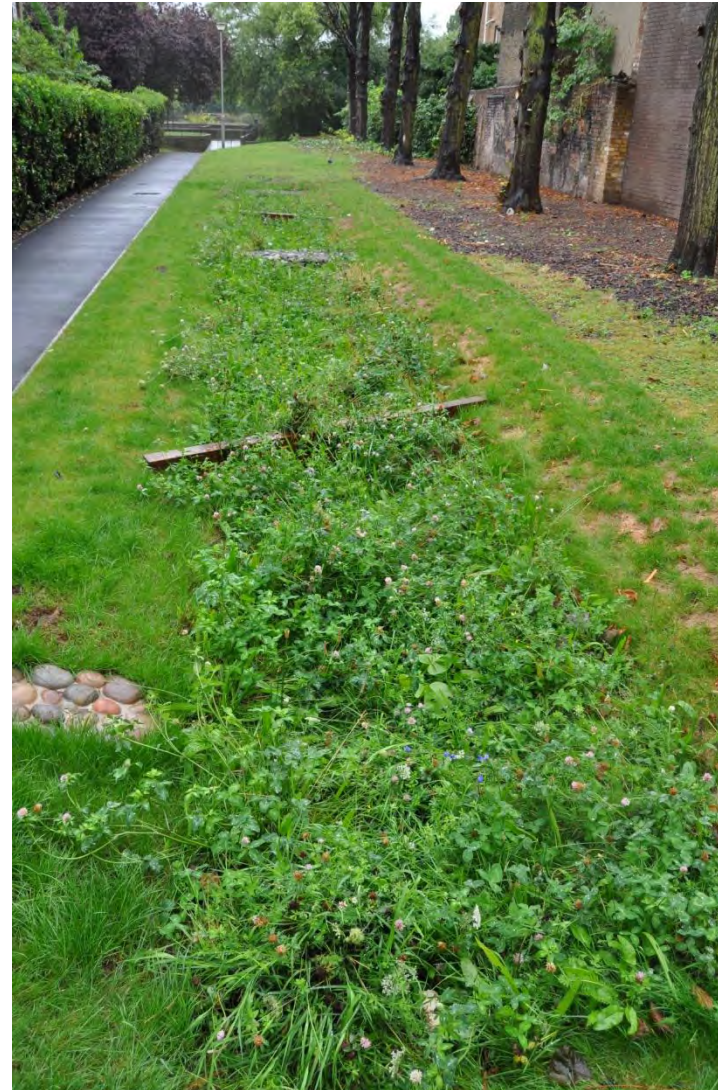
**Figure 42. Alexandra House swale during a heavy rain event on the 24th August 2015.** Images show i) water from Alexandra House roof being channelled into the swale; ii) no pooling at the end of the swale; iii) no pooling around the inlet to the swale.

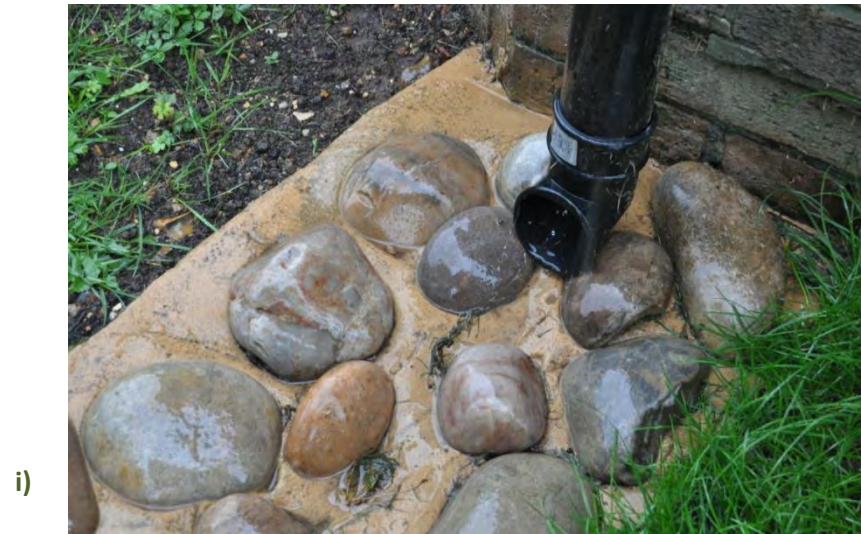
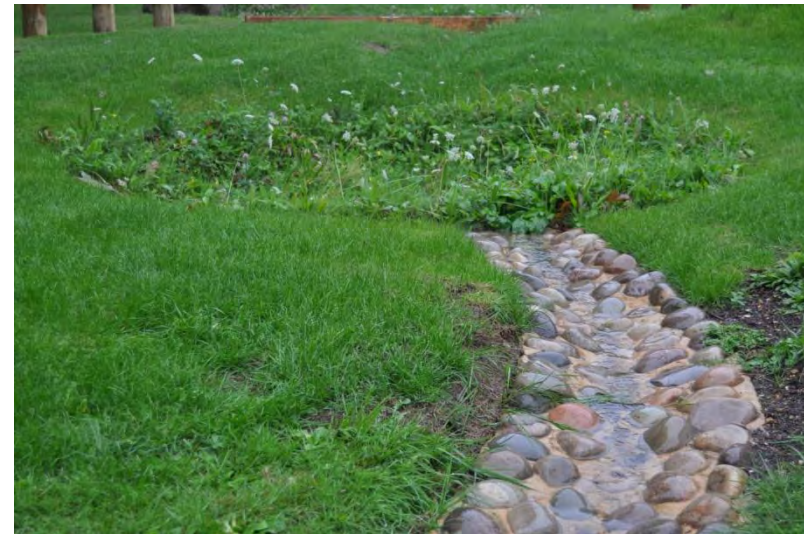
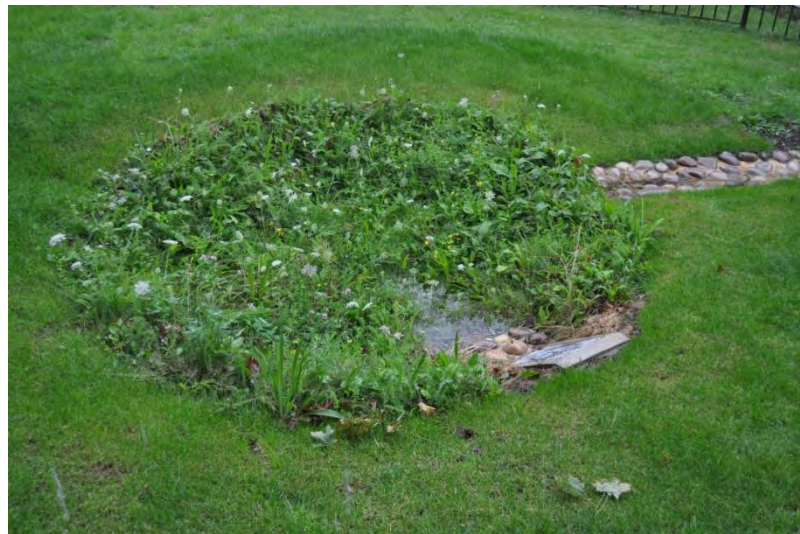
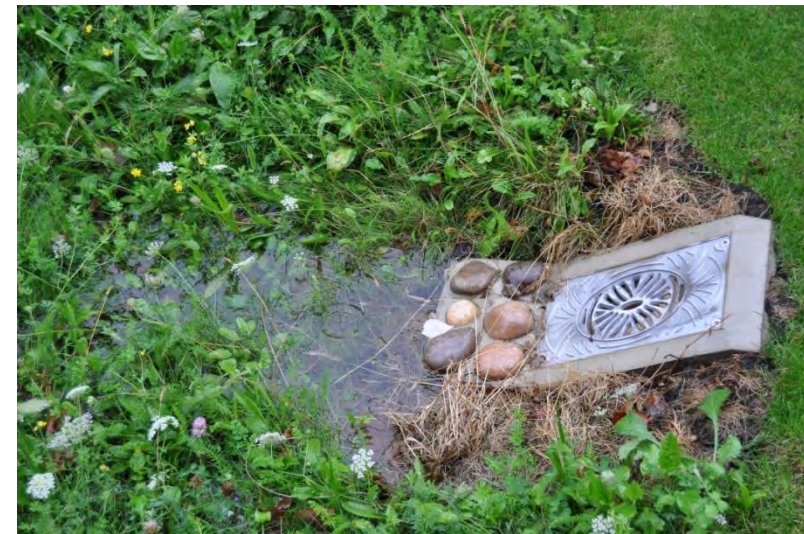
In the Community Hall basin there was evidence of substantial pooling during the heaviest rainfall period of this rain event. However, the pooling was not observed reaching the height of the overflow. It is proposed that rain simulation of a 1 in 100 year rain event is performed to assess the volume of this retention basin compared to the original design to ensure that it was profiled correctly.

**Figure 43. Community Hall basin during a heavy rain event on the 24th August 2015.** Images show i) water from Community Hall roof being intercepted before entering the storm drains; ii) intercepted rainwater being diverted into basin; iii) pooling in the basin; iv) pooling approaching the depth of the overflow.

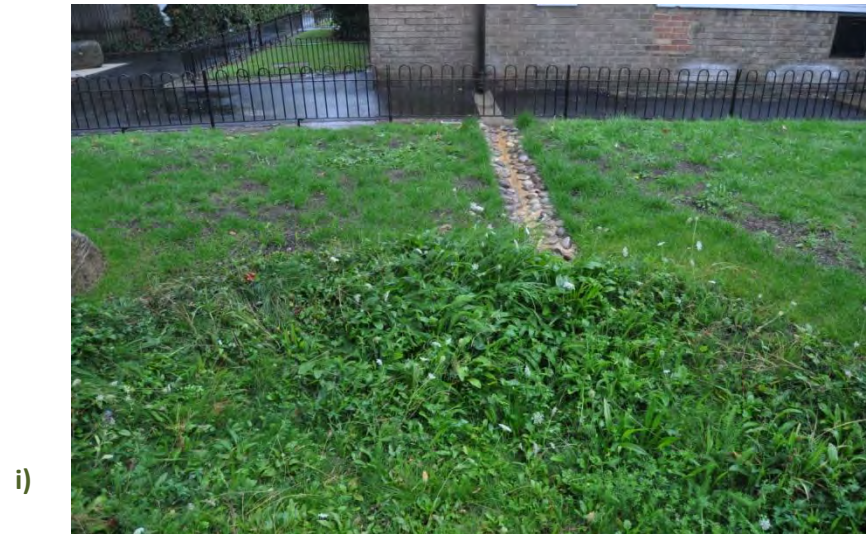
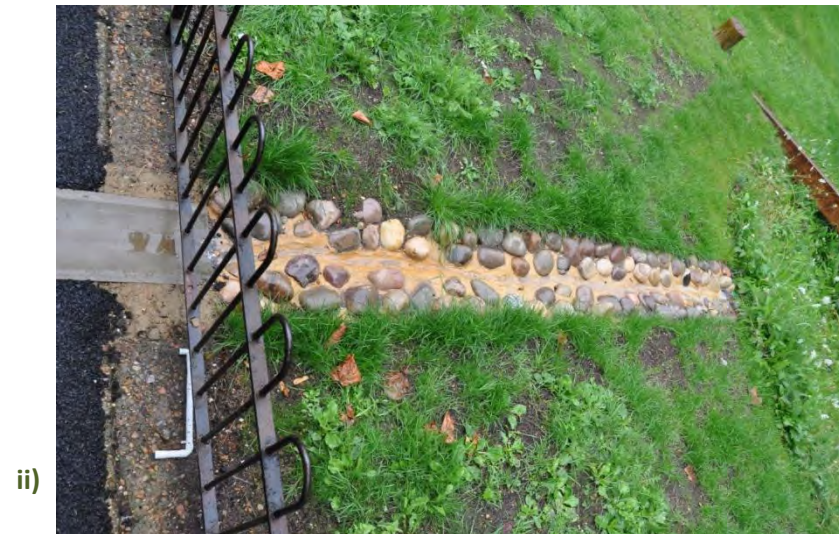
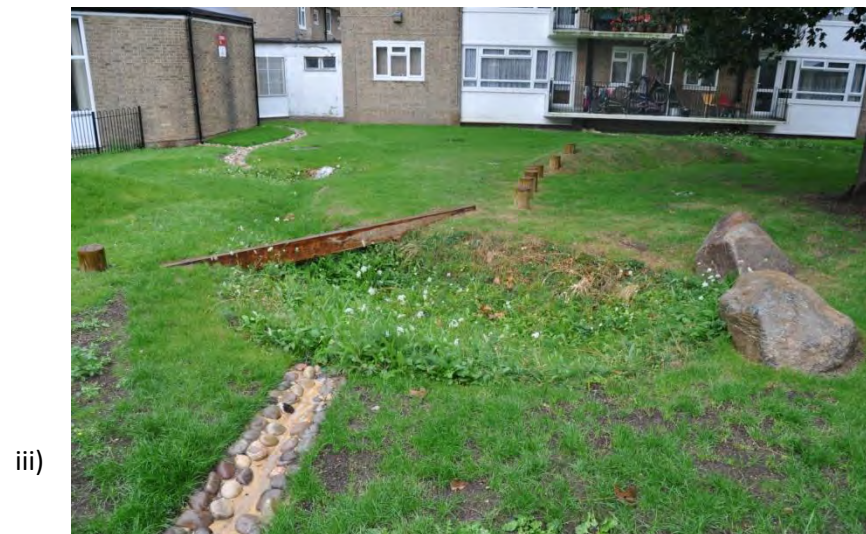
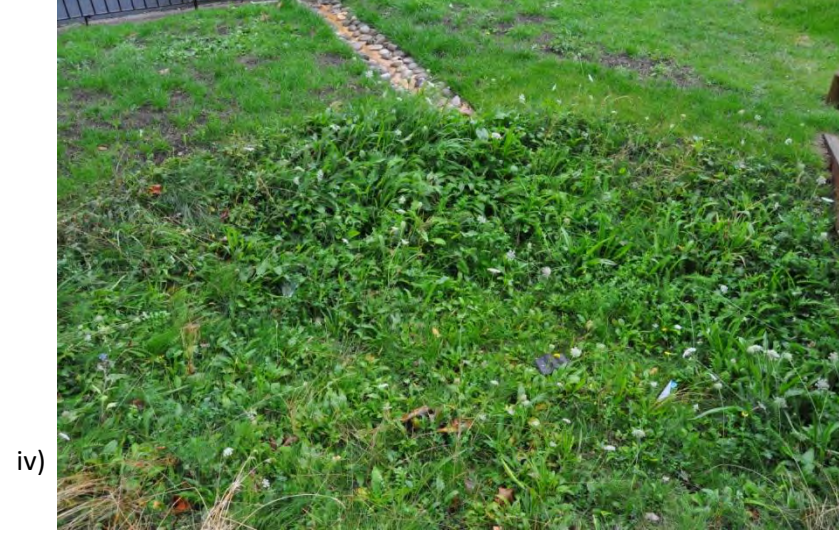
**Figure 44. Sophia House basin during a heavy rain event on the 24th August 2015.** Images show i) water from Sophia House roof being intercepted before entering the storm drains; ii) intercepted rainwater being diverted into basin; iii) & iv) no evidence of pooling in the basin.

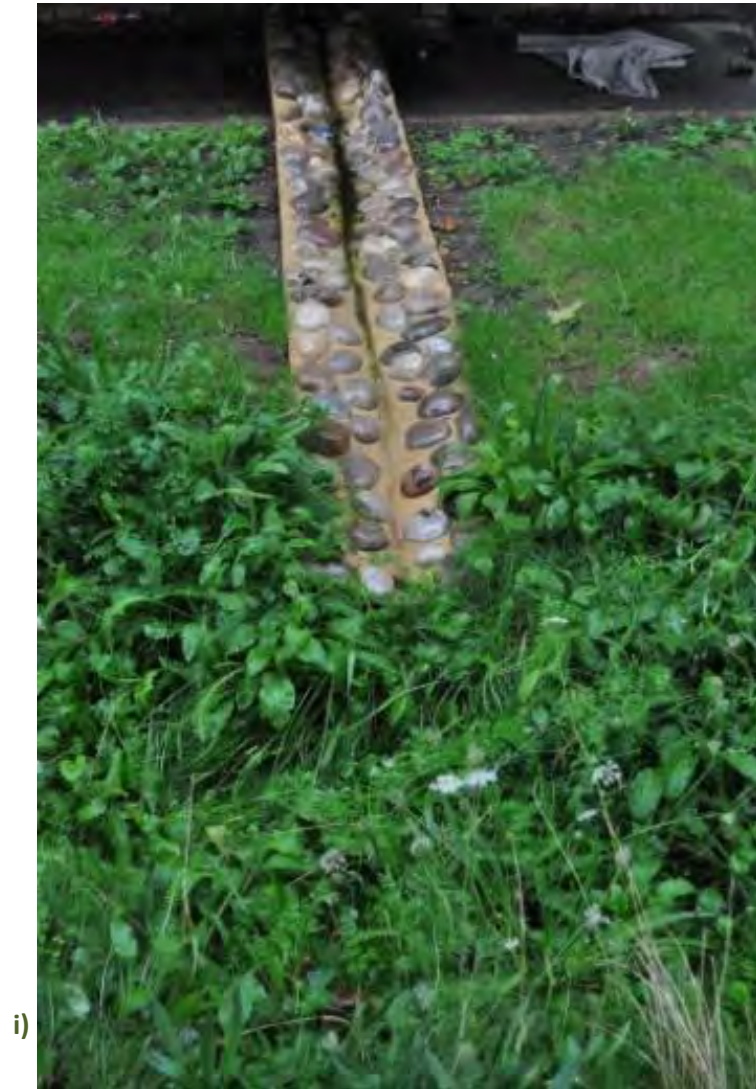
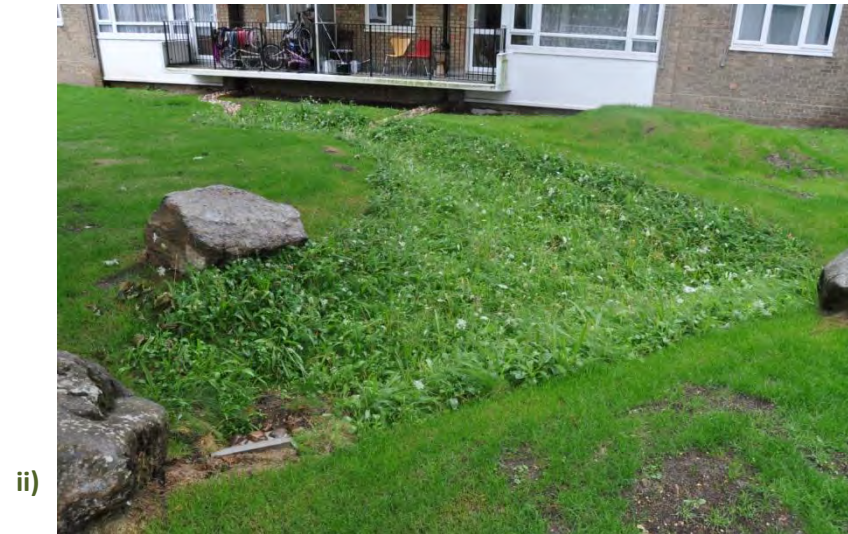
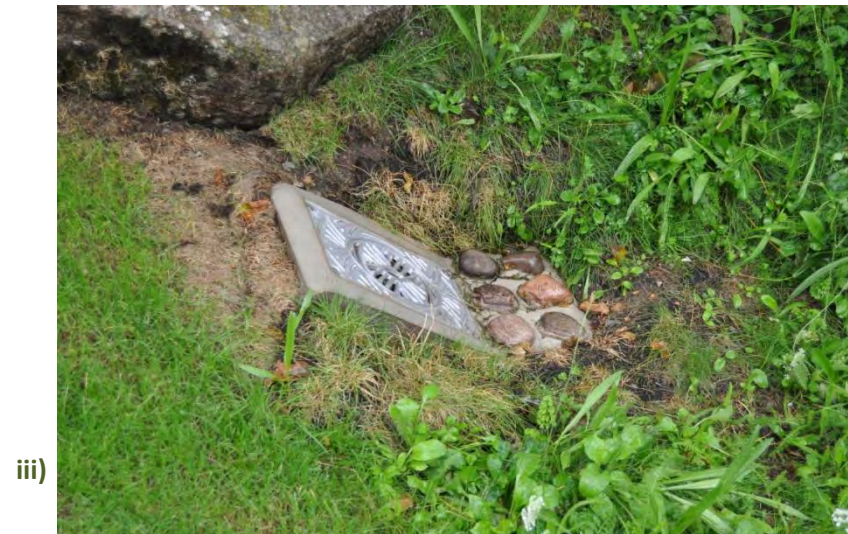
**Figure 45. Adella House grass basin during a heavy rain event on the 24th August 2015.** Images show i) water from Adella House roof being diverted into basin; ii) no evidence of pooling in basin; iii) no evidence of standing water near overflow.

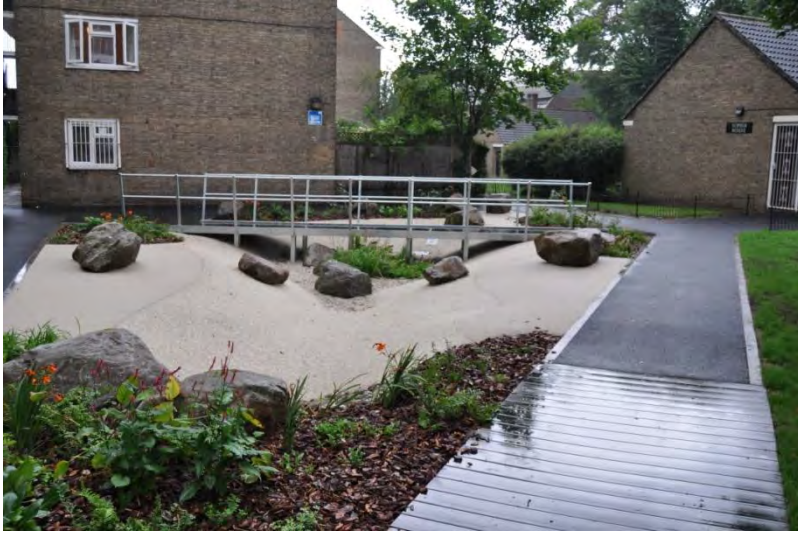
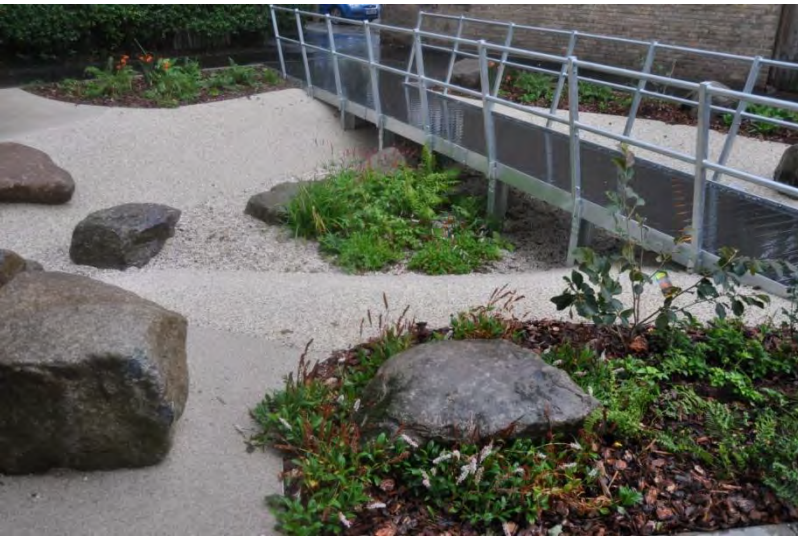
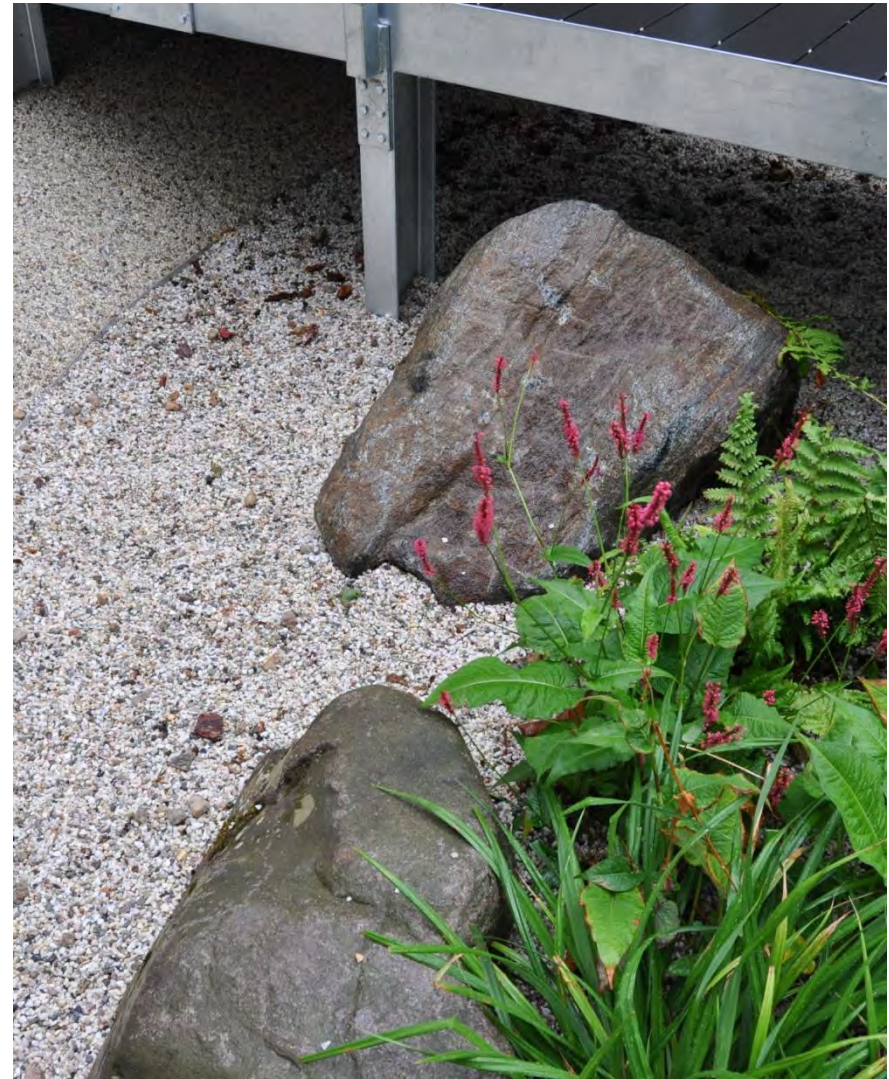
**Figure 46. Adella House stoney basin during a heavy rain event on the 24th August 2015. Images show i) water from hard standing areas running into basin; ii) & iii) no evidence of pooling in basin.**
