**Climate Proofing Housing Landscapes:  
Interim Monitoring Report**

**August 2015 to May 2016**

**Authors: Connop, S. and Clough, J.**

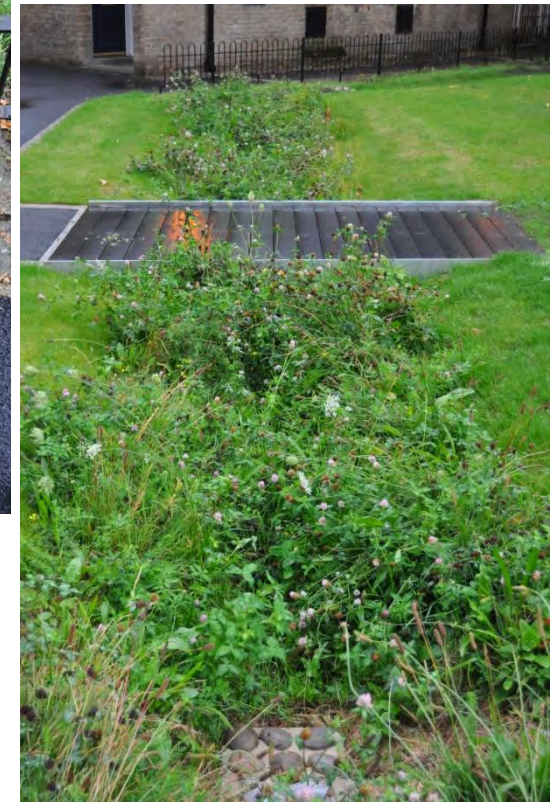
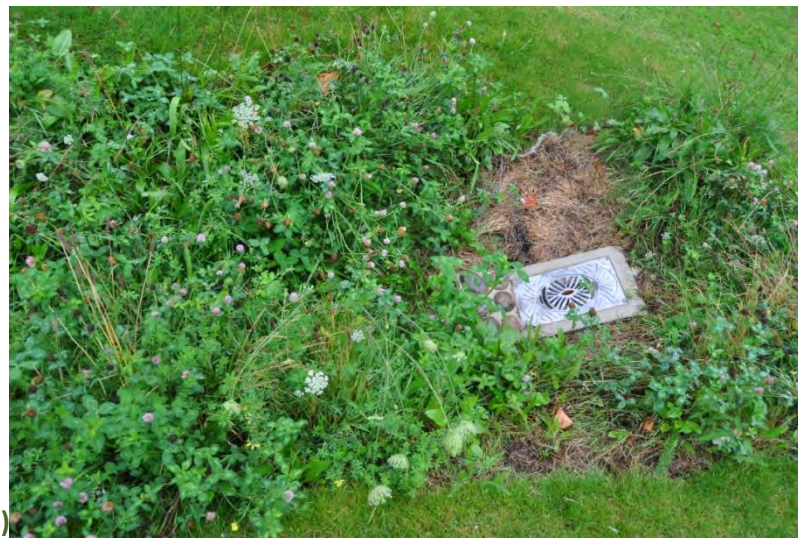
**Figure 47. Phillipa House basin during a heavy rain event on the 24th August 2015.** Images show i) rain from Phillipa House Roof being intercepted before entering the stormdrain system; ii) rain being channelled into Phillipa House basin; iii) no evidence of pooling near basin overflow; iii) no evidence of pooling in basin.

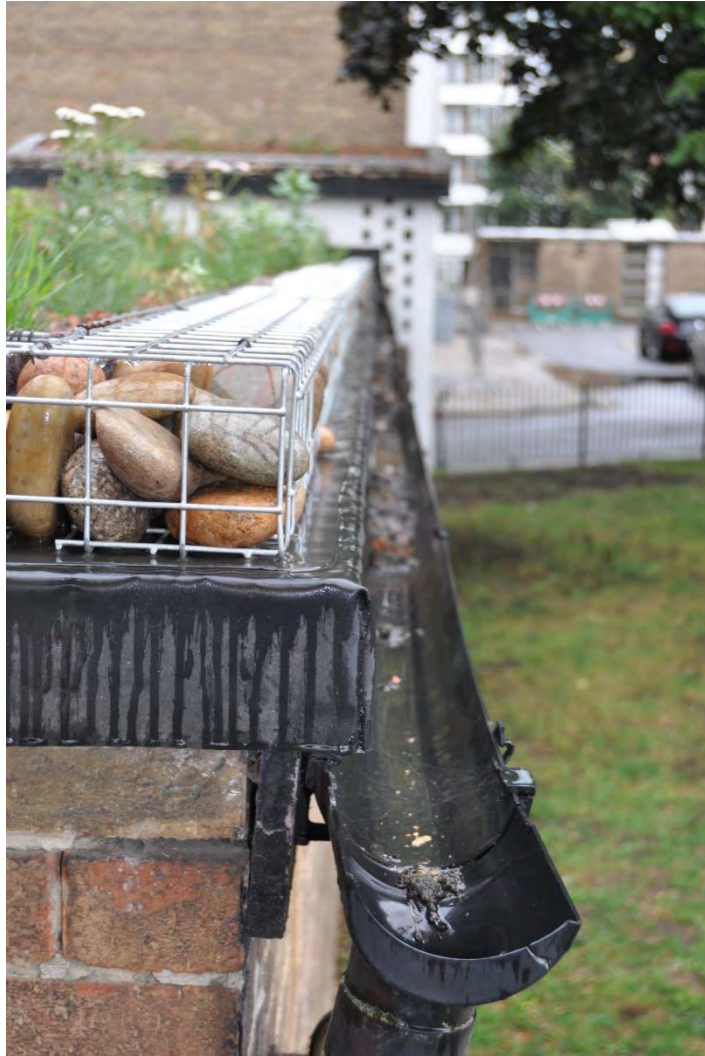
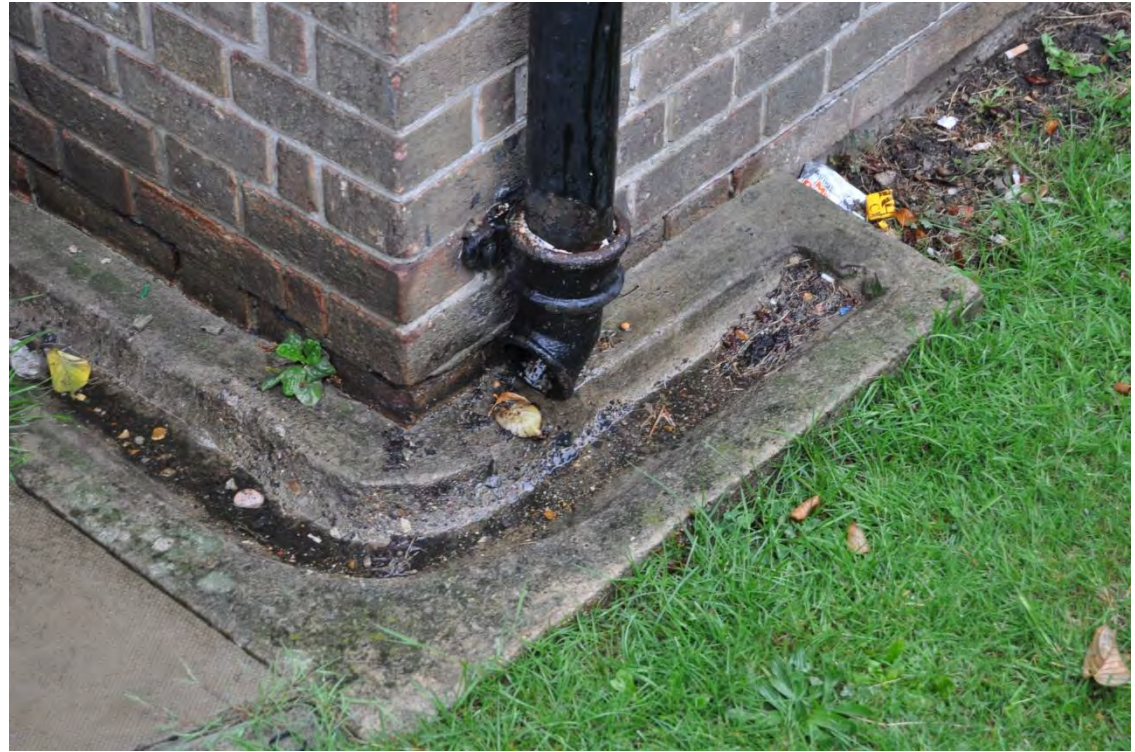
**Figure 48. Pram shed green roofs at Queen Caroline Estate during a heavy rain event on the 24th August 2015. Images show i) low runoff volumes from the roof into the surrounding gutter; ii) little runoff from downpipes to ground level storm drain system.**

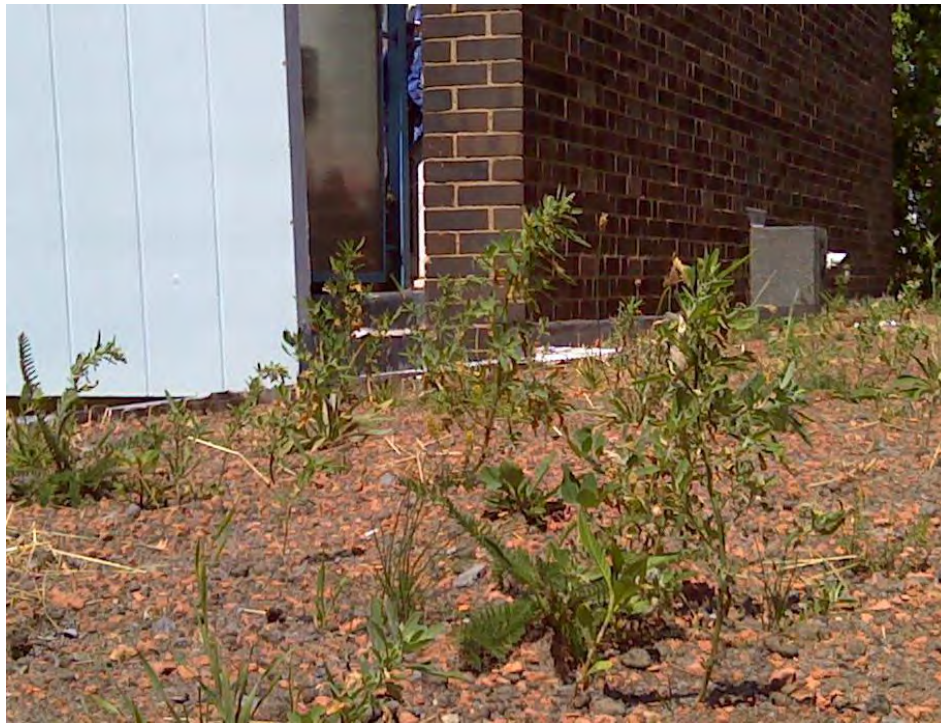
**Figure 49. Photo and infrared image of Cheeseman Terrace green roof on the 10th July 2015.** Infrared image reveals a temperature difference of 29.8°C between the hottest and coolest areas within the field of view. A FLIR QuickReport spotmeter was used to identify individual temperatures within the field of view. Hottest temperatures (>50°C) were associated with metal outlet covers and some areas of bare substrate on the green roof, areas of brickwork and bare areas of substrate were also recorded as substantially hotter than the maximum daily temperature recorded by a nearby weather station (38.9°C and 42.2°C respectively). Coolest temperatures were associated with vegetated areas of the roof with temperatures from 23.9°C to 27.1°C). Vegetation cover of the roof was sparse as the images were taken shortly after roof installation. It would be expected that greater cooling benefits would be achieved once the vegetation cover was more comprehensive.

Results for the hottest days that site visits were made with the thermal imaging camera are presented below in Figures 49 to 62. The hottest days when at site were the 10th July, 12th August, 27th August, 10th September and 25th September 2015. Maximum temperatures during the thermal photography on each of these days respectively were 26°C, 24°C, 20°C, 21°C, and 17°C.

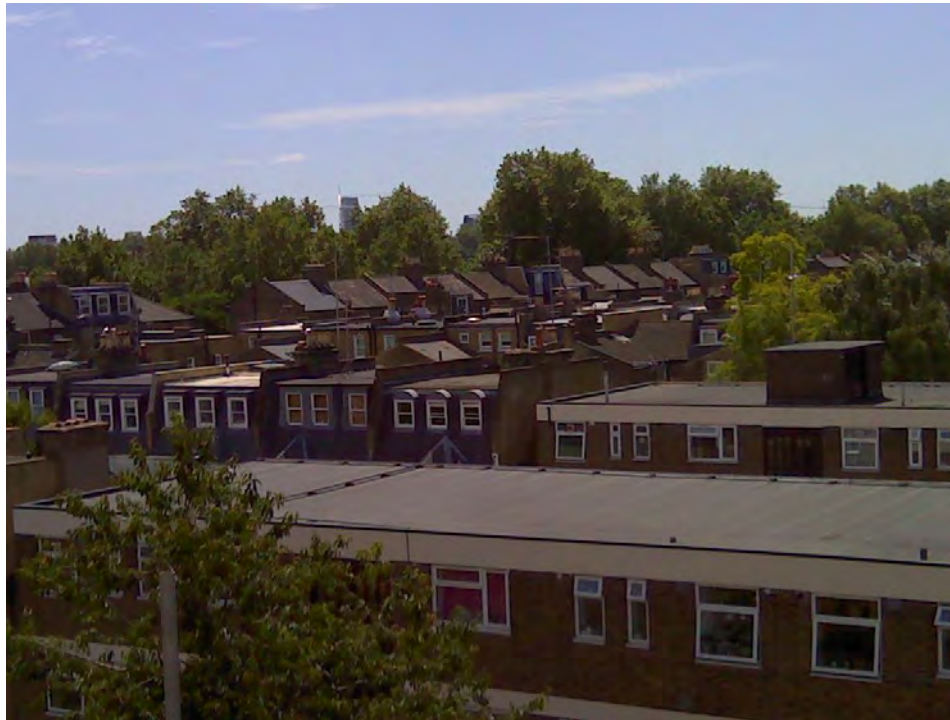
**Figure 52. Photo and infrared image of a neighbouring roof to the Richard Knight House green roof on the 10th July 2015.** A FLIR QuickReport spotmeter was used to identify individual temperatures within the field of view. The roof was selected as being the closest in design to the Richard Knight House roof prior to the green roof retrofit. Infrared imaging reveals temperatures from 59.6°C to 60.2°C associated with the flat roof waterproofing membrane. These temperatures were 12°C to 20°C degrees higher than those recorded on the unvegetated green roof substrate on Richard Knight House at the same time.

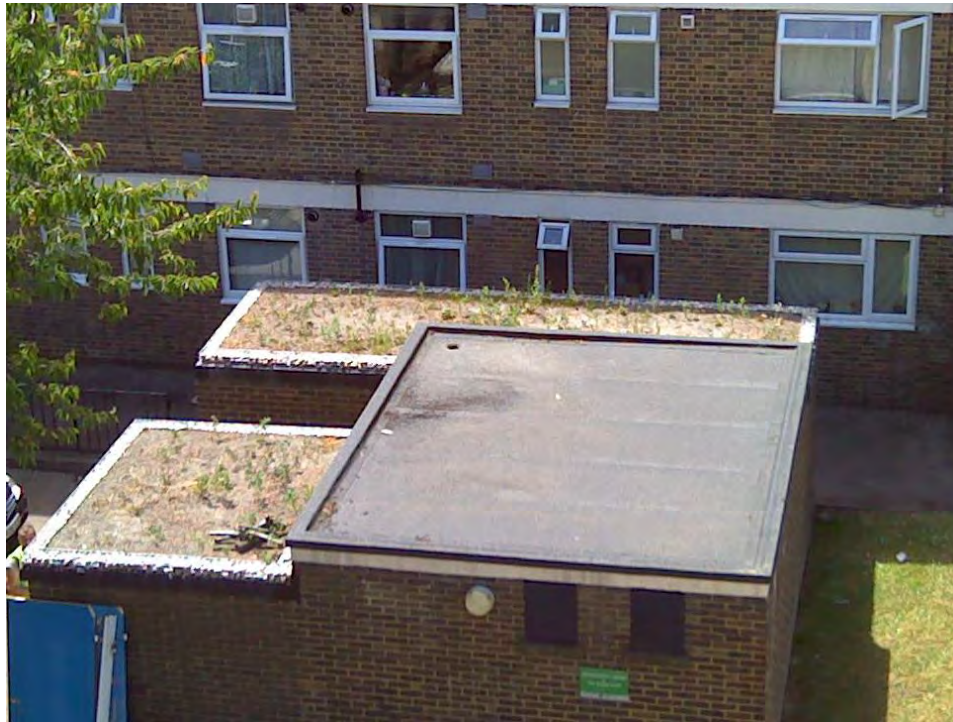
**Figure 53. Photo and infrared image of pram shed roofs at Richard Knight House 10th July 2015.** Image showing the difference in temperatures between the green roof retrofitted pram shed roofs and the bare roof. A FLIR QuickReport spotmeter was used to identify individual temperatures within the field of view. Infrared imaging reveals temperatures from 50.3°C to 51.5°C on the bare flat roof and temperatures of 33.6°C to 48.2°C on the green roofs. Lowest temperatures on the green roof were associated with vegetated areas and deadwood pile areas. Due to images being taken soon after roof installation vegetation was sparse. Highest temperatures on the green roofs were associated with bare substrate areas that were not yet colonised.

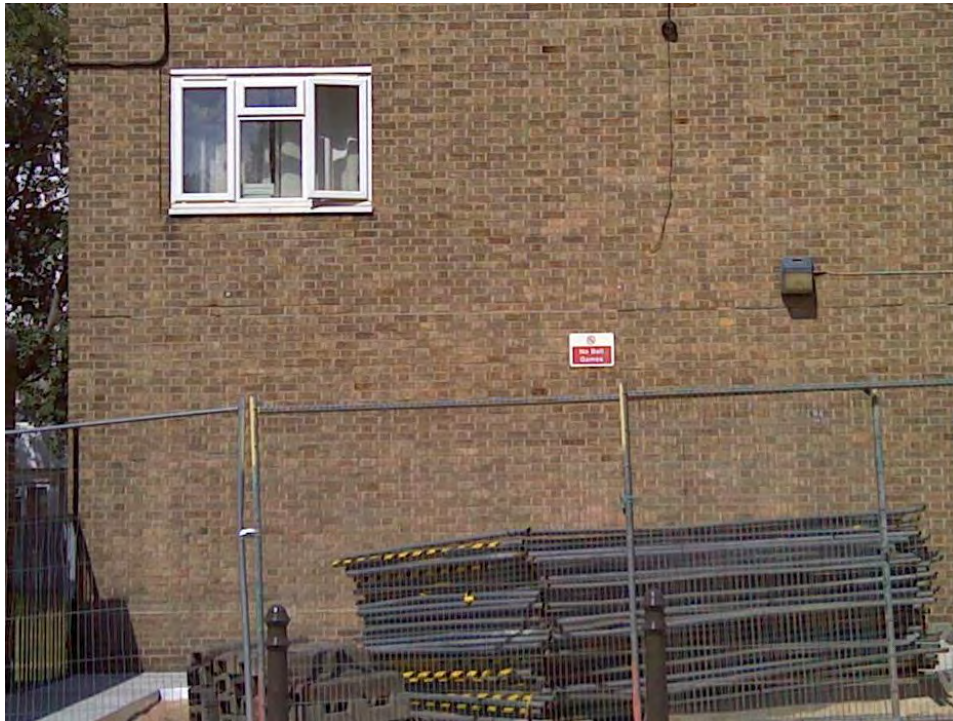
**Figure 54. Photo and infrared image of wall of Mary House, Queen Caroline Estate, 10th July 2015.** Image showing the location planned for the vertical rain garden SuDS intervention. A FLIR QuickReport spotmeter was used to identify individual temperatures within the field of view. Infrared imaging reveals temperatures from 41.2°C to 44.3°C on the bare brick of the wall. Neighbouring walls were also photographed with the infrared camera to find a control wall with similar thermal signature for monitoring after the installation of the vertical green wall.

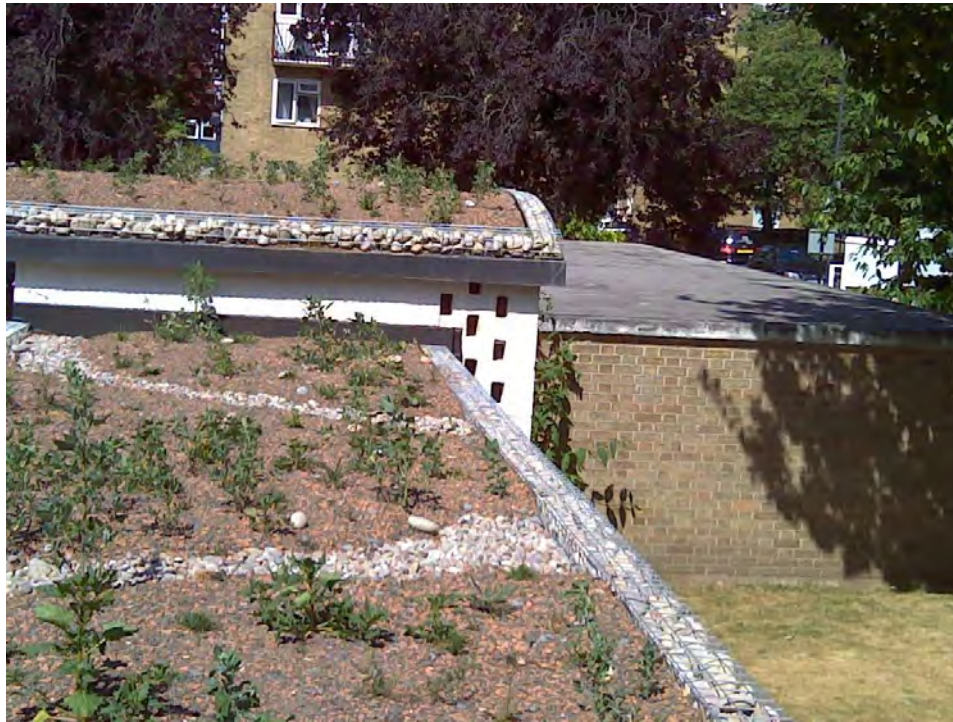
**Figure 55. Photo and infrared image of pram shed roofs at Queen Caroline Estate 10th July 2015.** A FLIR QuickReport spotmeter was used to identify individual temperatures within the field of view. Image showing the difference in temperatures between the green roof retrofitted pram shed roofs and the bare roof. Infrared imaging reveals temperatures from 42.5°C to 45.3°C on the bare flat roof and temperatures of 28.7°C to 57.7°C on the green roofs. Lowest temperatures on the green roof were associated with vegetated areas, highest temperatures were associated with bare substrate areas that were not yet colonised. Images were taken soon after green roof installation so vegetation was still sparse. [N.B. other images of only the bare roof recorded temperatures of 48.9 on areas hidden from the field of view of the above image].

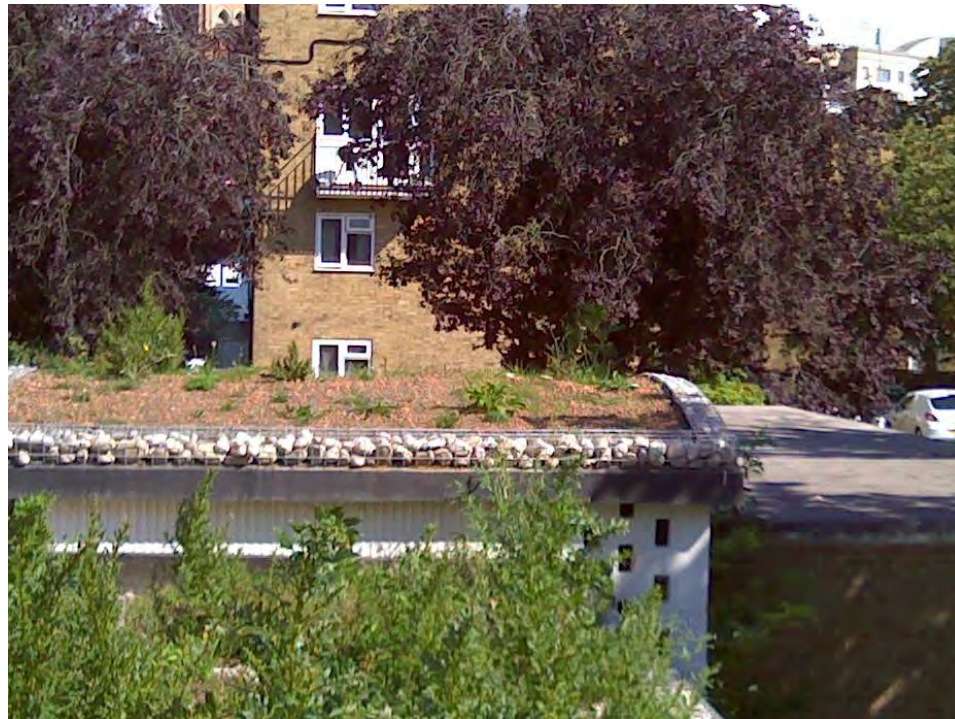
**Figure 56. Photo and infrared image of pram shed roofs at Queen Caroline Estate 10th September 2015.** Image showing the difference in temperatures between the green roof retrofitted pram shed roofs and the bare roof. A FLIR QuickReport spotmeter was used to identify individual temperatures within the field of view. Infrared imaging reveals temperatures from 27.1°C to 27.9°C on the bare flat roof and temperatures of 18.6°C to 35.9°C on the green roofs. Lowest temperatures on the green roof were associated with vegetated areas, highest temperatures were associated with bare substrate areas that were not yet colonised. Images were taken after green roof vegetation had time to colonise. As such much more substantial areas of the green roofs recorded cooler temperatures than on previous visits.

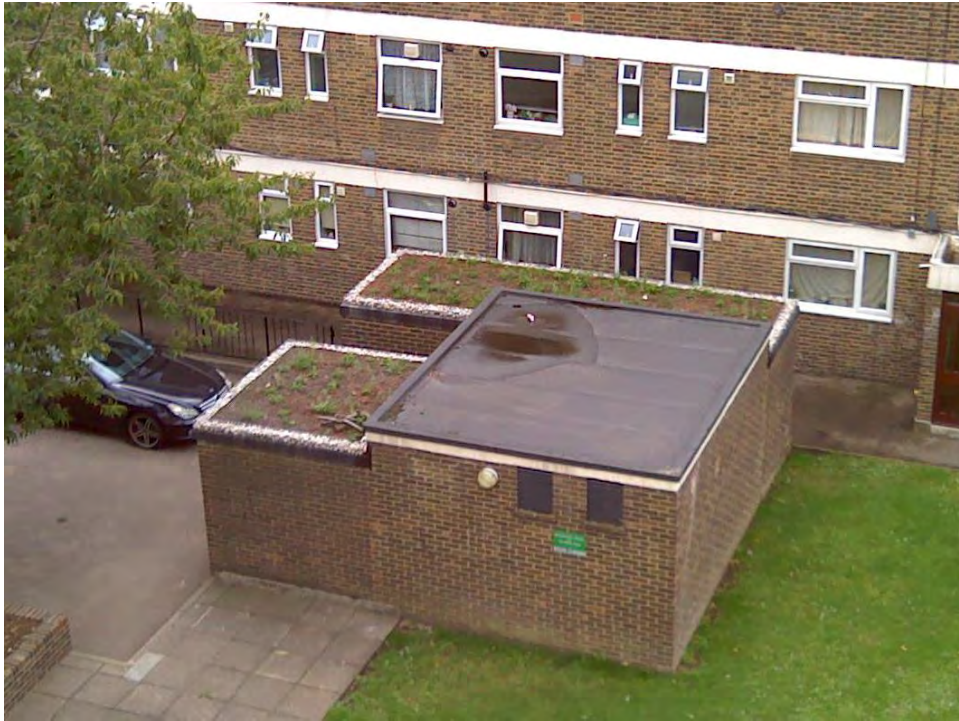
**Figure 61. Photo and infrared image of Pram shed roofs at Richard Knight House 27th August 2015.** Image showing the difference in temperatures between the green roof areas and the flat roof area. A FLIR QuickReport spotmeter was used to identify individual temperatures within the field of view. Infrared imaging reveals temperatures from 18.9°C to 21.0°C on one of the greened roof areas and 18.8°C to 19.8°C on the other. Temperatures on the bare roof area of the pram sheds was higher with temperatures of 27.3°C to 28.5°C on the bare area with temperatures reaching as high as 21.5°C even where there was evidence of pooled rain. This image indicates that green roof areas provided the greatest benefit in terms of urban cooling.

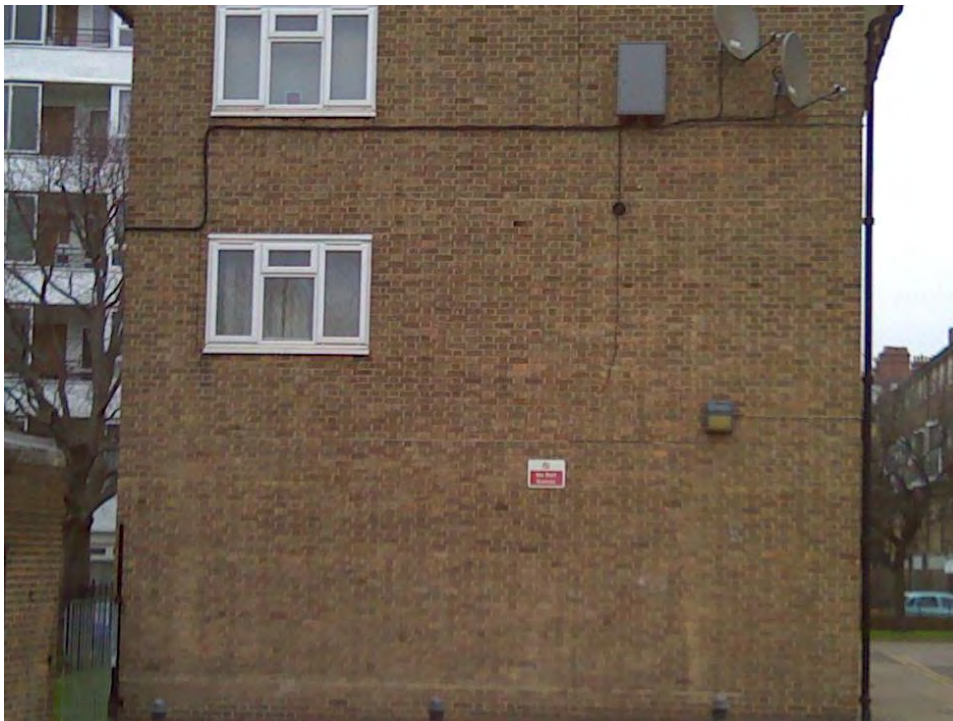
**Figure 66. Photo and infrared image of wall area where vertical rain garden is planned to be installed at Queen Caroline Estate, 21st January 2016.** Image showing the temperatures on the external wall of Mary House. A FLIR QuickReport spotmeter was used to identify individual temperatures within the field of view. Infrared imaging reveals temperatures from 1.8°C to 3.5°C on the bare wall and a temperature of 7.9°C on an external light. Thermal imaging pictures were also made of similar walls on neighbouring buildings to get an assessment of their value as control walls for comparison following the installation of the vertical rain garden at Mary House.

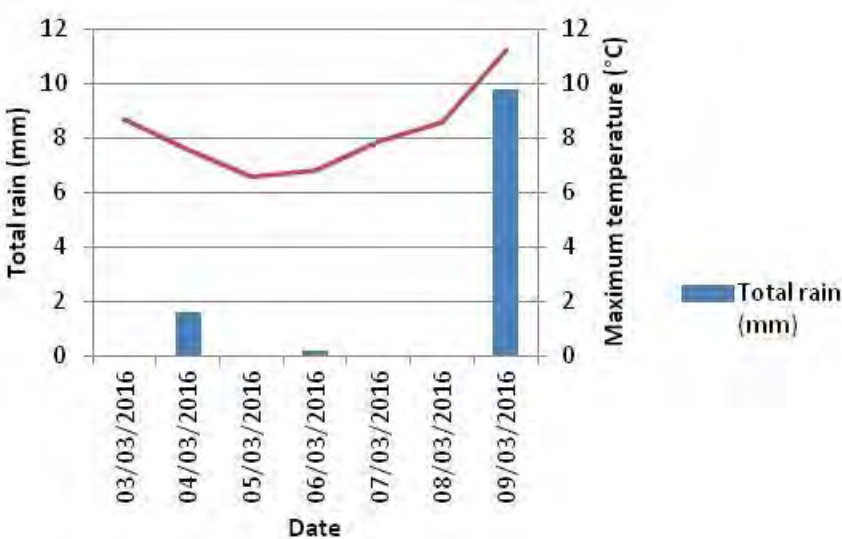
**Figure 80. Prevailing weather conditions preceding one of the five largest rain events at Queen Caroline Estate, Hammersmith.** Rain event was 9.8 mm on 9th March 2016.

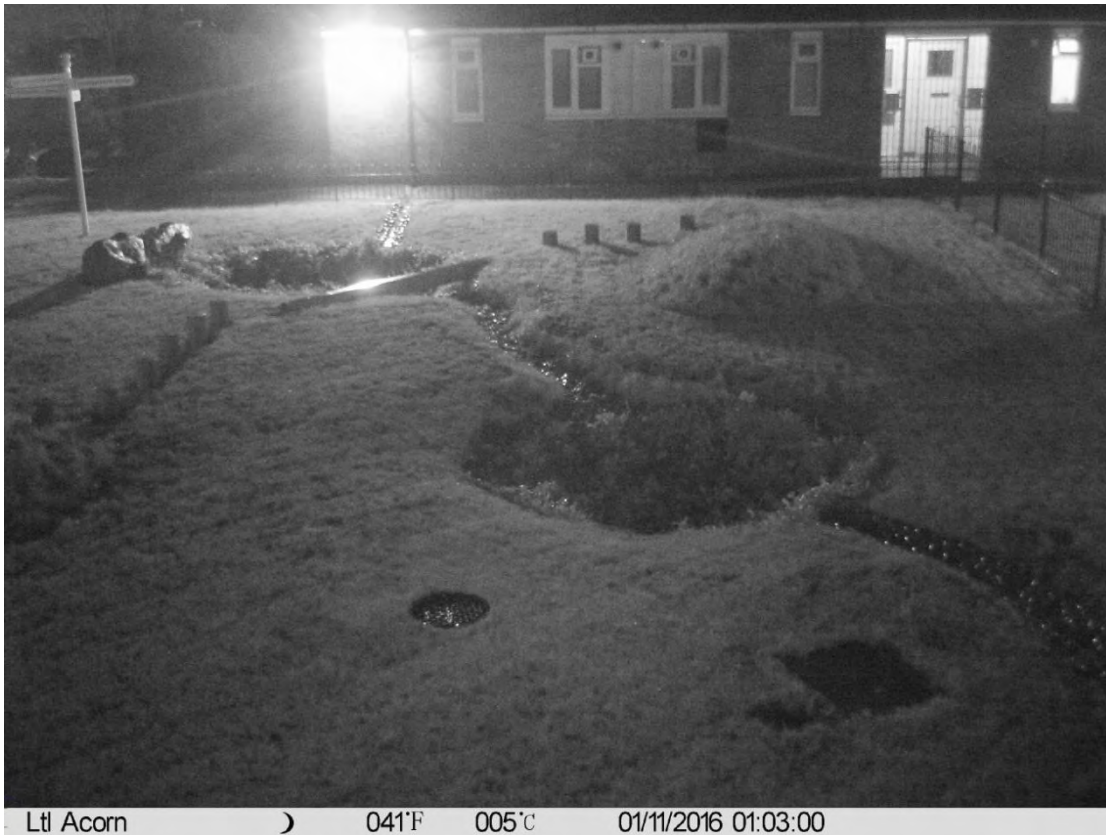
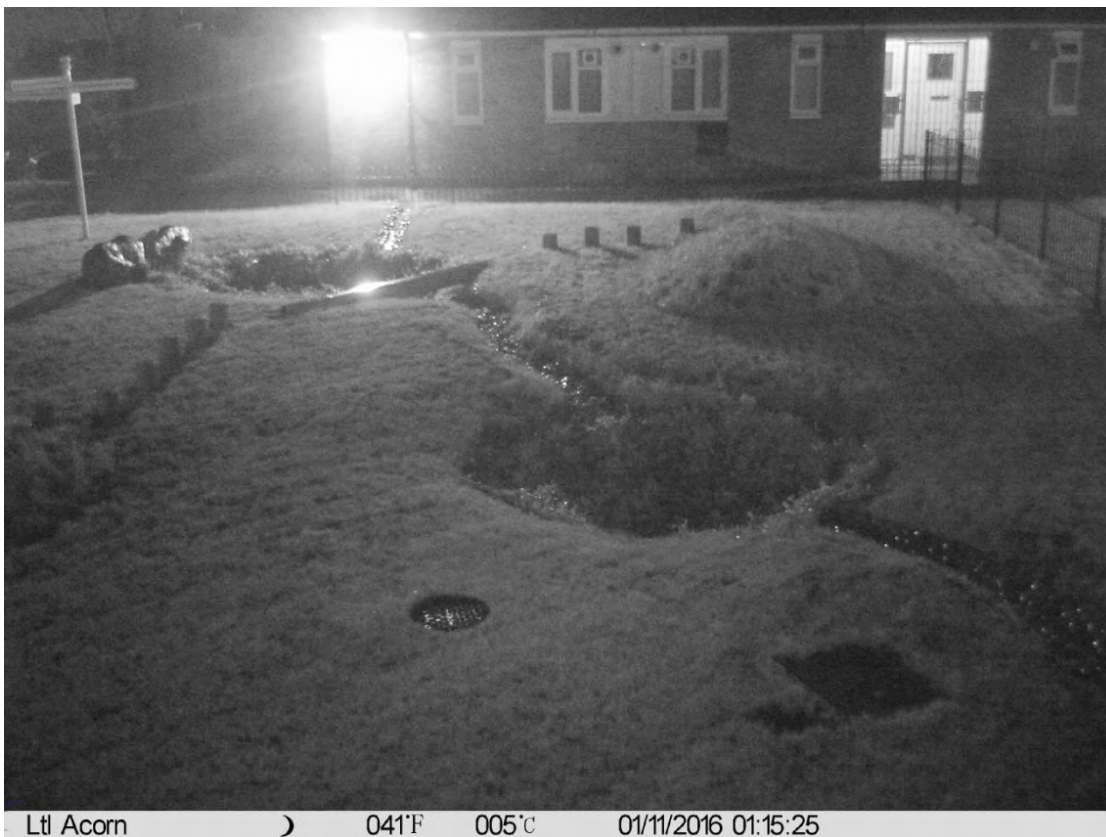
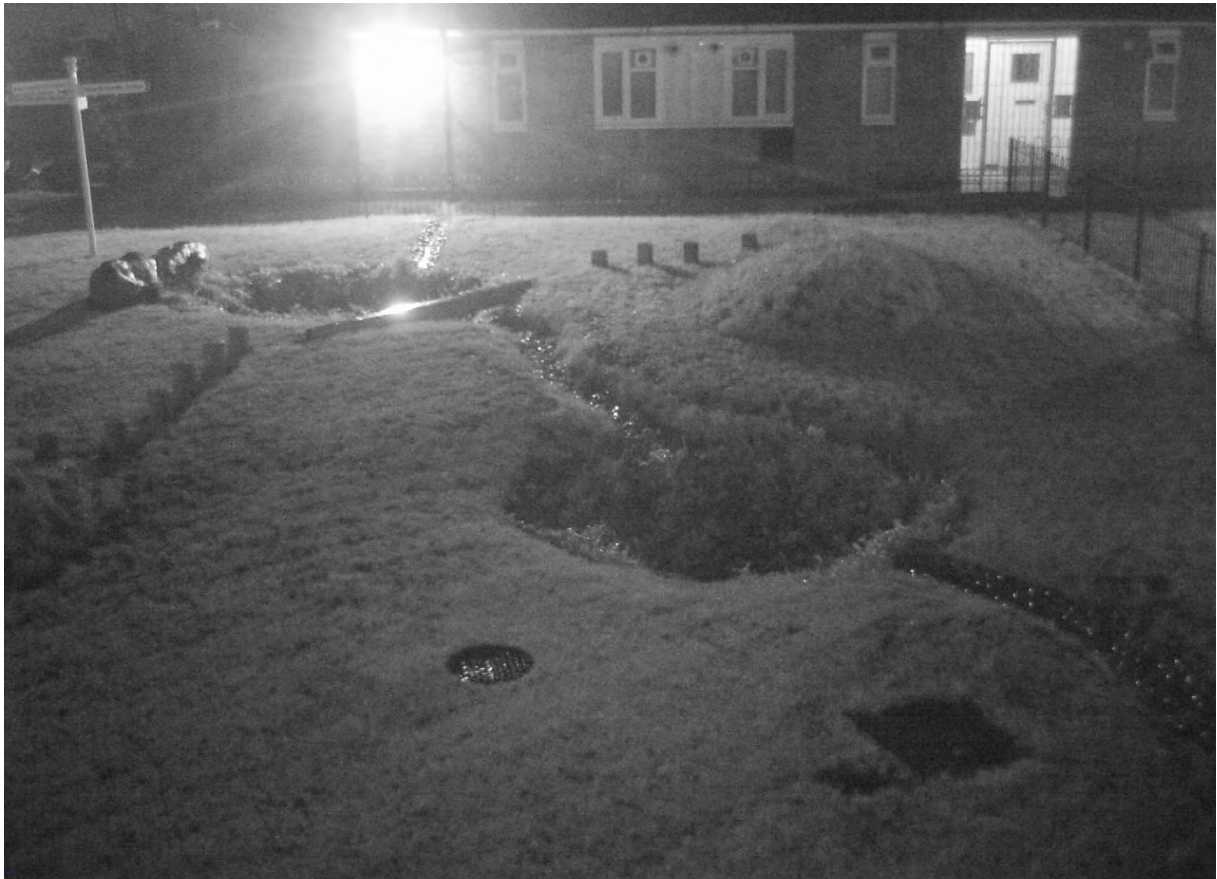
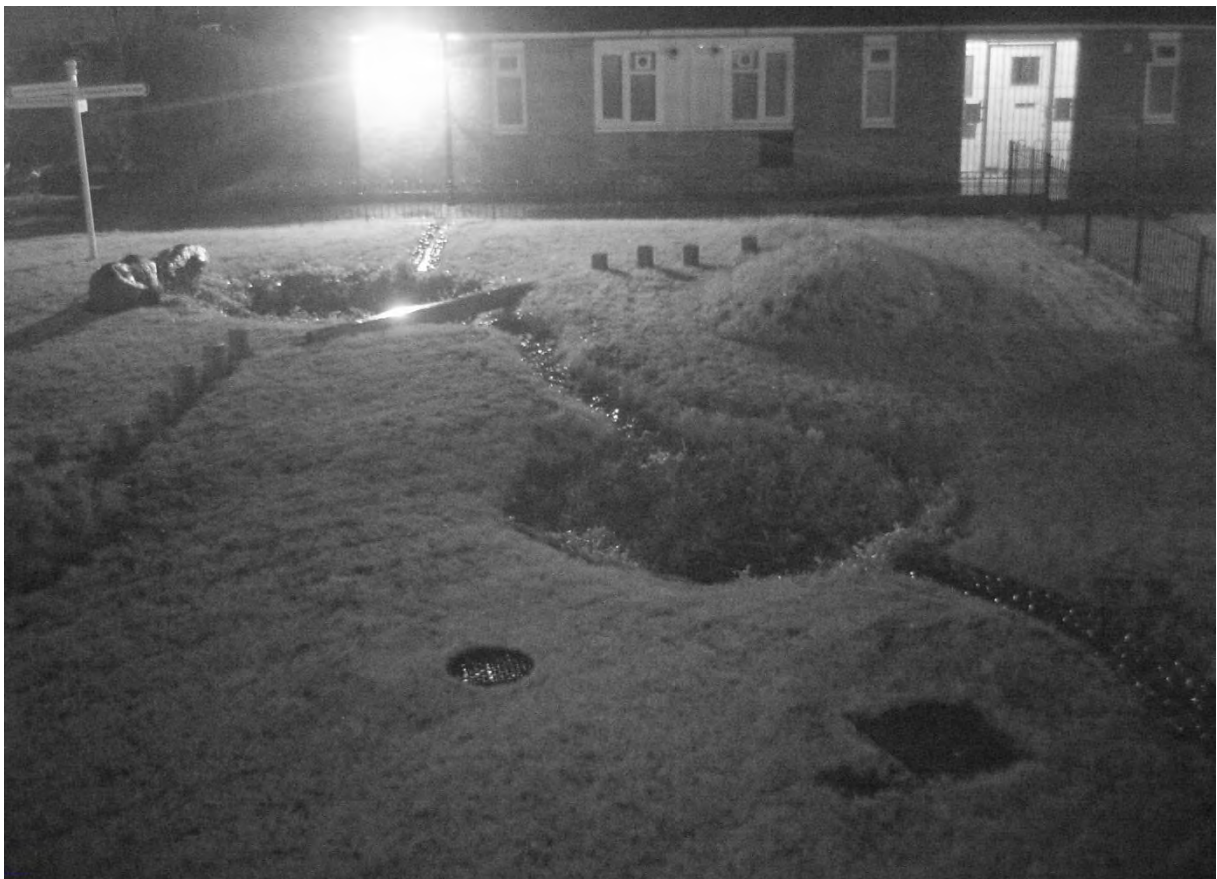
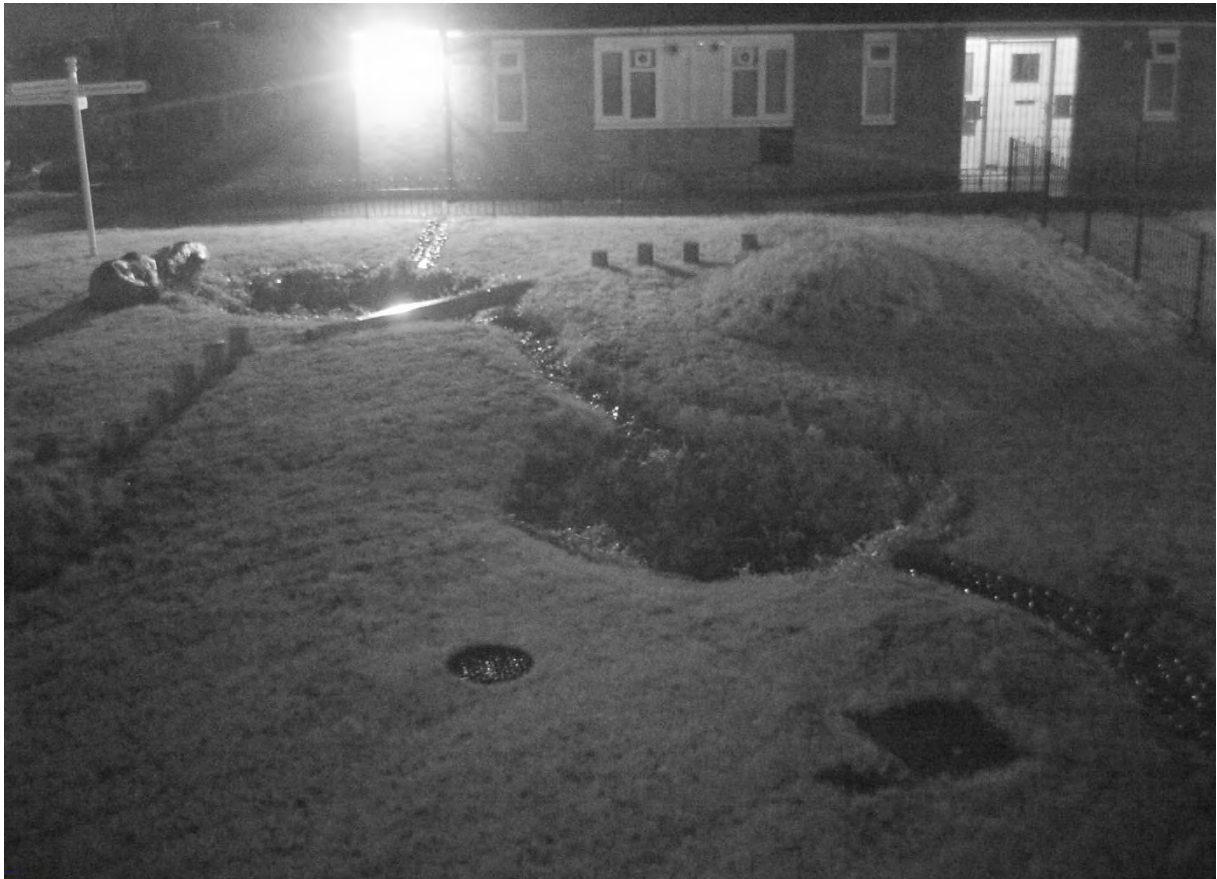
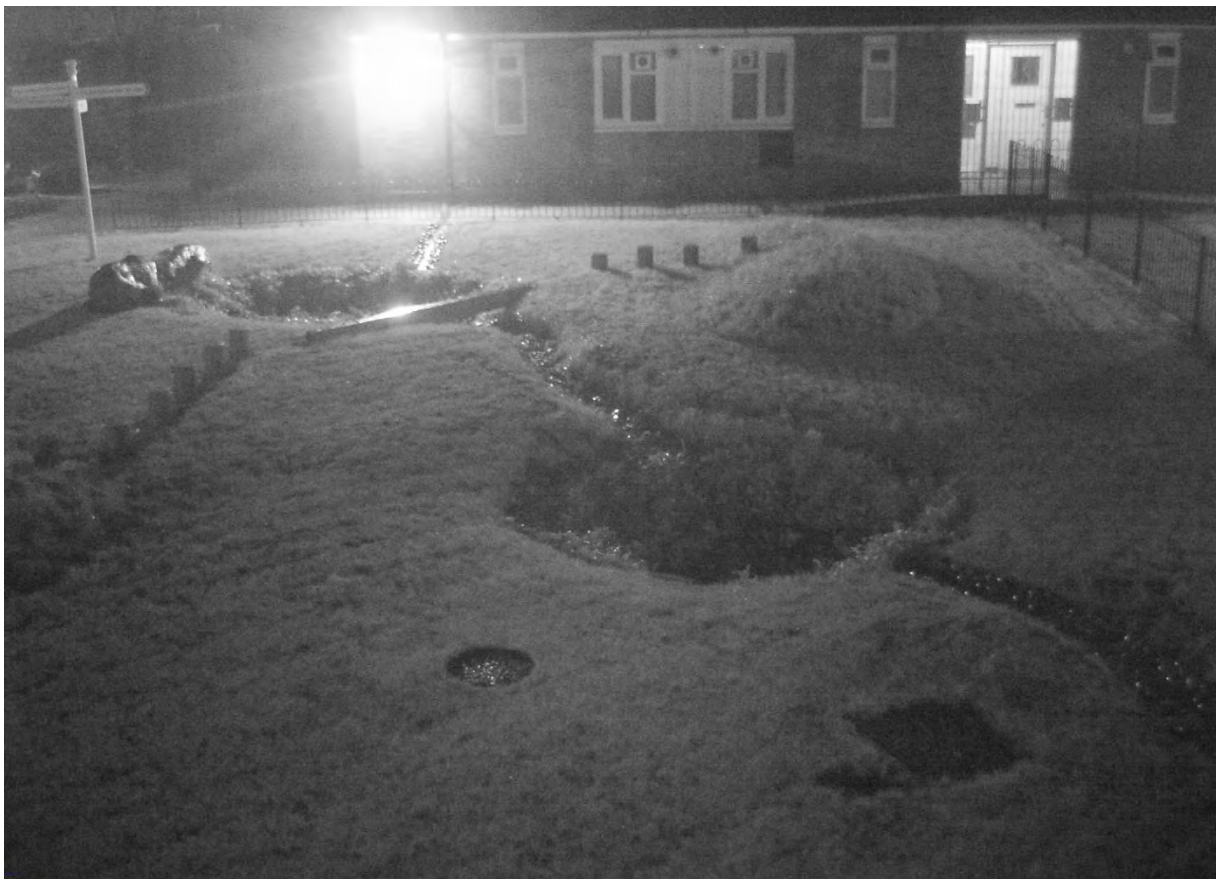
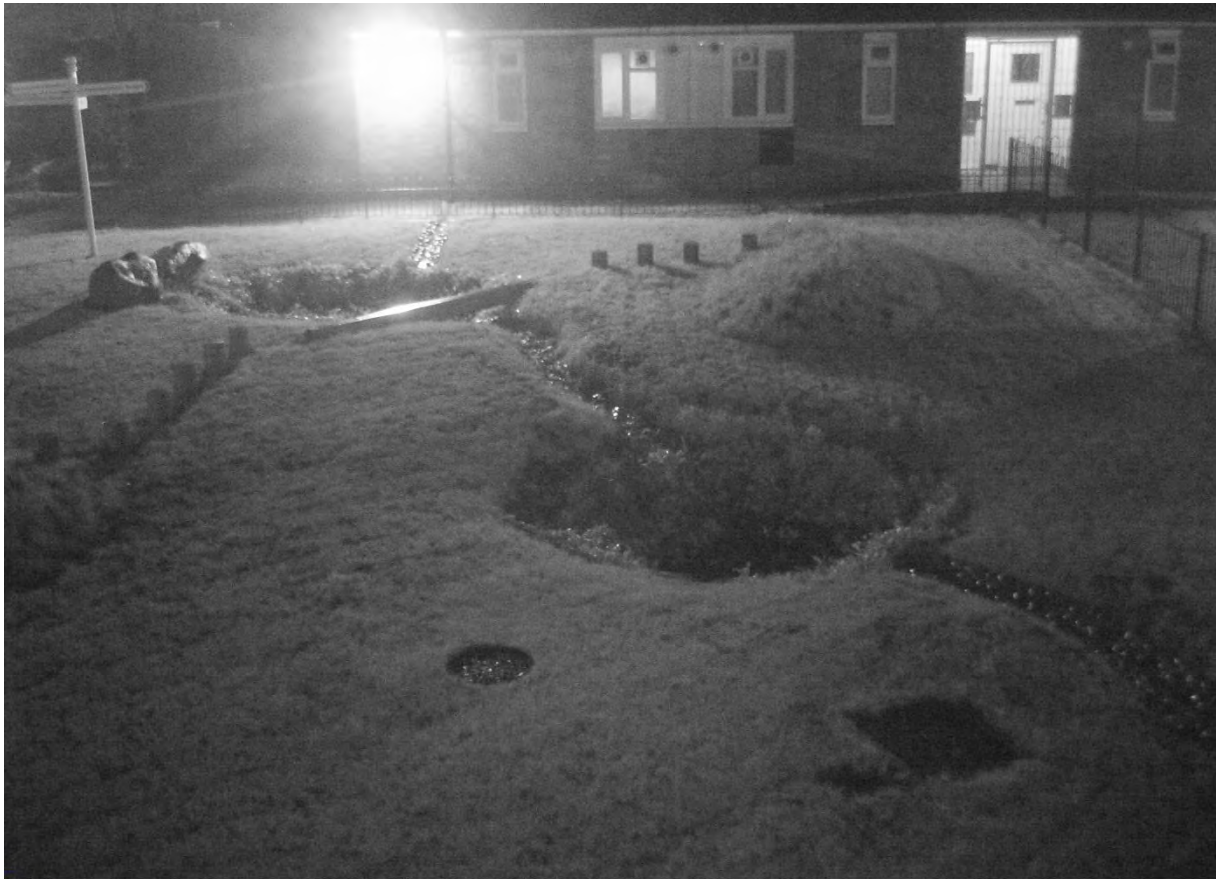
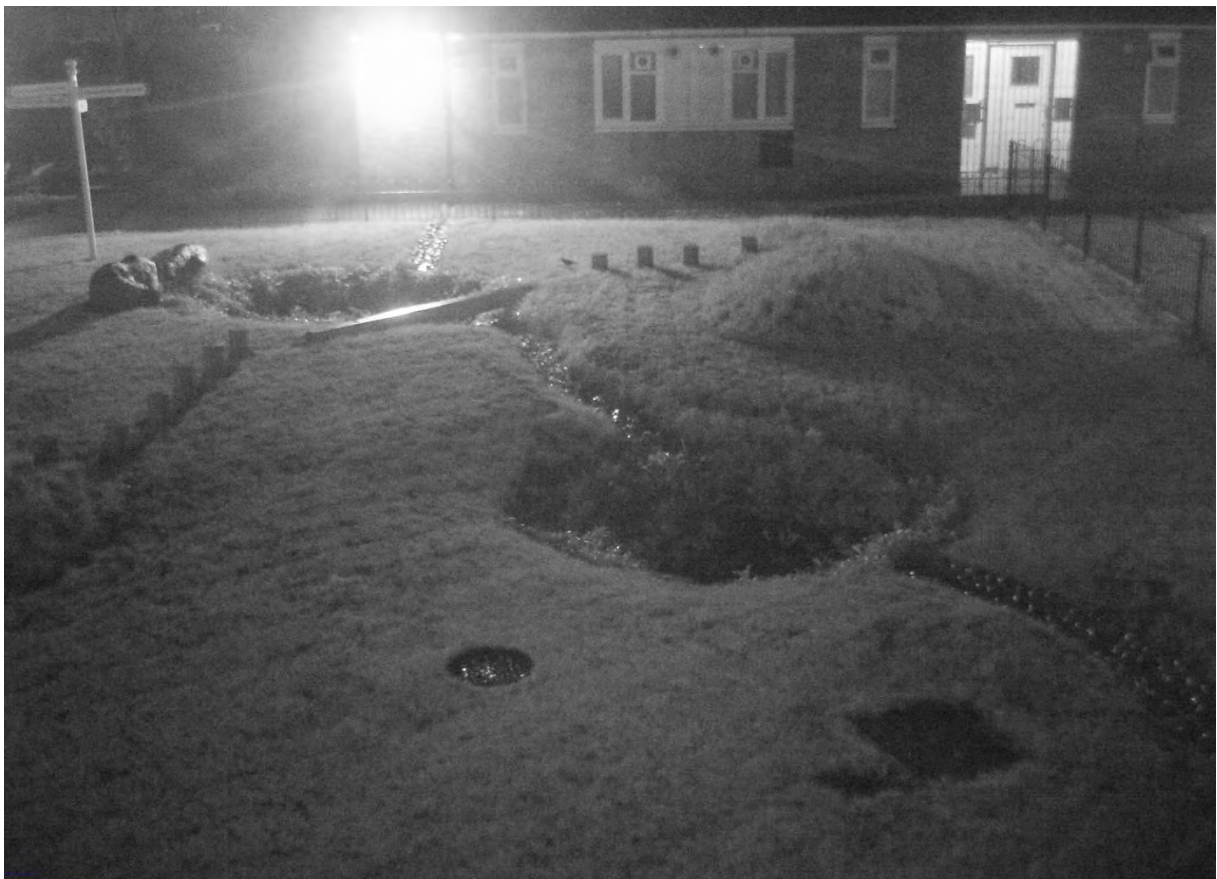
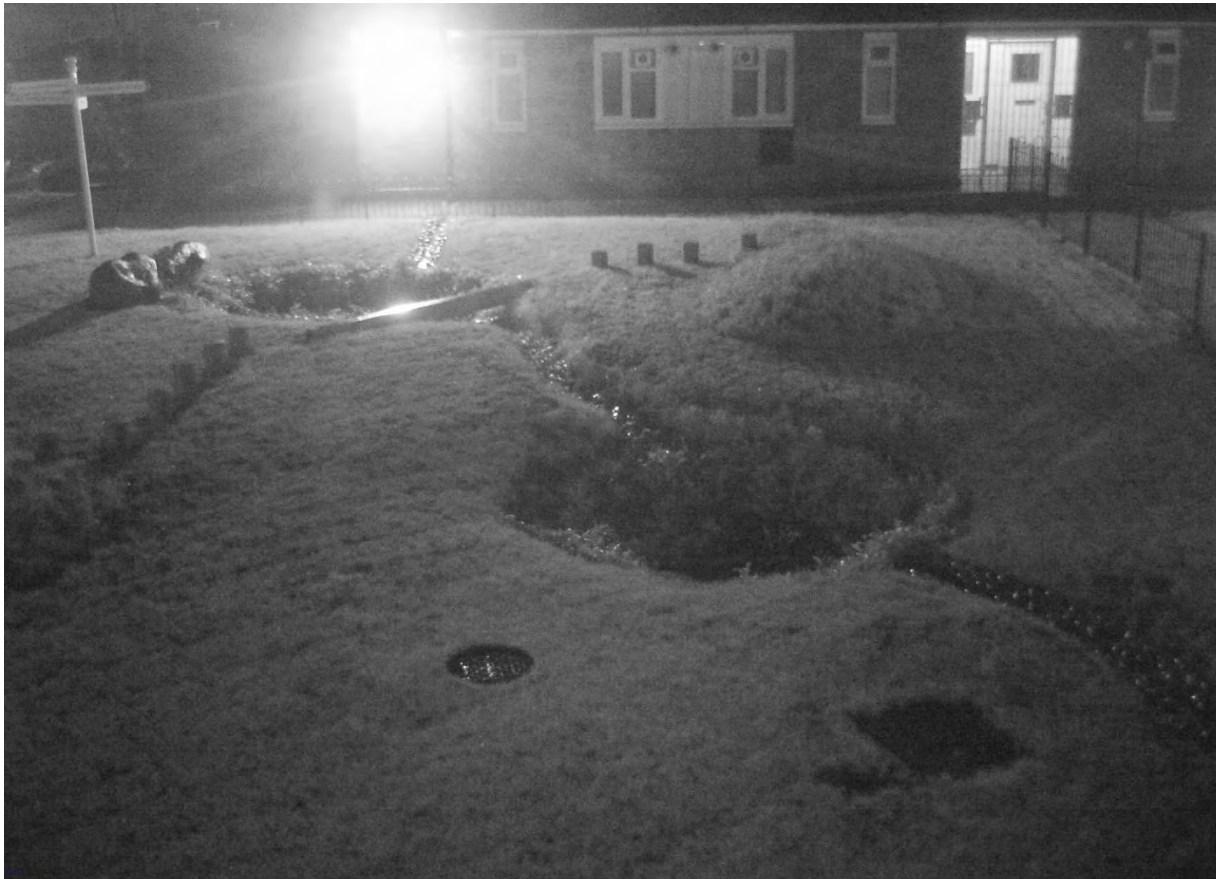
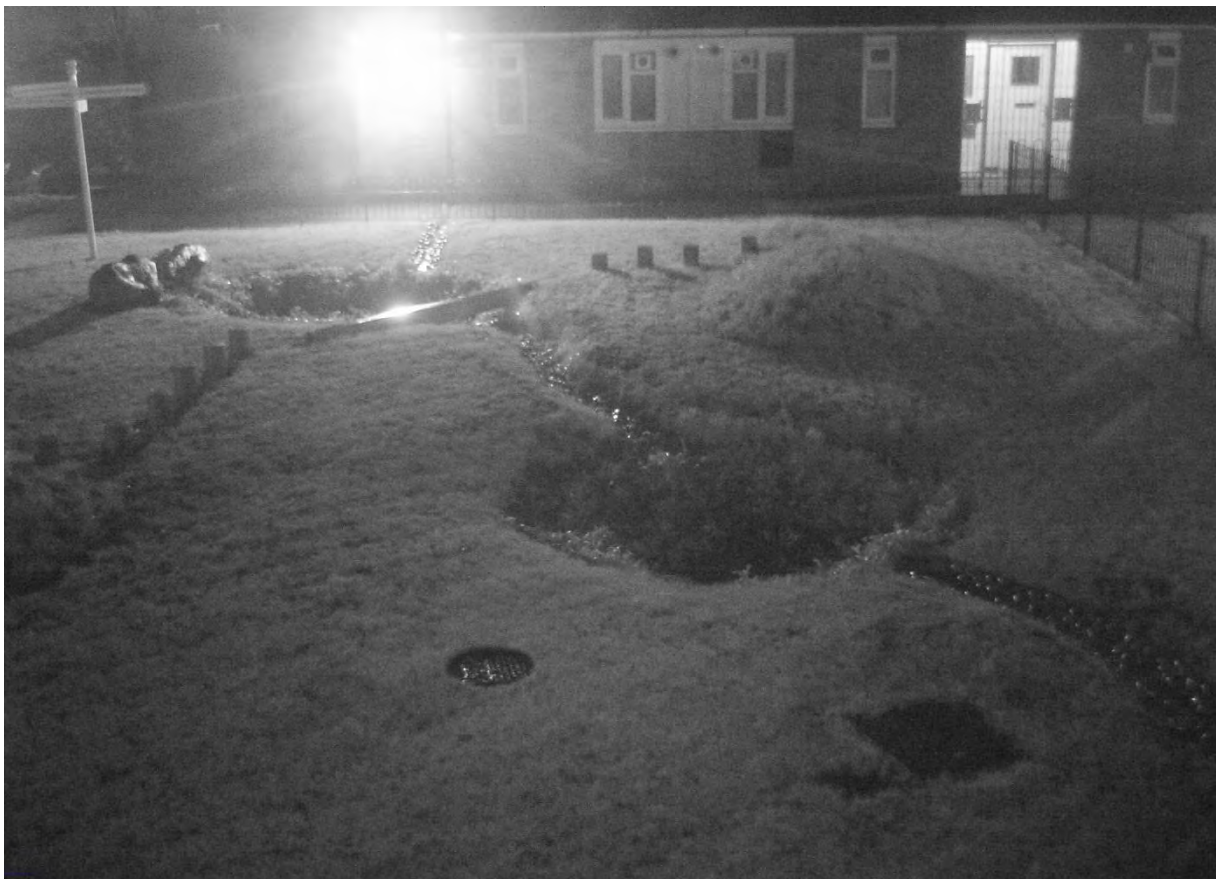
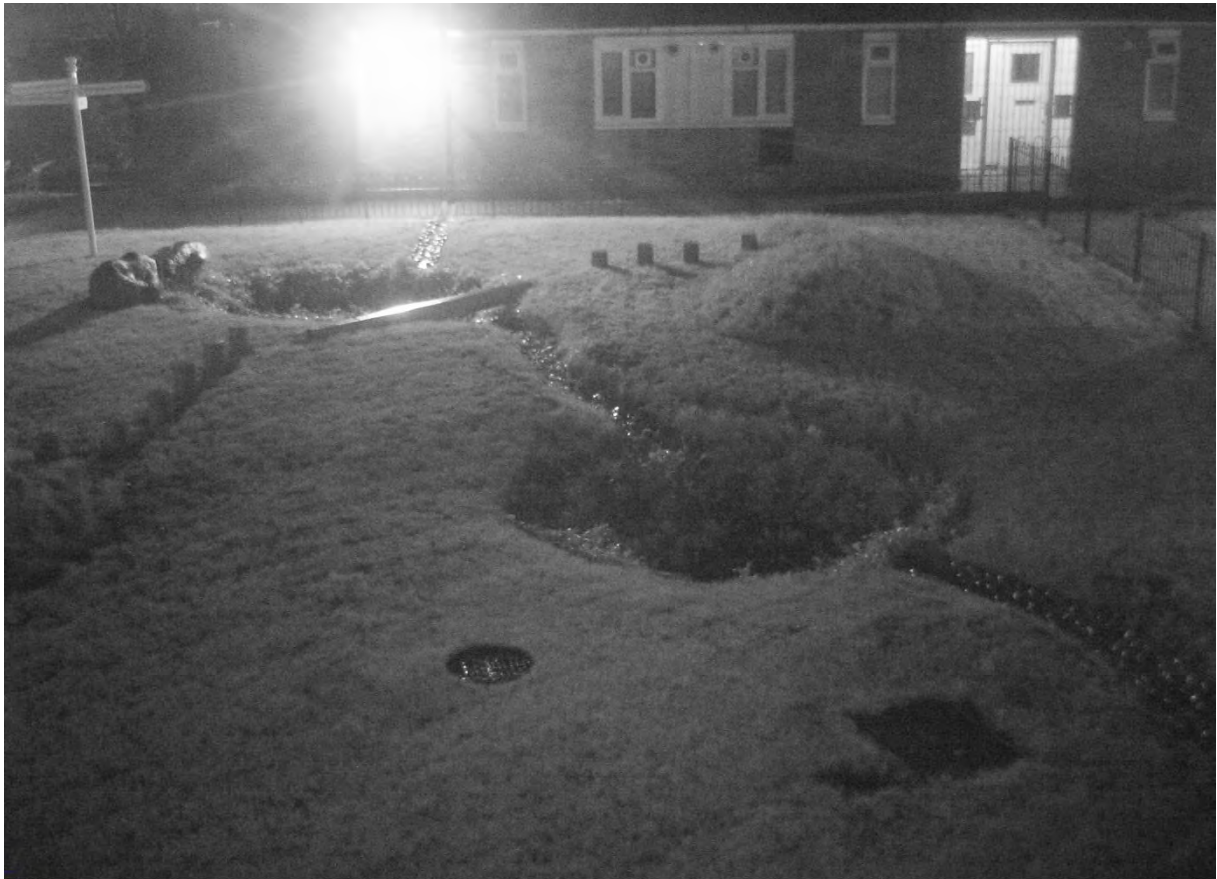
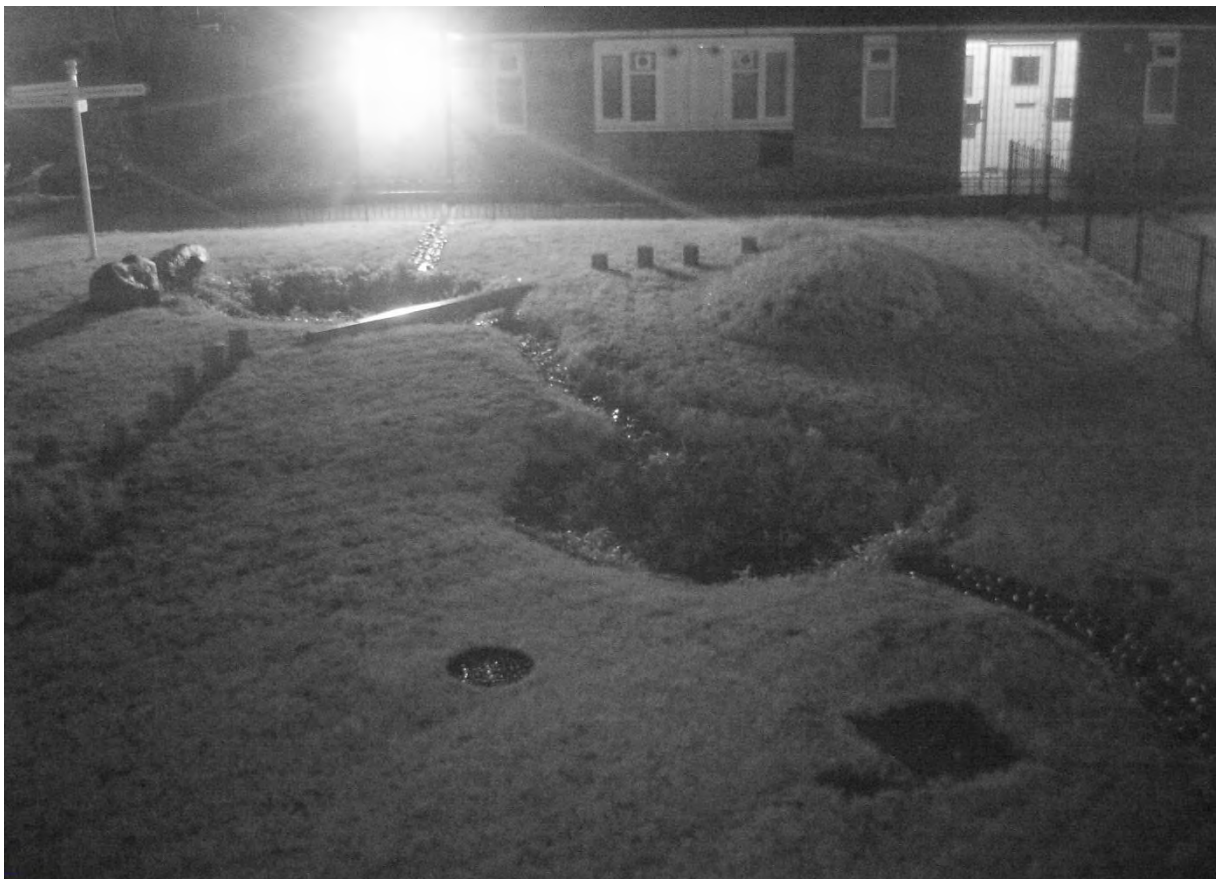
*A4 - Adella House grass basin and Adella House stoney basin (FPC3) performance during 18.2 mm rain event on 11th January 2016*
