**Climate Proofing Housing Landscapes:  
Interim Monitoring Report**

**August 2015 to May 2016**

**Authors: Connop, S. and Clough, J.**

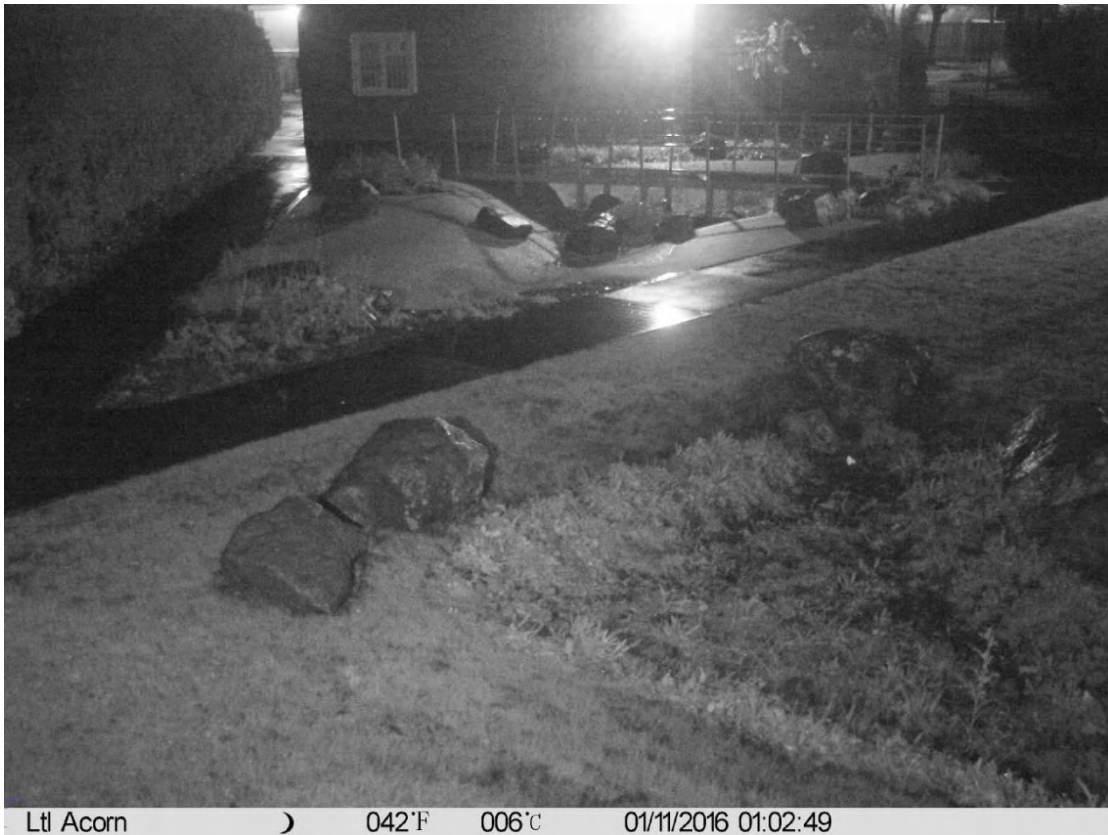
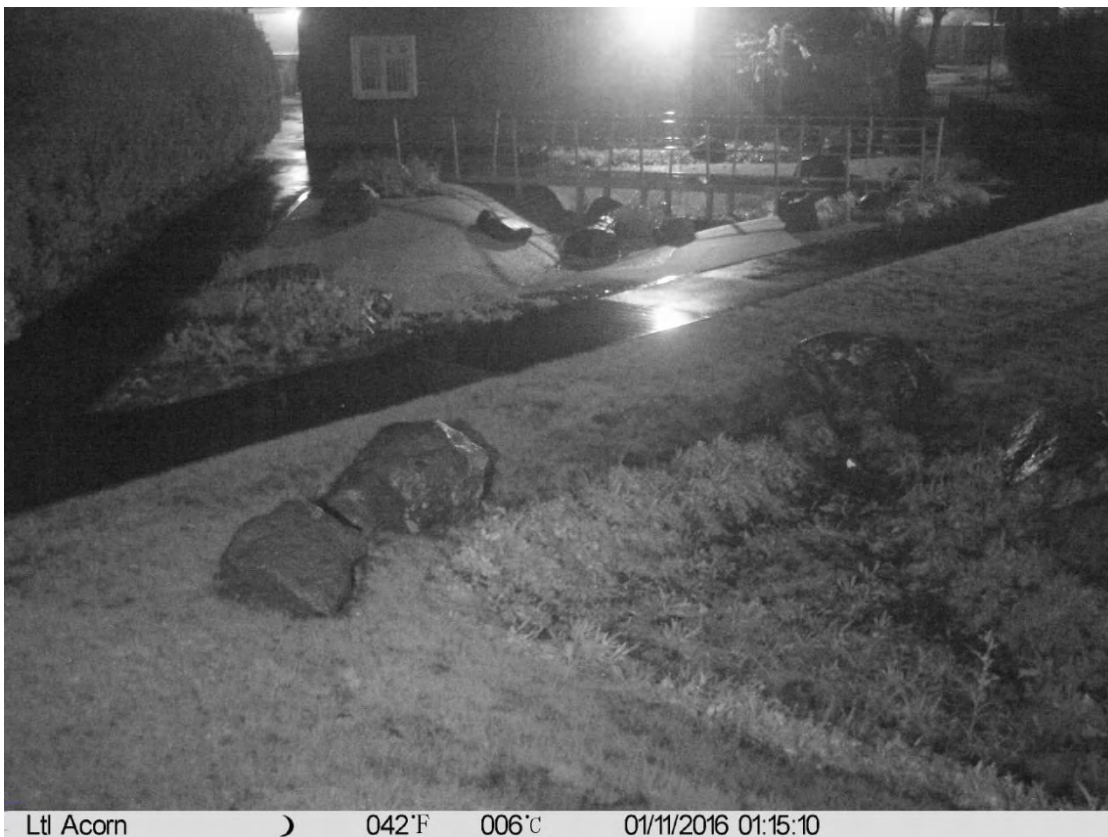
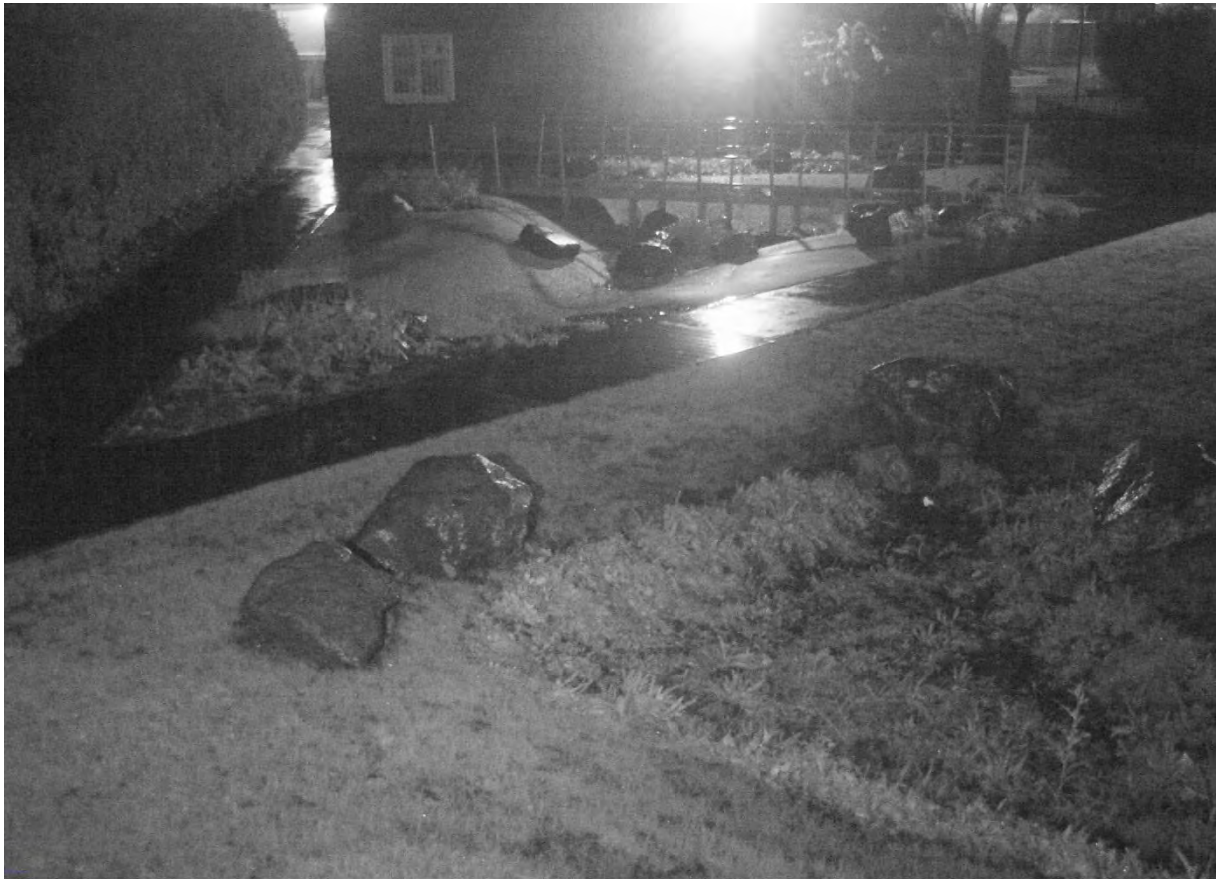
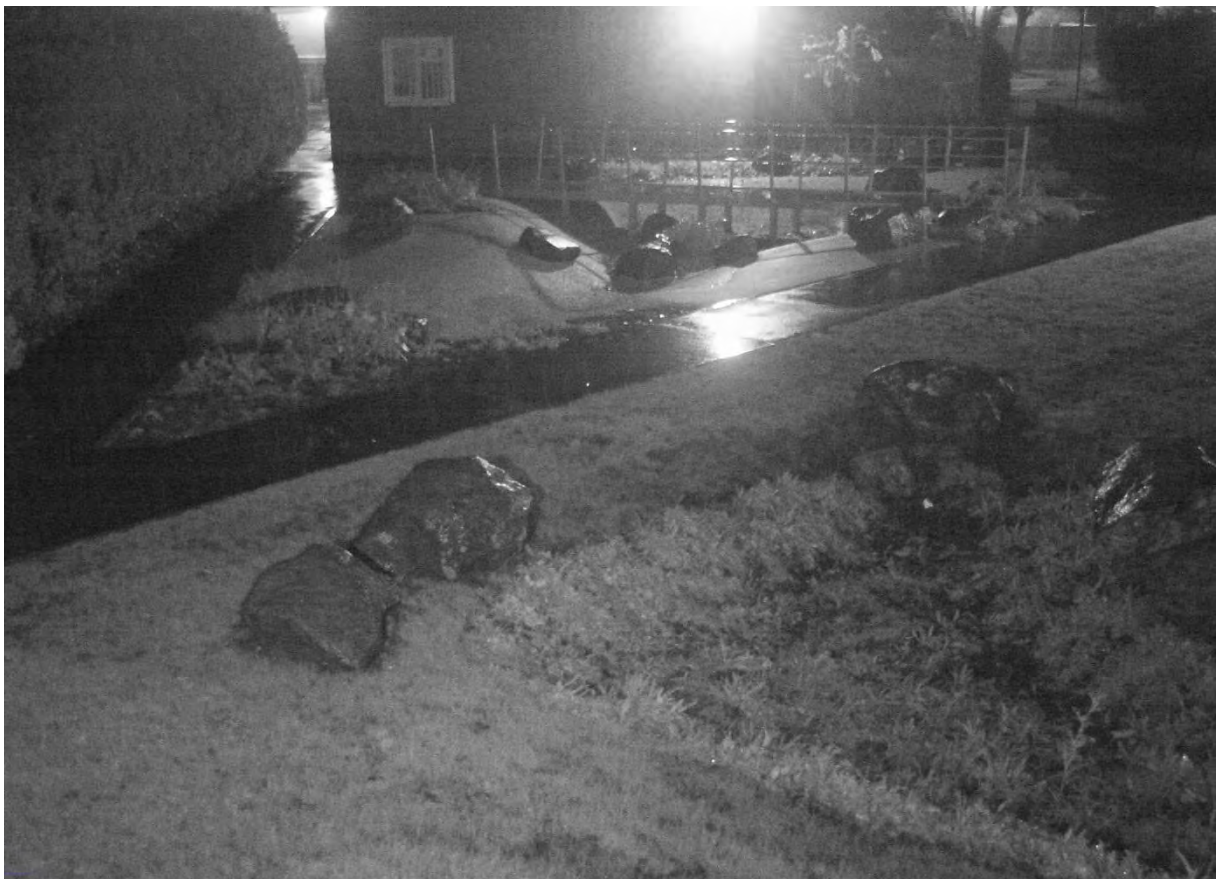
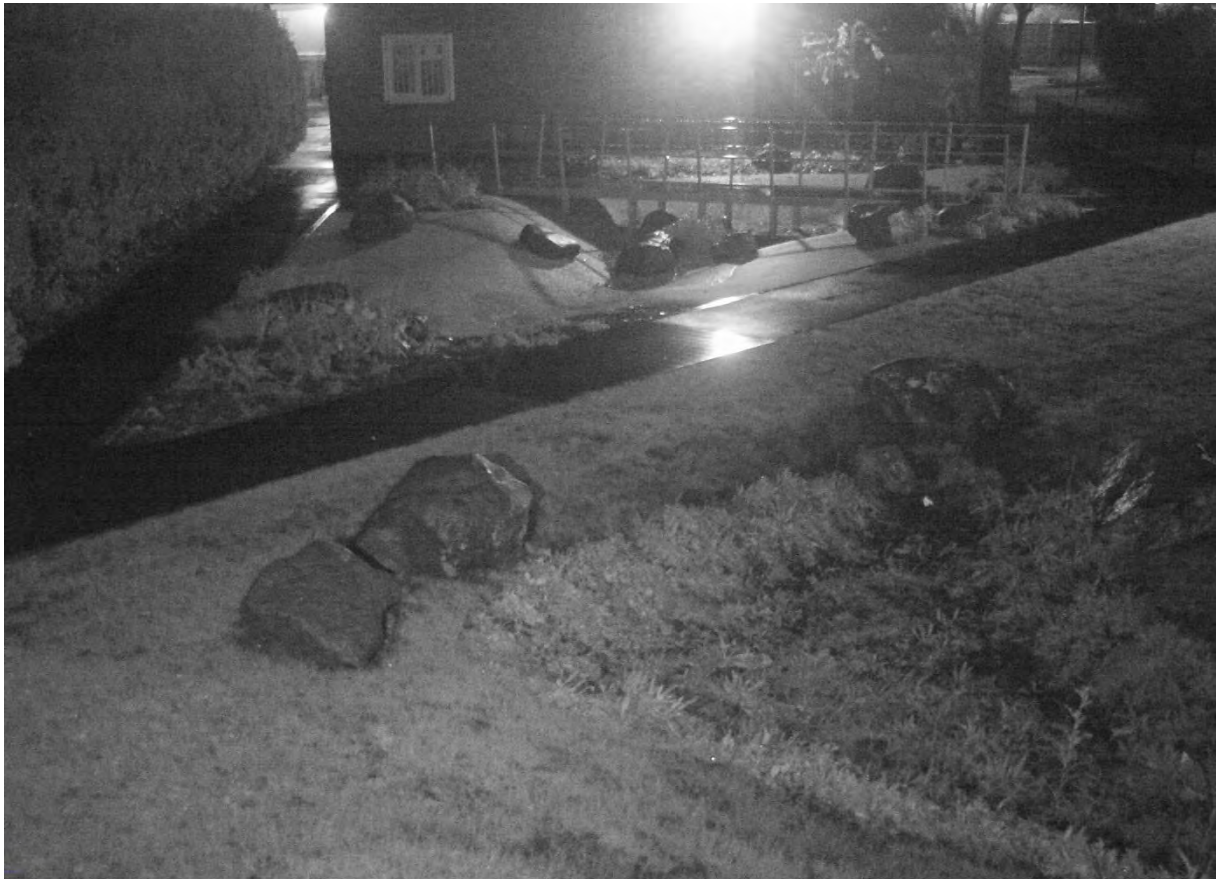
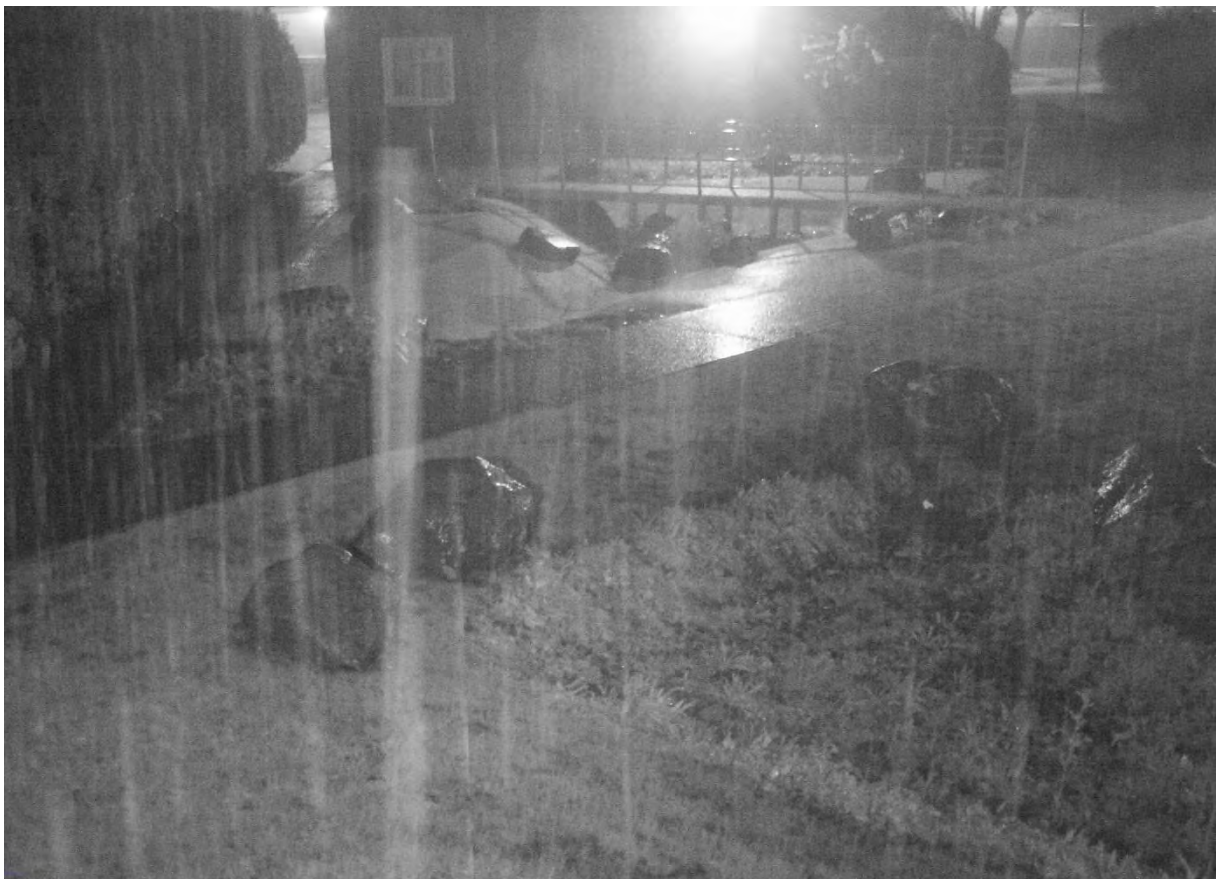
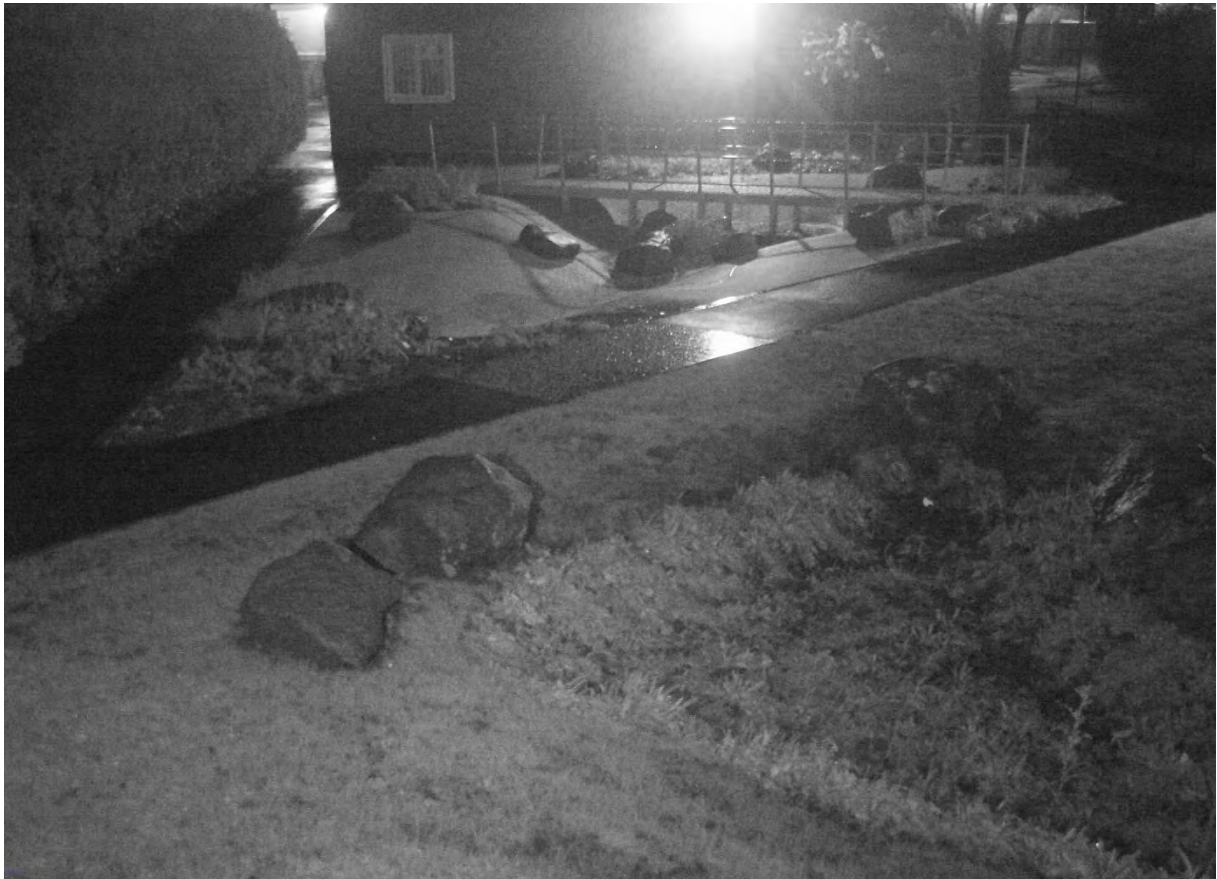
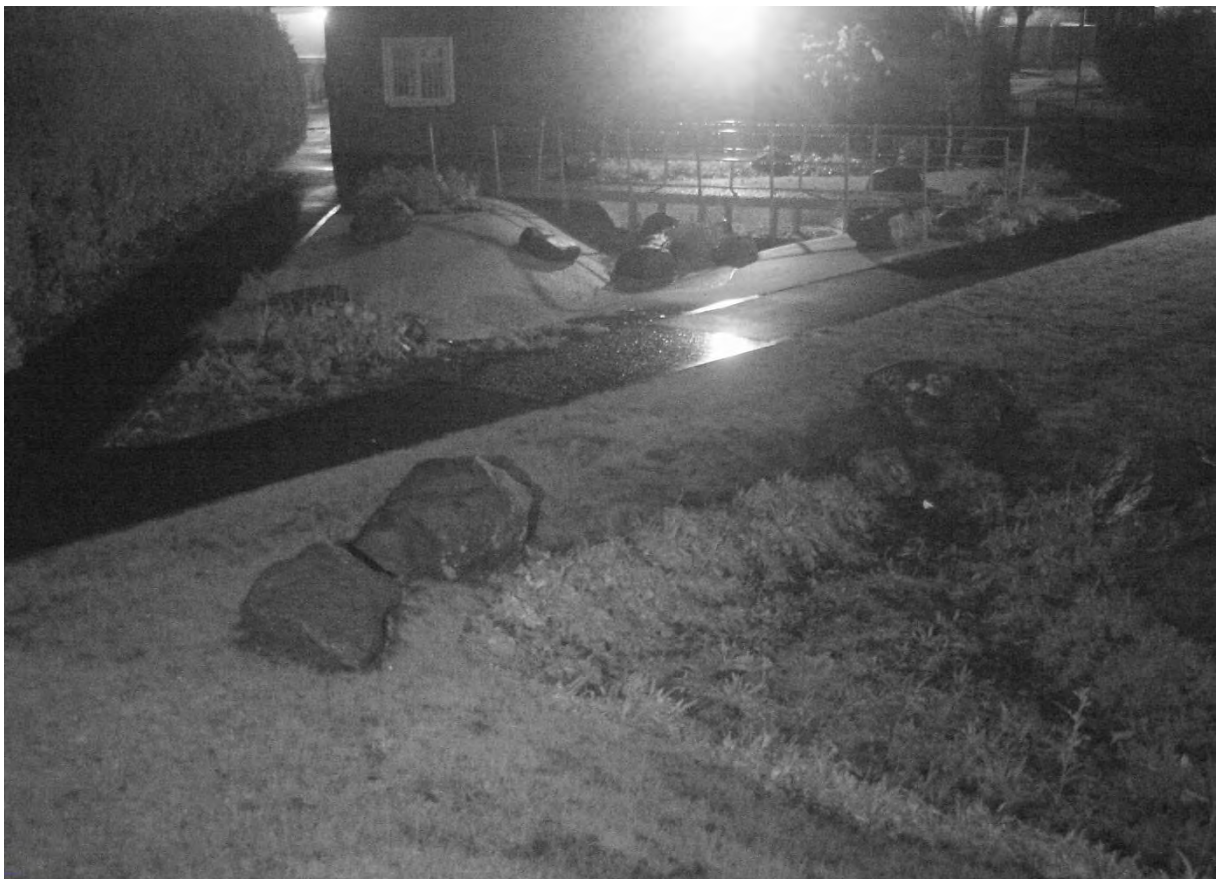
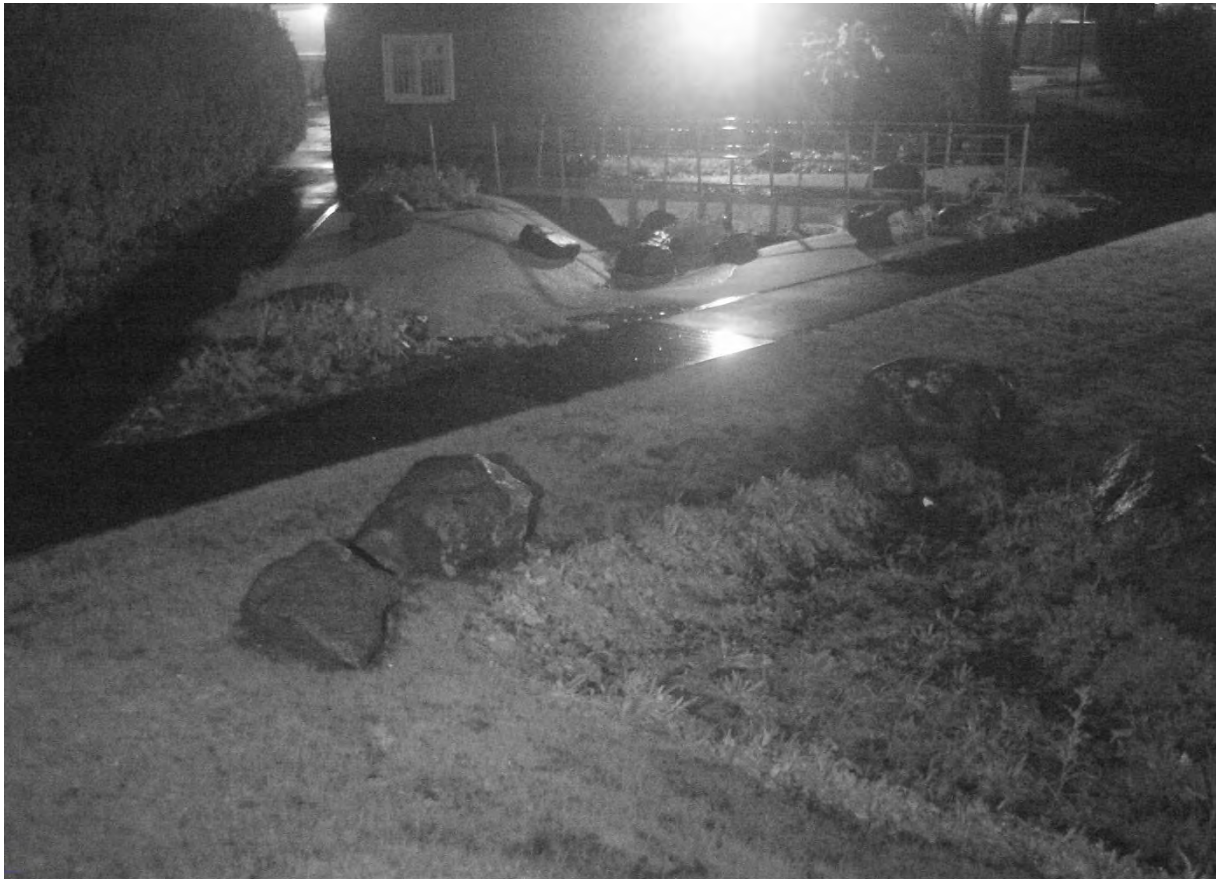
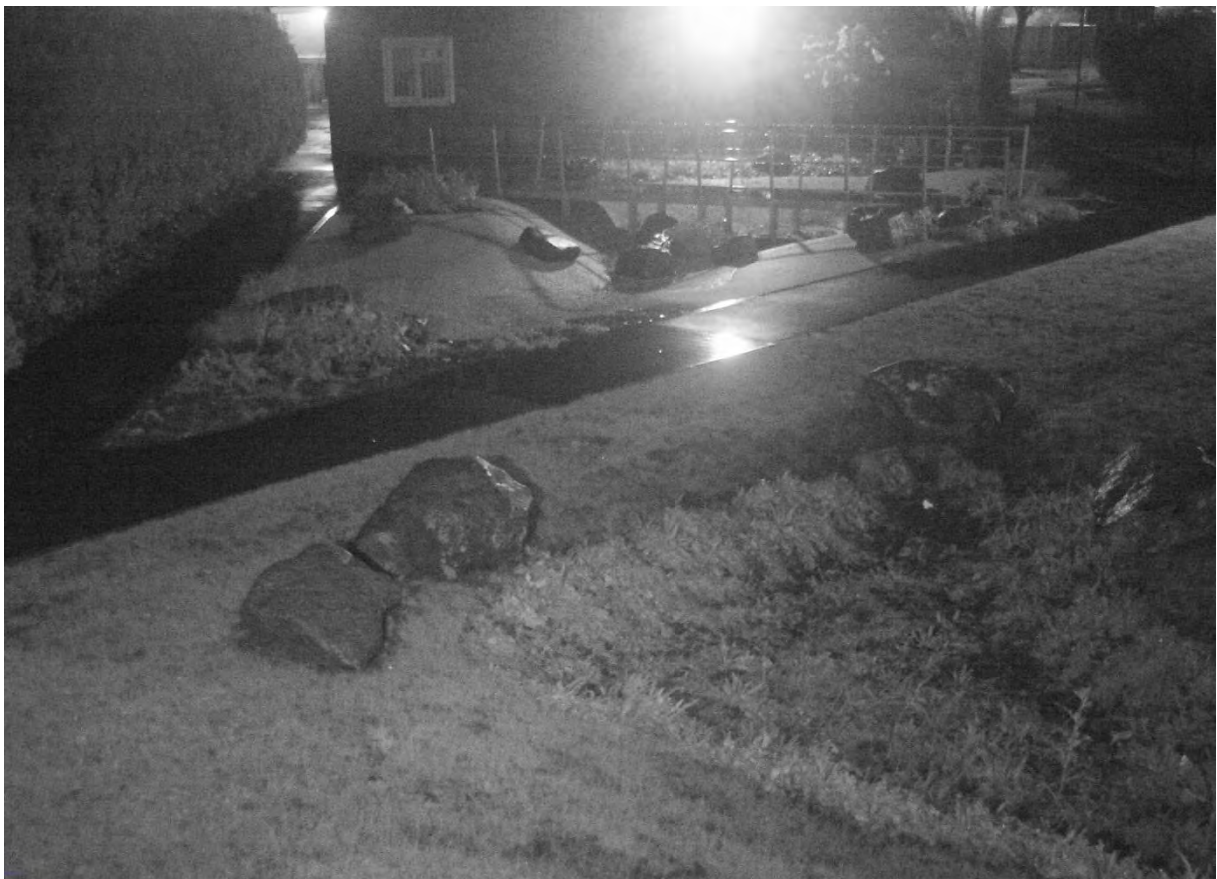
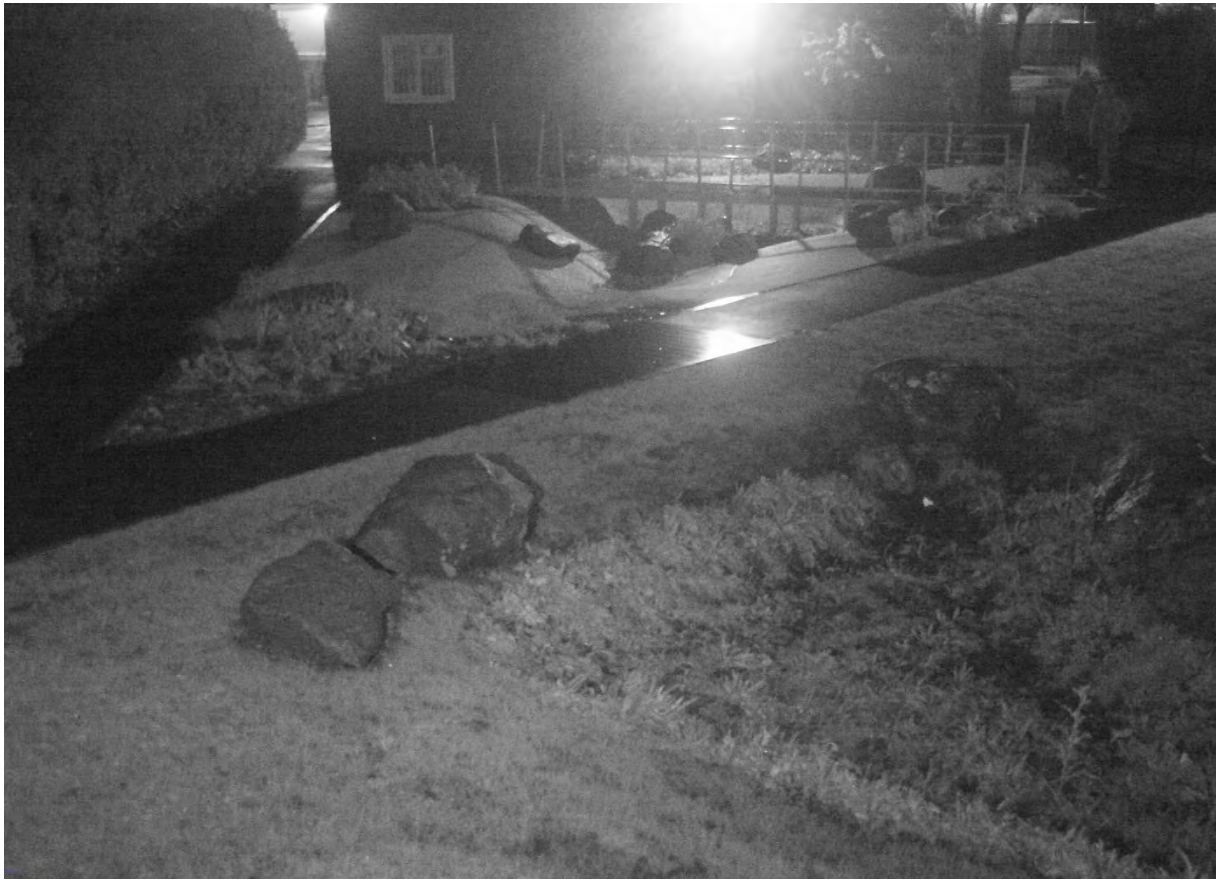
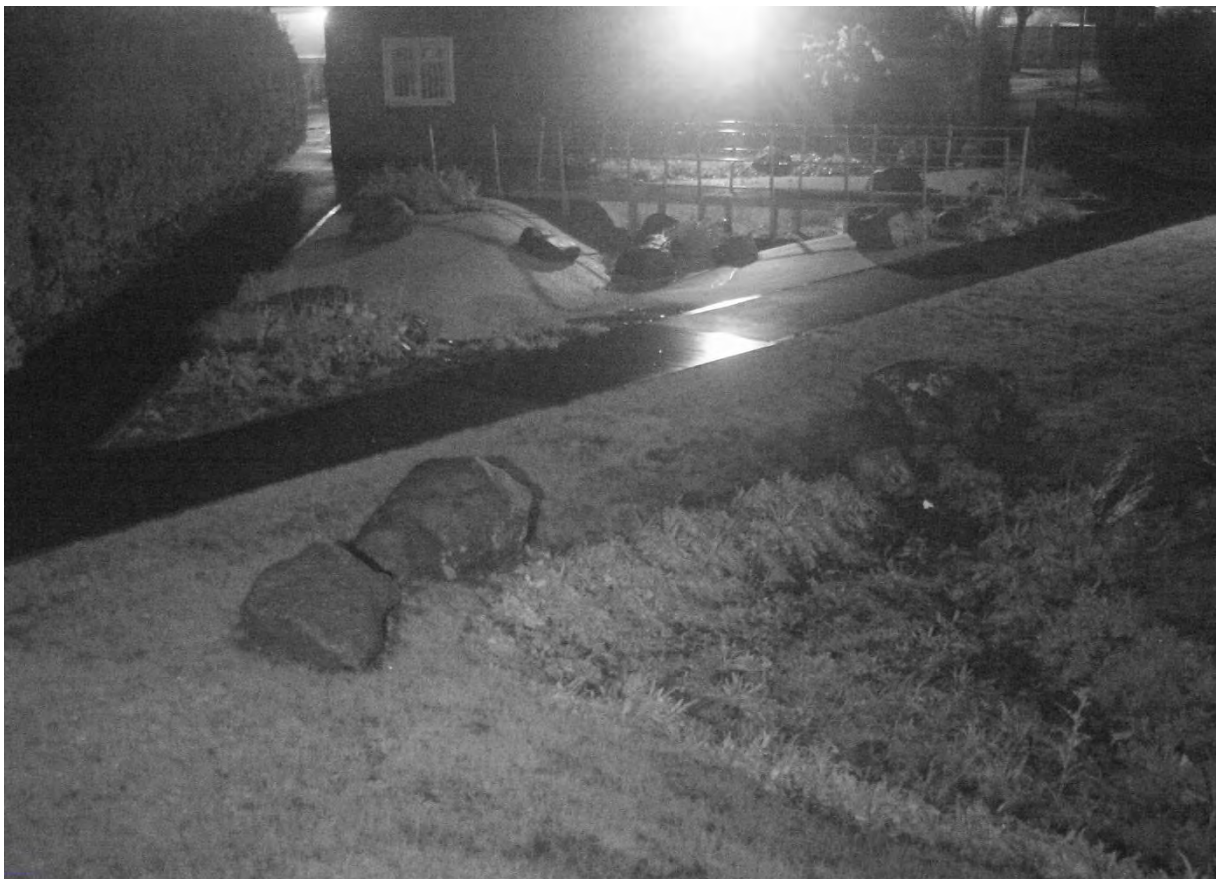
*A5 Richard Knight House rain garden performance during 11.6 mm rain event on 11th January 2016*
