**Climate Proofing Housing Landscapes:  
Monitoring Report 2**

**June 2016 to September 2016**

Authors: Connop, S., Clough, J., Gunawardena, D. and Nash, C.

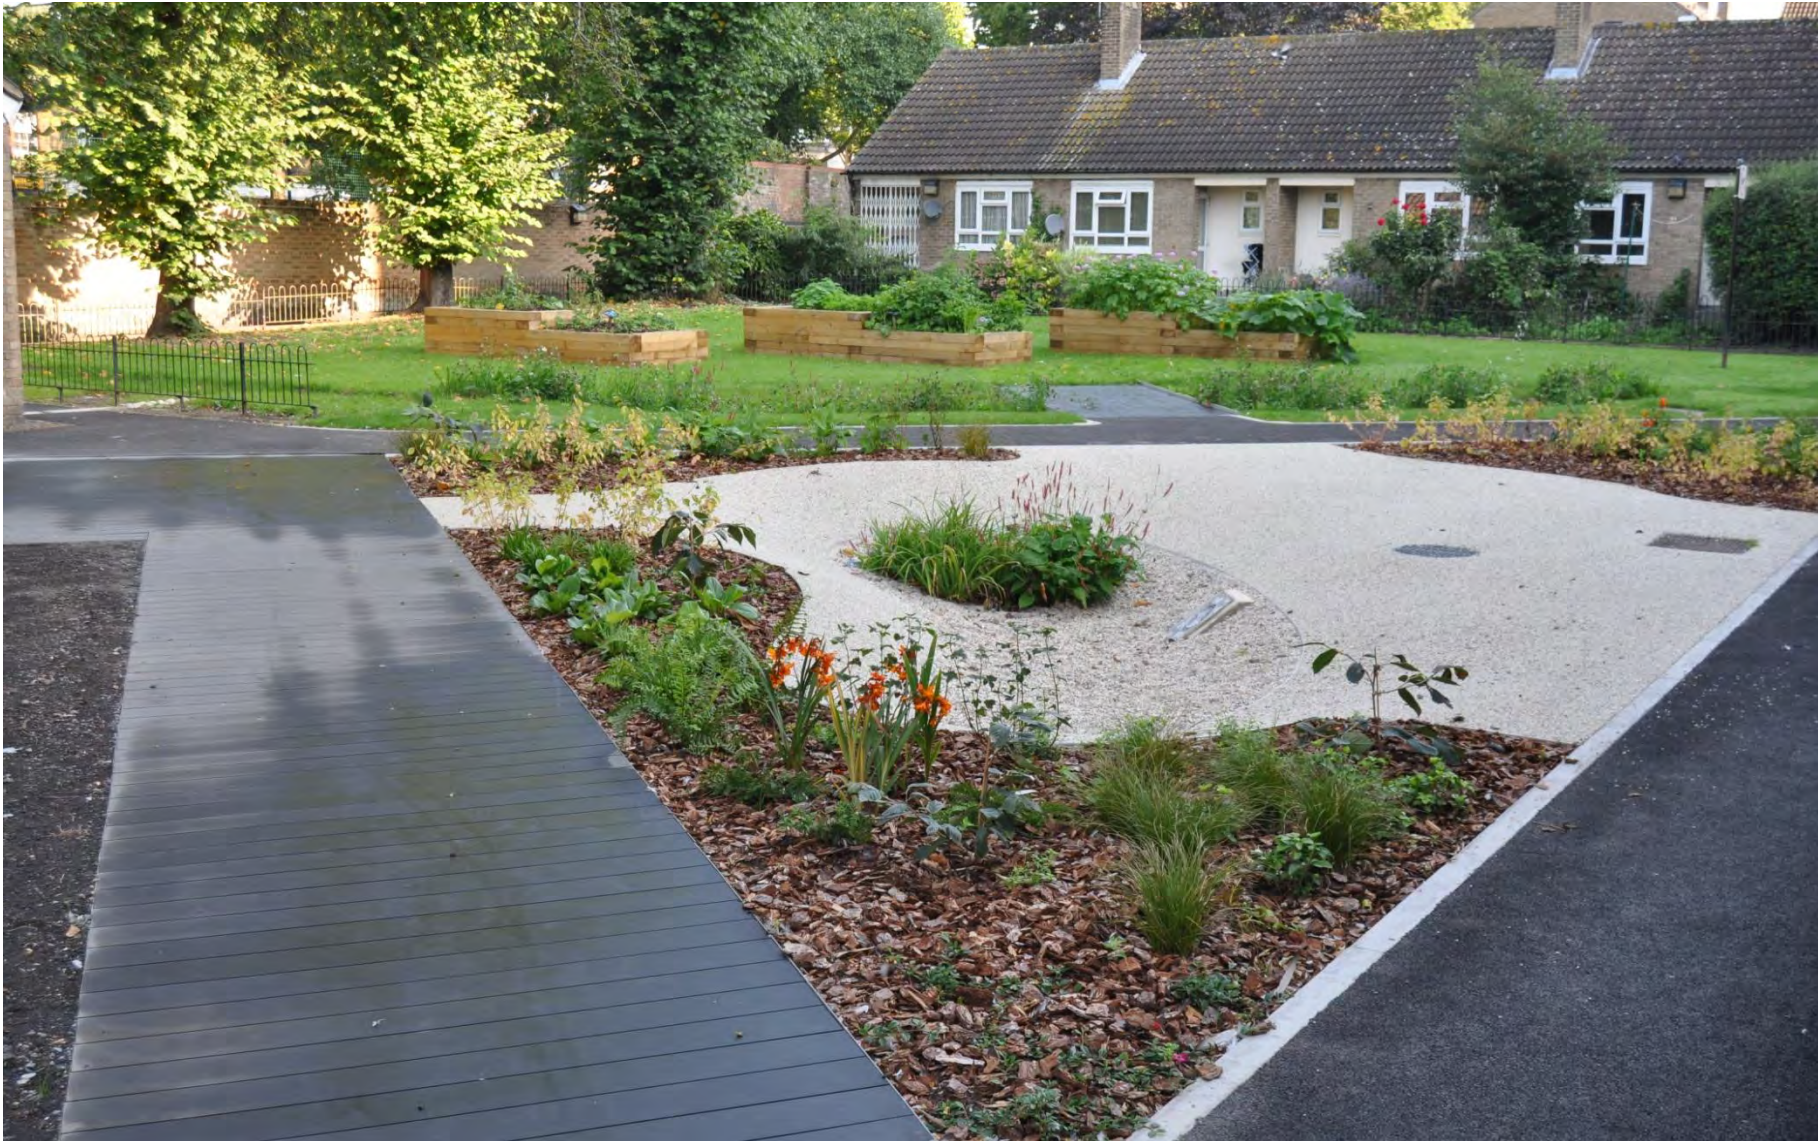
**Figure 1. Green infrastructure retrofit at Queen Caroline Estate, London Borough of Hammersmith & Fulham.** Raised planters, permeable pathways, ornamental planting, pollinator-friendly swales and detention basins.

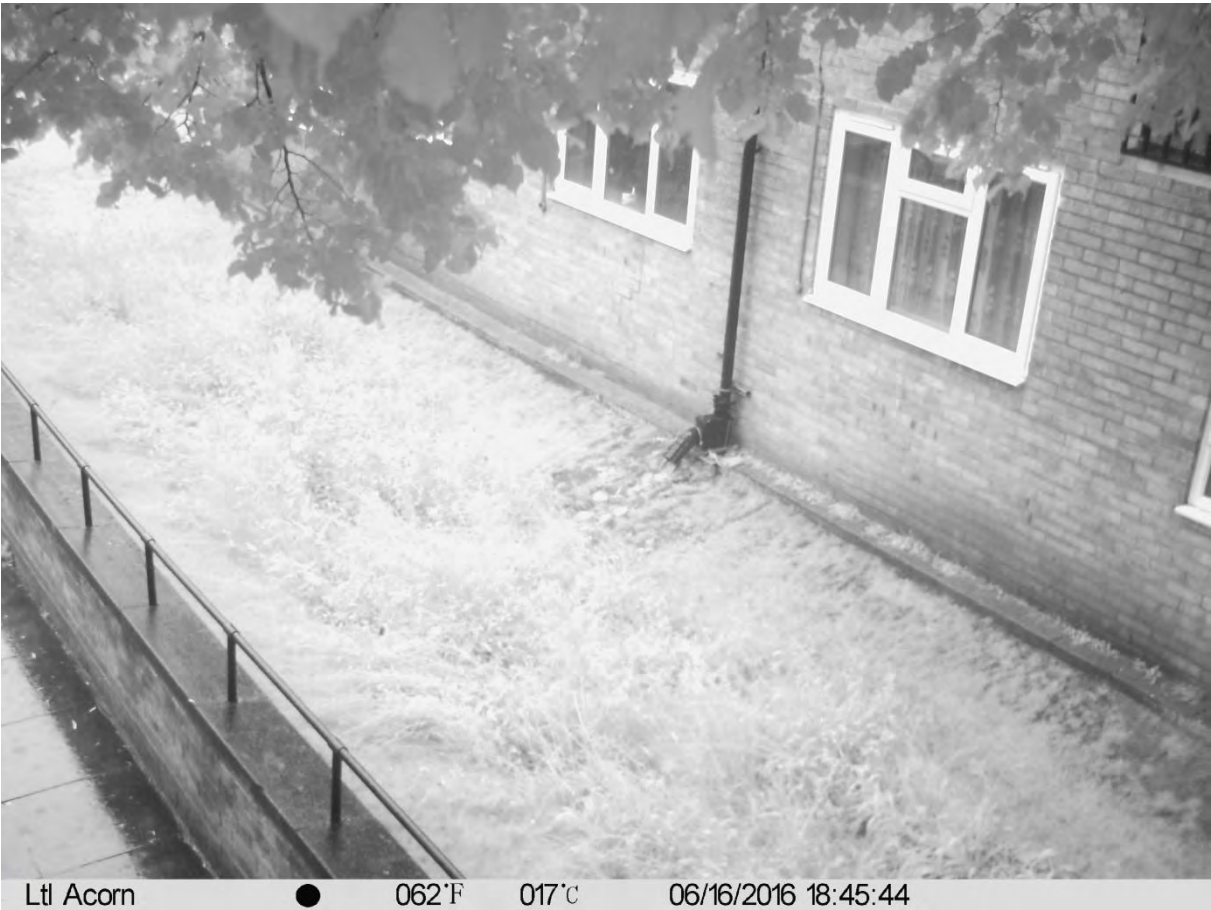
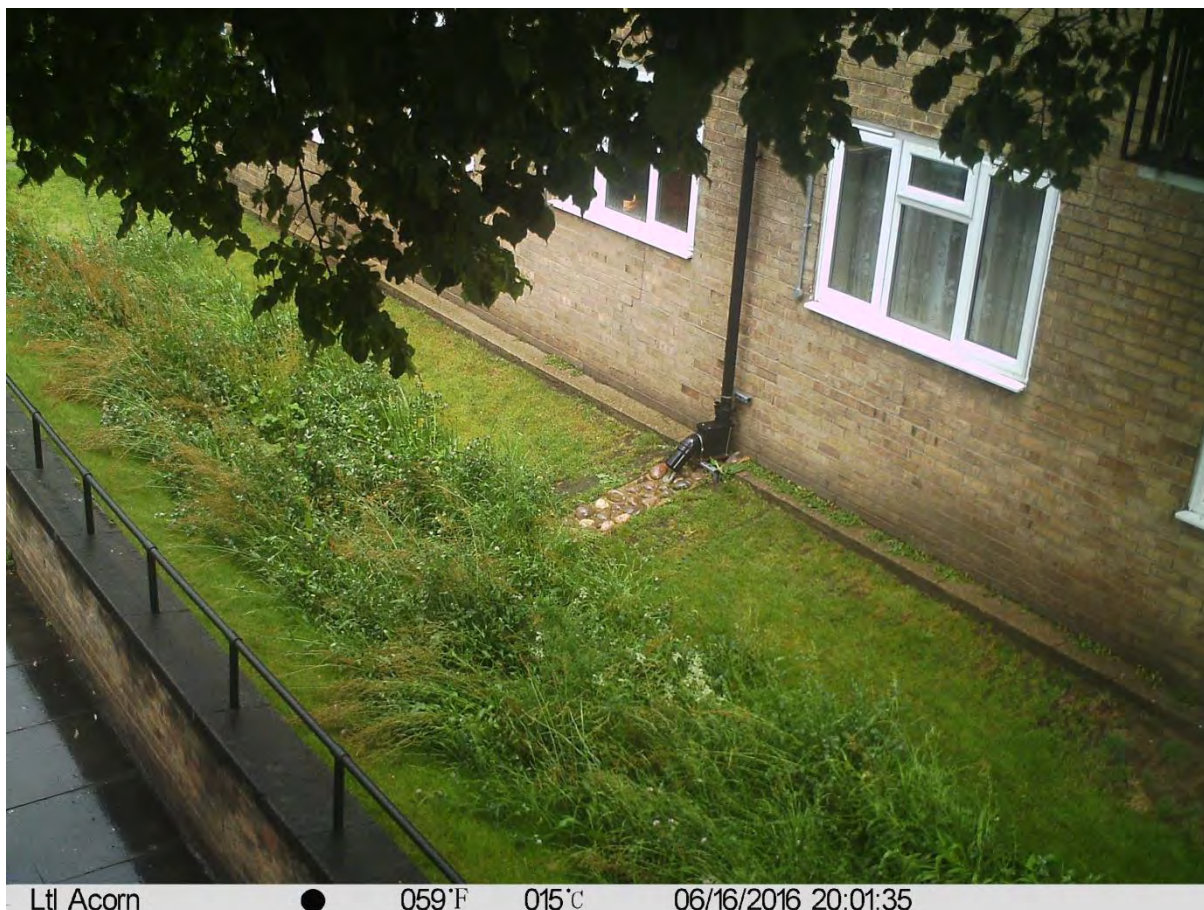
**Figure 8. Time-lapse camera images from Beatrice House swale (FPC4).** Images show i) evidence of swale filling during period of highest rain intensity at 18:45 on 16/06/2016 [32.8 mm of rain at maximum intensity of 188.8 mm/hr] and ii) evidence of infiltration/conveyance by the end of the intense rain event at 20:00 on the same day.

A complete collection of the images from the Beatrice swale during the heaviest rain event recorded since the monitoring equipment was installed (from 18:30 to 20:00 on the 12th June 2016) are presented in Appendix A. They demonstrate that the swale was able to retain and attenuate all of the rainfall that fell directly onto the area and that which was diverted from the roofs of Beatrice House. The images also demonstrate that at around 18:45 during the peak of the rainfall, despite substantial input from the downpipe, there was no obvious standing water within the swale (Figure 8.i). The light conditions immediately after this time make it difficult to see whether pooling occurred after this (low light levels causing a switch between day vision and night vision - see Appendix A), but by the time of the next clear images at 20:00, at the end of the intense rain event, there was no obvious pooled water (Figure 8. ii) indicating that the swale was releasing the stormwater by infiltration and/or conveyance.

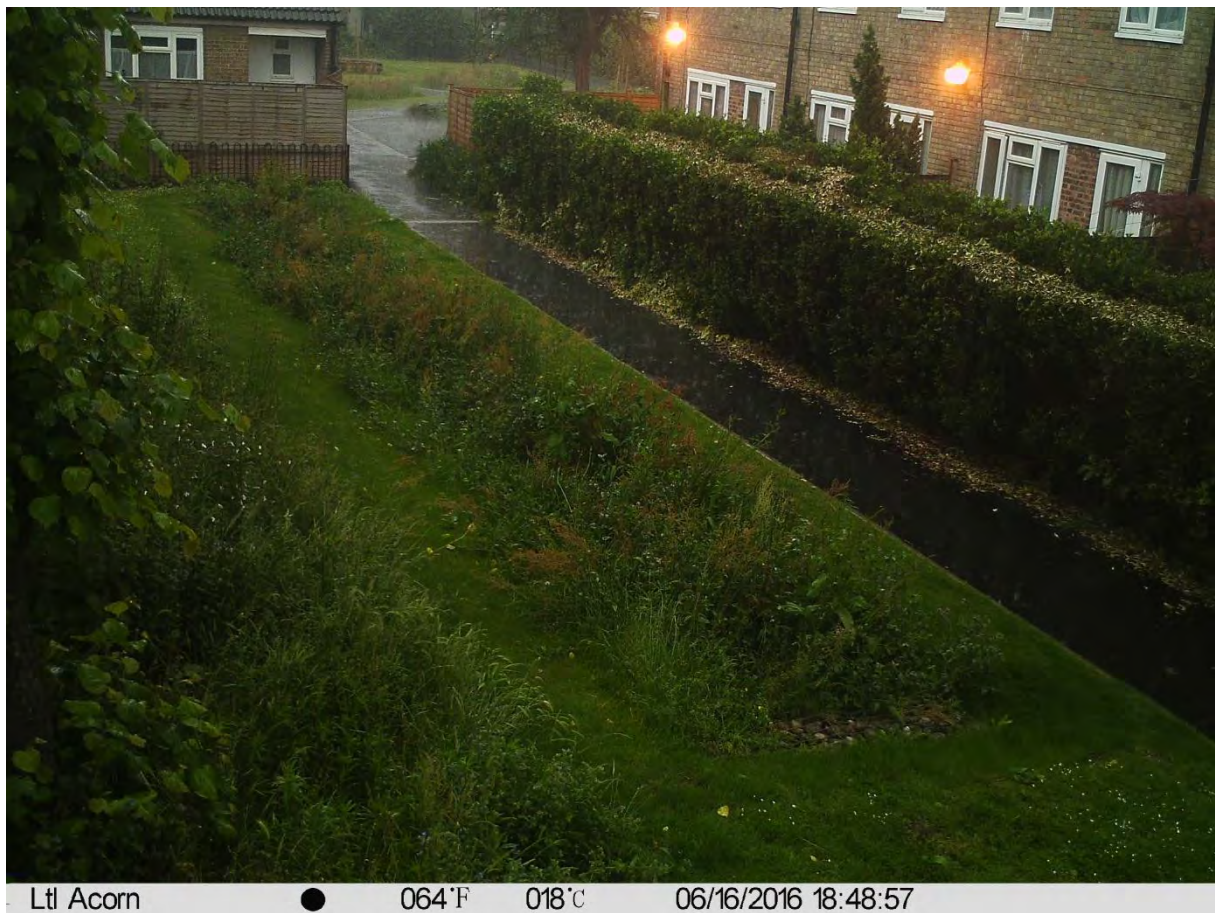
**Figure 9. Time-lapse camera images from Alexandra House swale (FPC1).** Image shows no evidence of swale filling excessively during period of highest rain intensity 18:30 to 20:00 on 16/06/2016 [32.8 mm of rain at maximum intensity of 188.8 mm/hr].

Images showing the performance of the Alexander House swale for the same rain event are presented in Appendix A2. The swale was designed to take stormwater from the surrounding ground level permeable and hardstanding areas and from the roof of the neighbouring Alexandra House. Whilst the fixed point photos showed evidence of the intensity of the rain event in relation to pooling on the ground, there was no evidence of any substantial filling or overflowing of the swale. This was the case even during the most intense period of rainfall (Figure 9). This indicated that the swale was performing as expected for this rain event. It is important to note at this point, however, that lack of maintenance of the guttering on Alexandra House might mean that not all of the rain falling on the areas of the roof that should be diverted to the swale is actually reaching the swale.

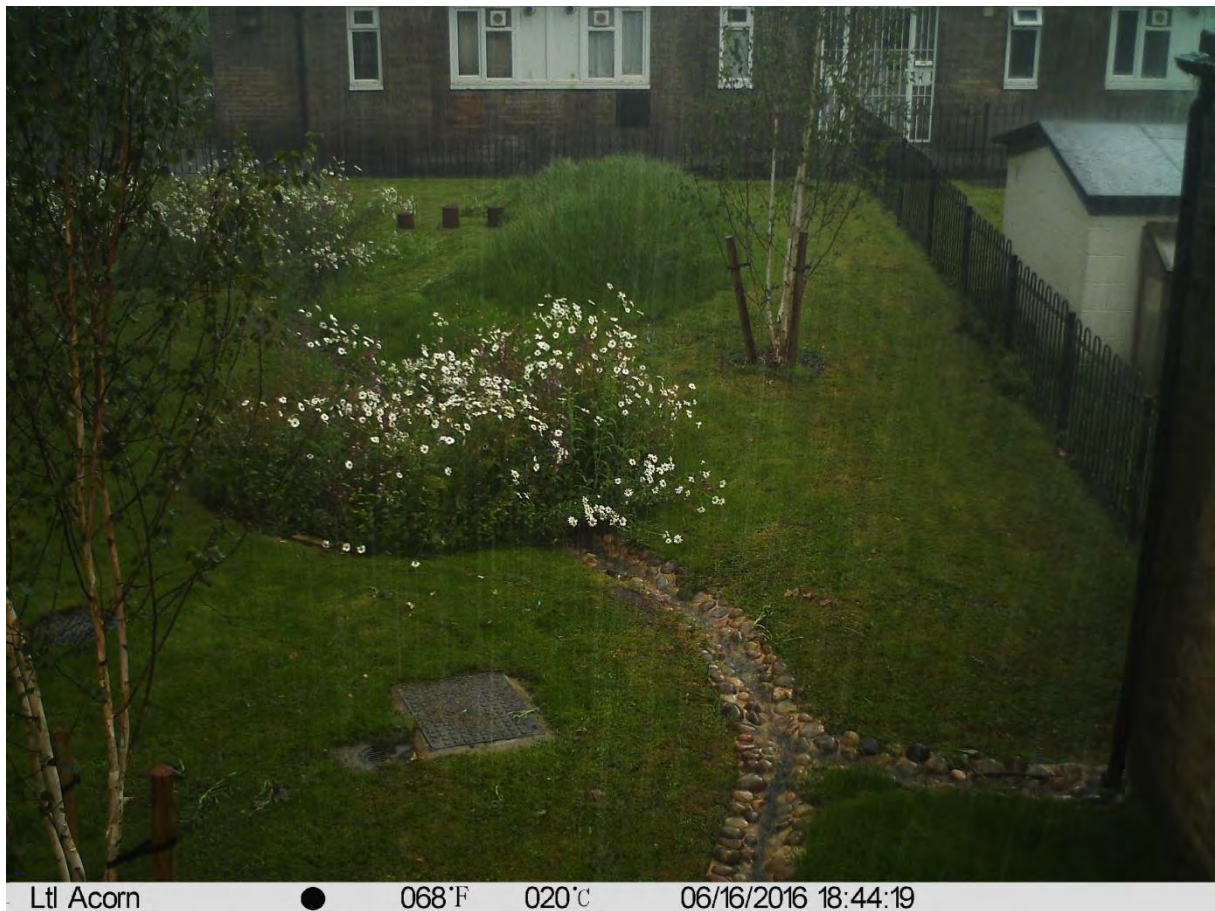
**Figure 10. Time-lapse camera images from Community Hall and Sophia House basins (FPC2).** Image shows no evidence of swale filling excessively during period of highest rain intensity 18:30 to 20:00 on 16/06/2016 [32.8 mm of rain at maximum intensity of 188.8 mm/hr].

Images showing the performance of the Community Hall and Sofia House grass basins for the same rain event are presented in Appendix A3. The basins were designed to take stormwater from the surrounding ground level permeable and hardstanding areas and from the roof of the neighbouring Community Hall and Sophia House. Whilst the fixed point photos showed evidence of the intensity of the rain event in relation to pooling on the ground, there was no evidence of any substantial filling of the basins. This was the case even during the most intense period of rainfall (Figure 10). This indicated that the basins were performing as expected for this rain event.

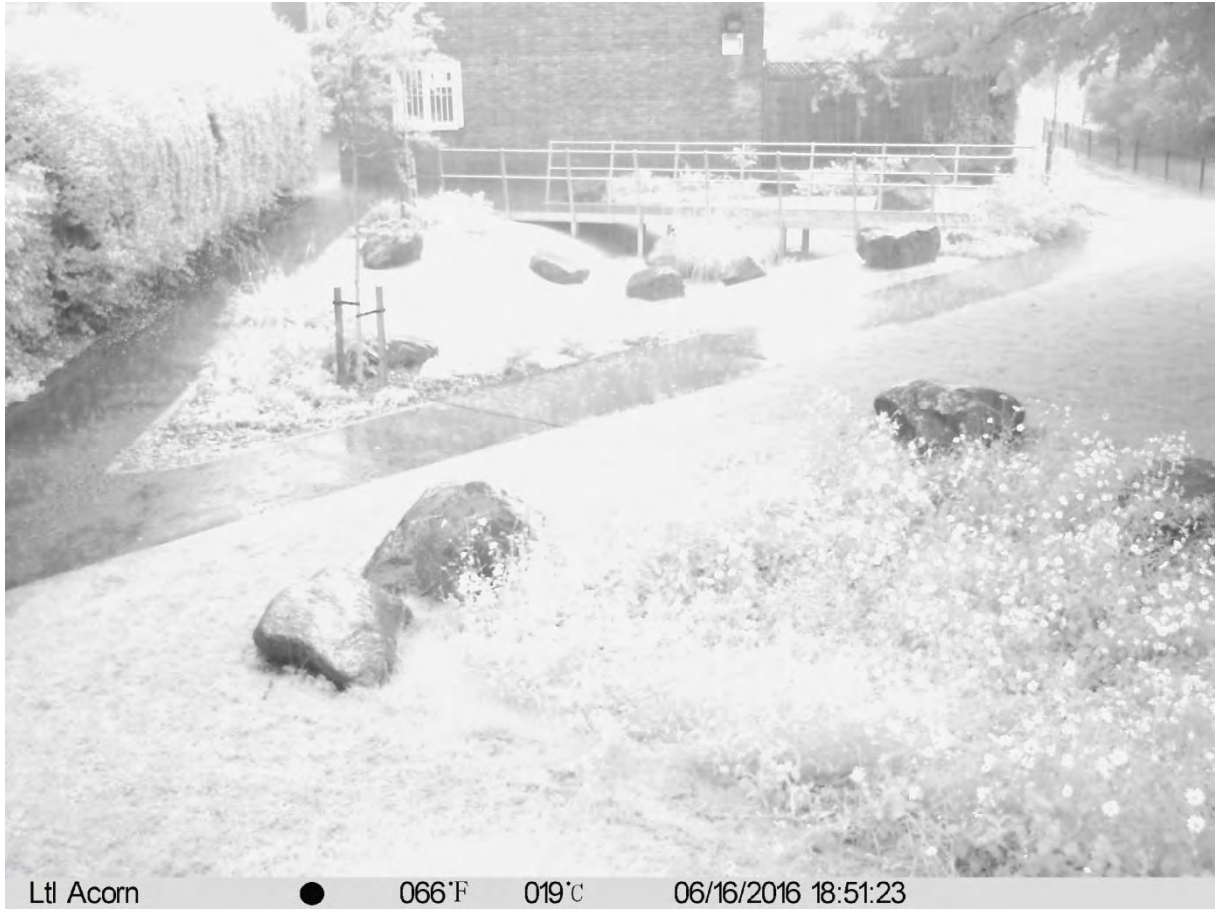
**Figure 11. Time-lapse camera images from Adella House grass basin and Adella House stoney basin (FPC3).** Image shows no evidence of swale filling excessively during period of highest rain intensity 18:30 to 20:00 on 16/06/2016 [32.8 mm of rain at maximum intensity of 188.8 mm/hr].

Images showing the performance of the Adella House grass basin and Adella House stoney basin for the same rain event are presented in Appendix A4. The basins were designed to take stormwater from the surrounding ground level permeable and hardstanding areas and from the roof of Adella House. Whilst the fixed point photos showed evidence of the intensity of the rain event in relation to pooling on the ground, there was no evidence of any substantial filling of the basins. This was the case even during the most intense period of rainfall (Figure 11). This indicated that the basins were performing as expected for this rain event. It is important to note at this point, however, that lack of maintenance of the guttering on Adella House might mean that not all of the rain falling on the areas of the roof that should be diverted to the basins is actually reaching the basins.

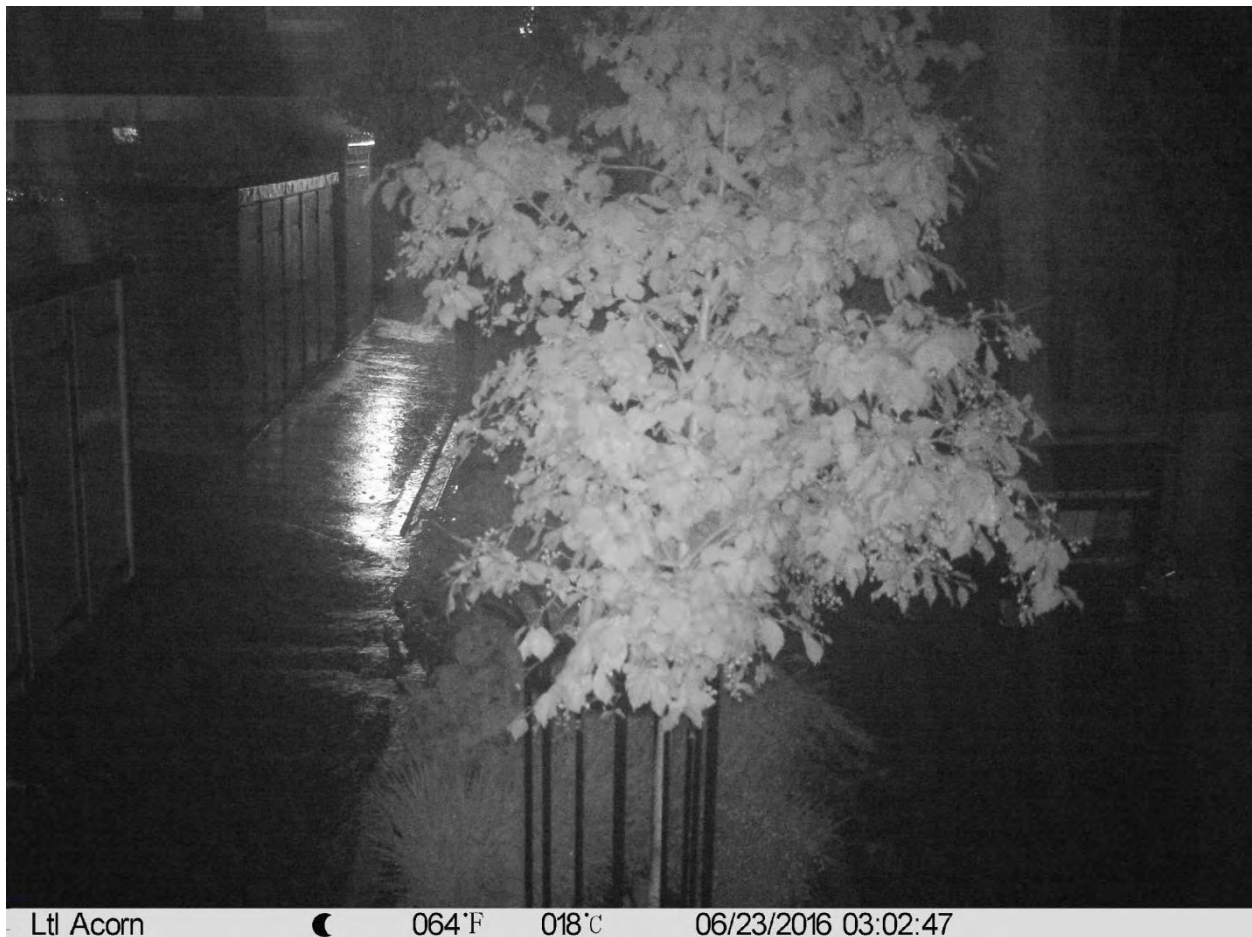
**Figure 13. Time-lapse camera images from Richard Knight House rain garden (FPC5).** Image shows no evidence of rain garden filling excessively during period of highest rain intensity 01:00 and 04:00 on 23/06/2016 [17.2 mm of rain at maximum intensity of 91.4 mm/hr].

Images showing the performance of the Richard Knight House rain garden for the rain event on 23rd June 2016 are presented in Appendix A5. The basins were designed to take stormwater from the ground level permeable and hardstanding areas surrounding the rain garden, from the green roofs on the pram sheds and from the roof of a neighbouring house. Whilst the fixed point photos showed evidence of the intensity of the rain event in relation to pooling on the ground, there was no evidence of any substantial filling of the basins. This was the case even during the most intense period of rainfall (Figure 13). This indicated that the basins were performing as expected for this rain event.

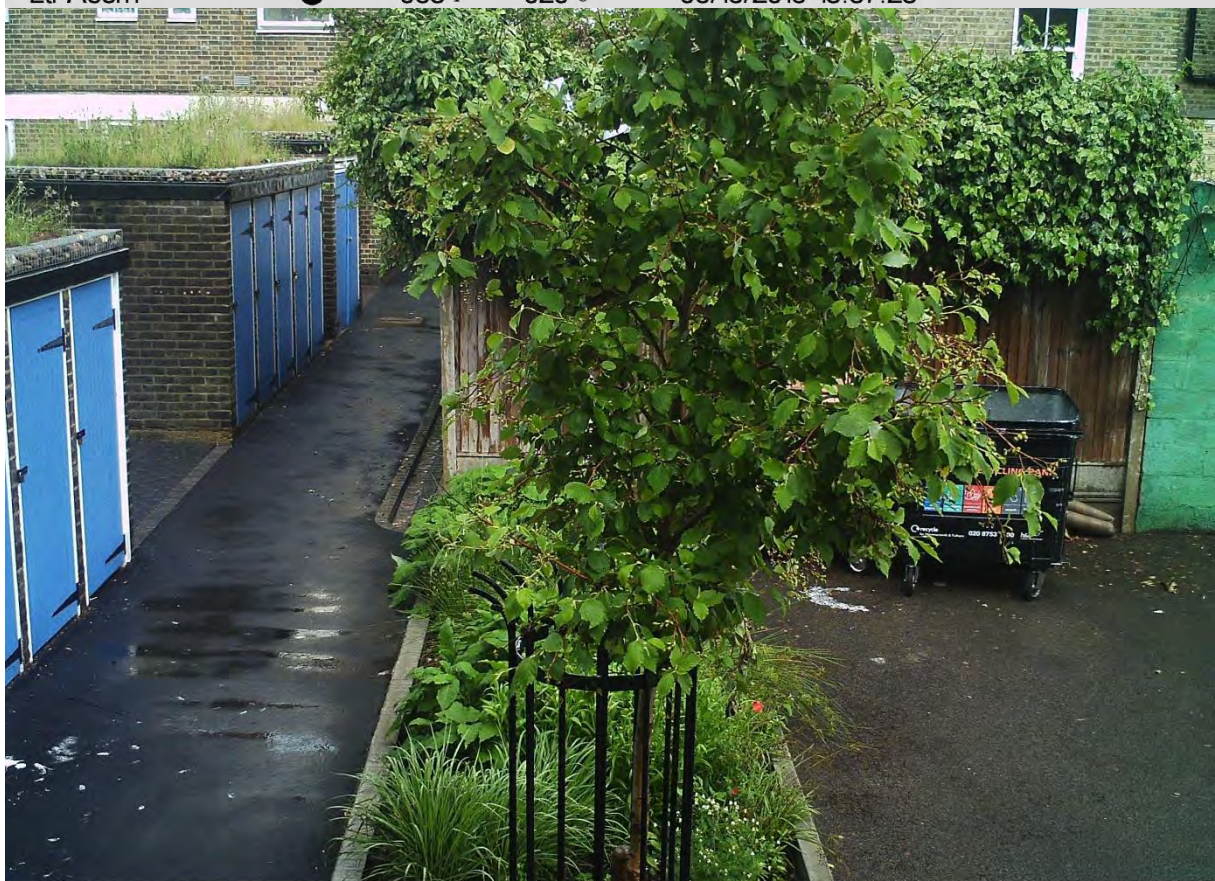
Despite this intense and substantial nature of the rainfall over a short period, the time-lapse camera images revealed no evidence of excessive filling of the Richard Knight House rain garden (Figure 15).

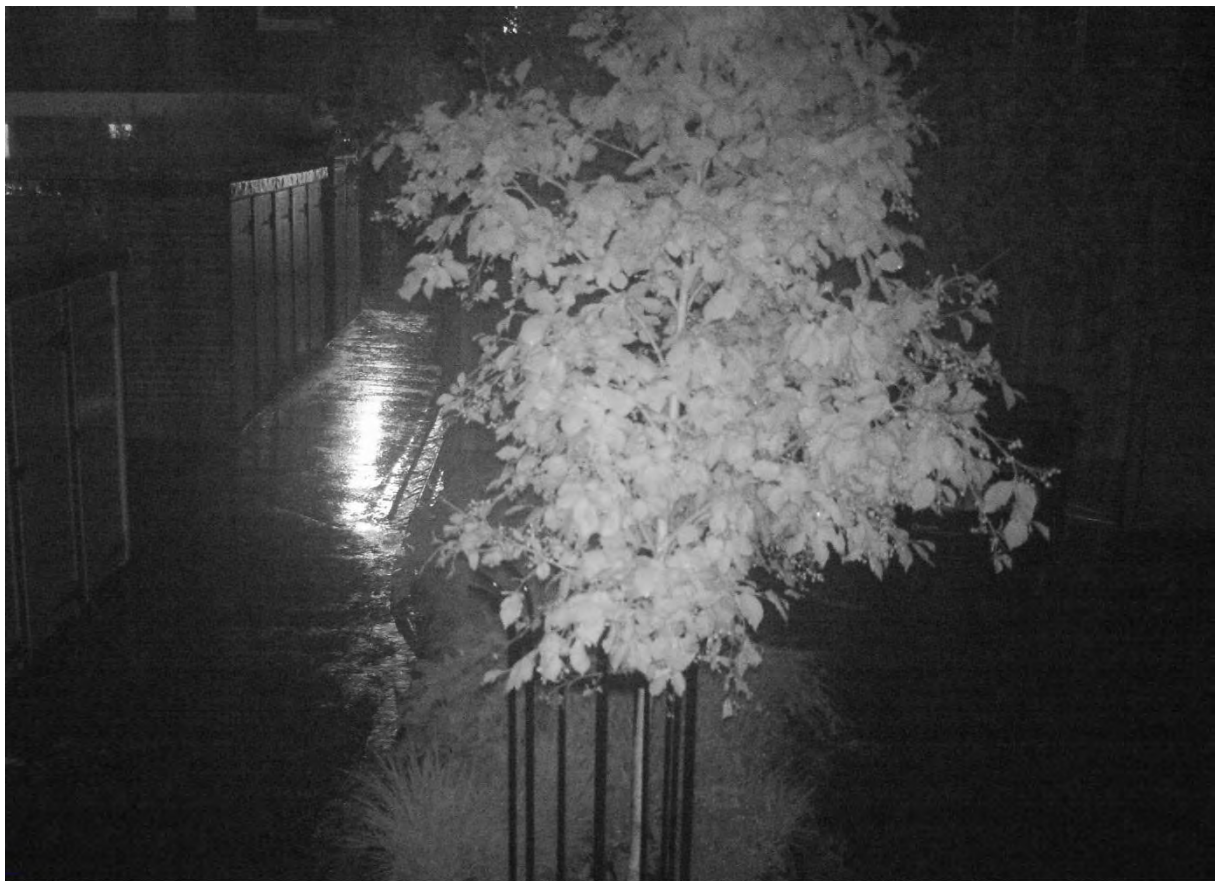
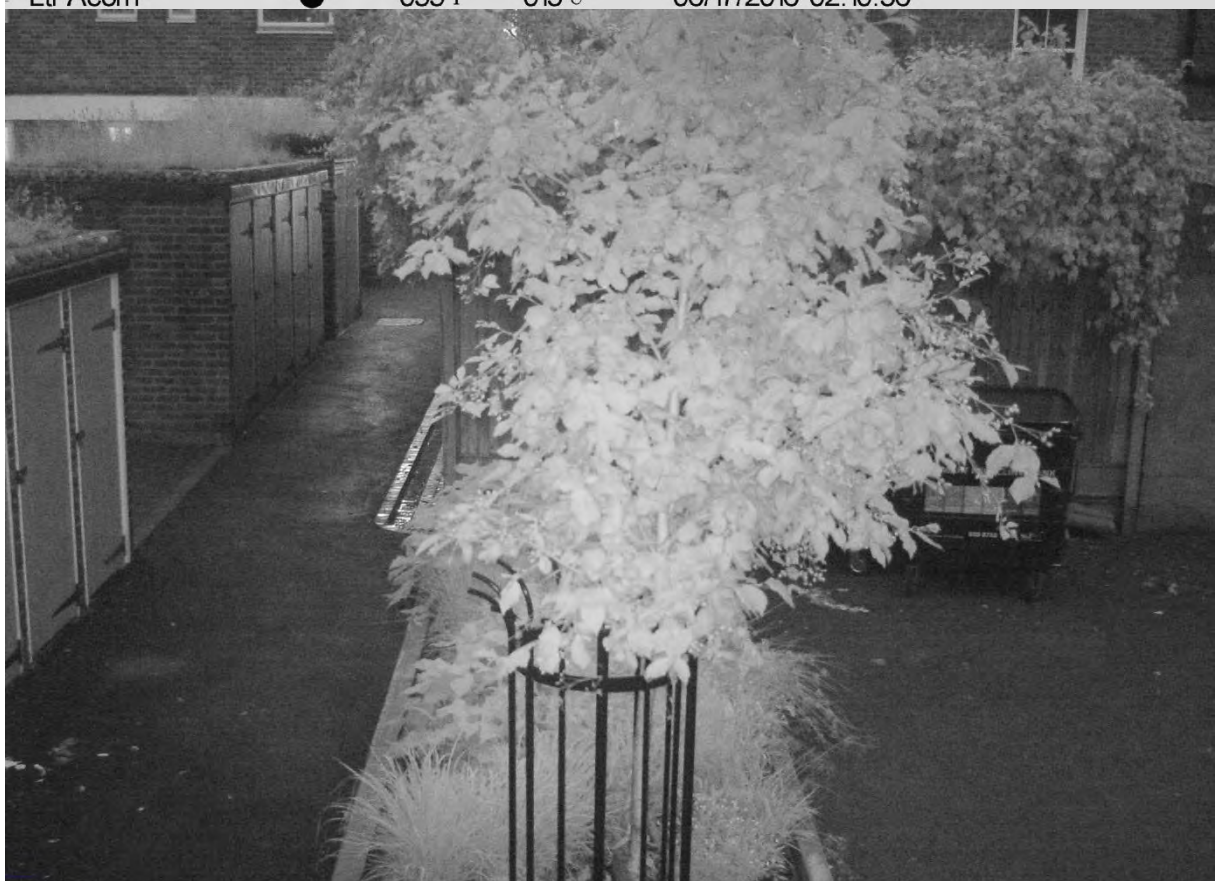
Despite this intense and substantial nature of the rainfall over a short period, the time-lapse camera images revealed no evidence of excessive filling of the Richard Knight House rain garden (Figure 17).

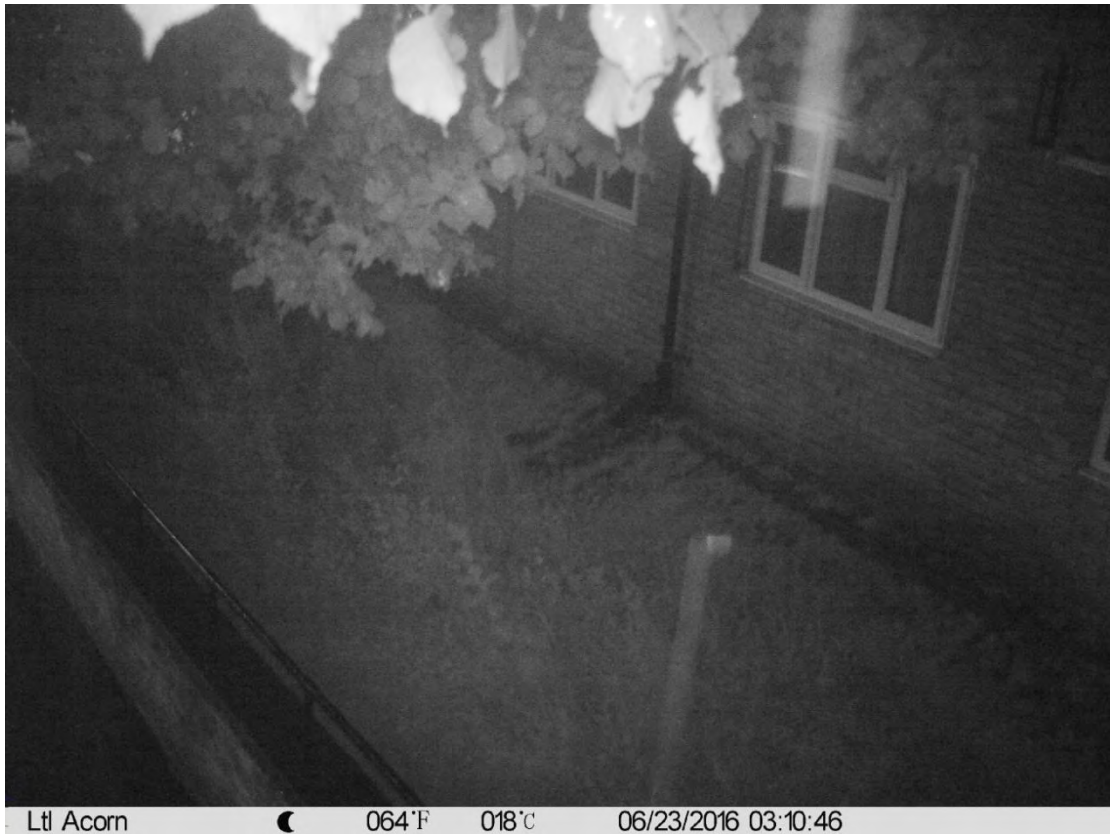
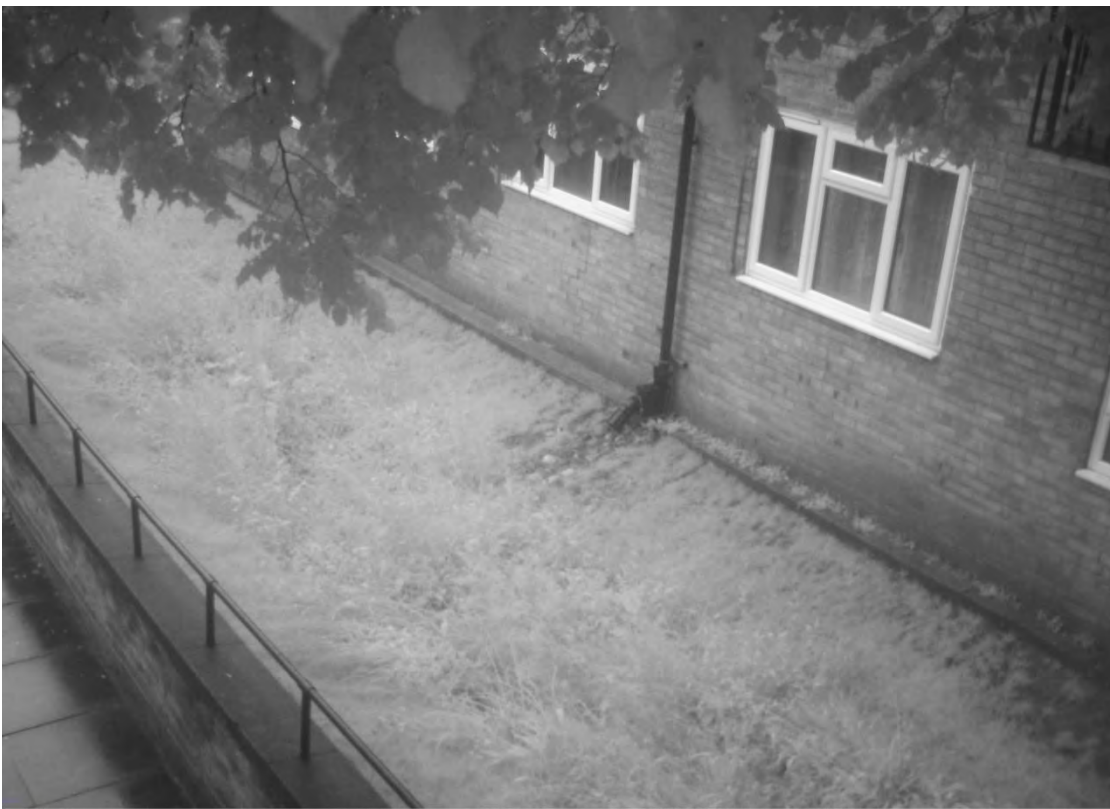
**Figure 19. Time-lapse camera images from Beatrice House swale (FPC4).** Images show no sign of excessive pooling in the swale i) during the period of intense rainfall or ii) following the cessation of the most intense period of the rain event.

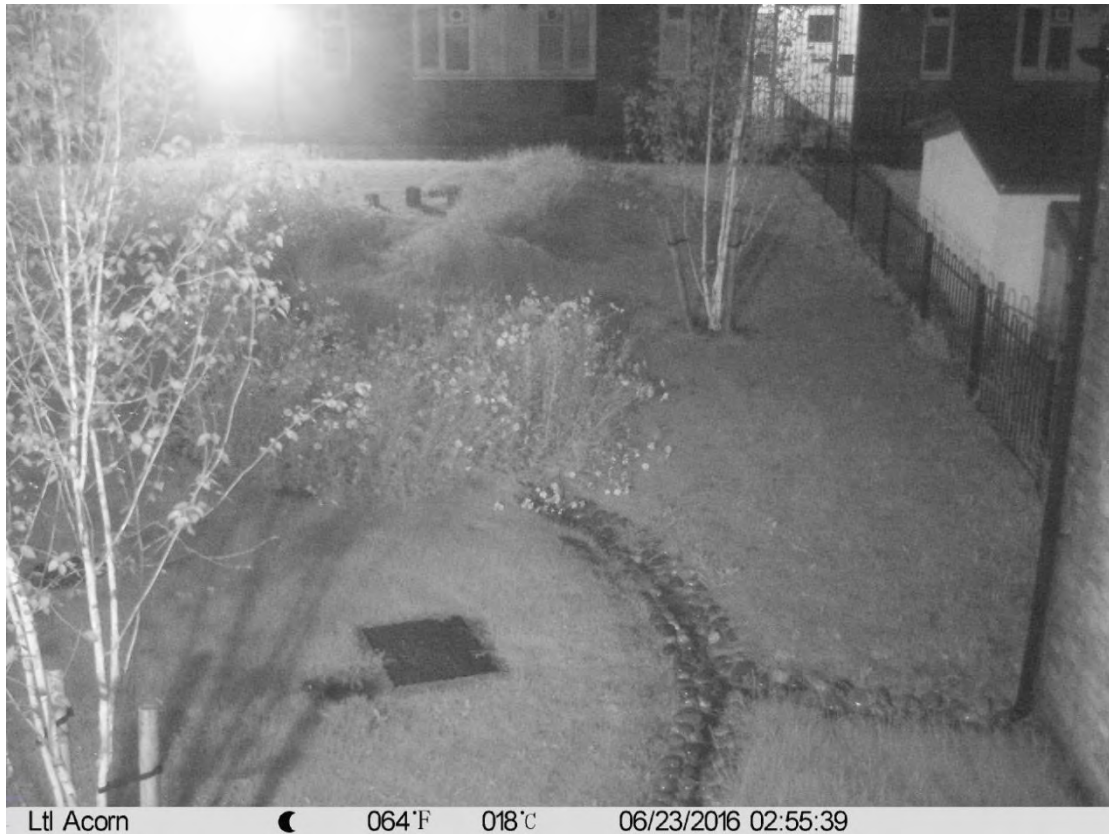
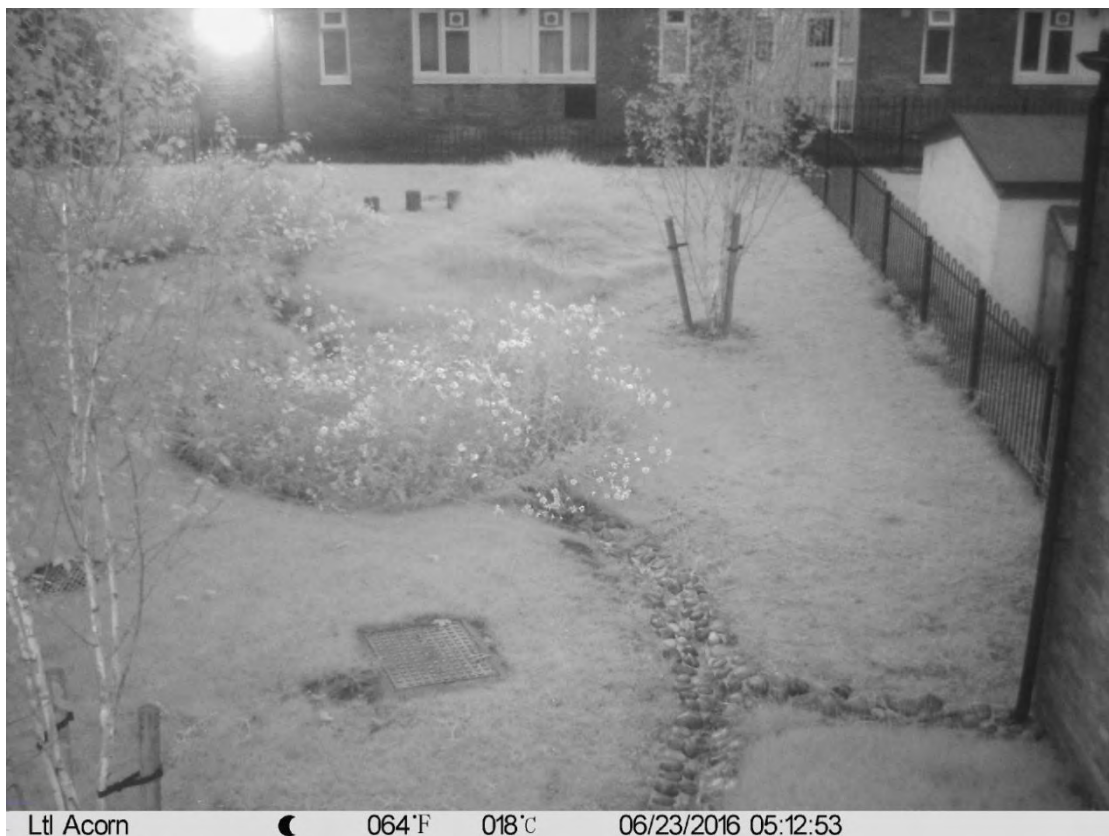
**Figure 20. Time-lapse camera images from Adella House basin (FPC2).** Images show no sign of excessive pooling in the basin i) during the period of intense rainfall or ii) following the cessation of the most intense period of the rain event.

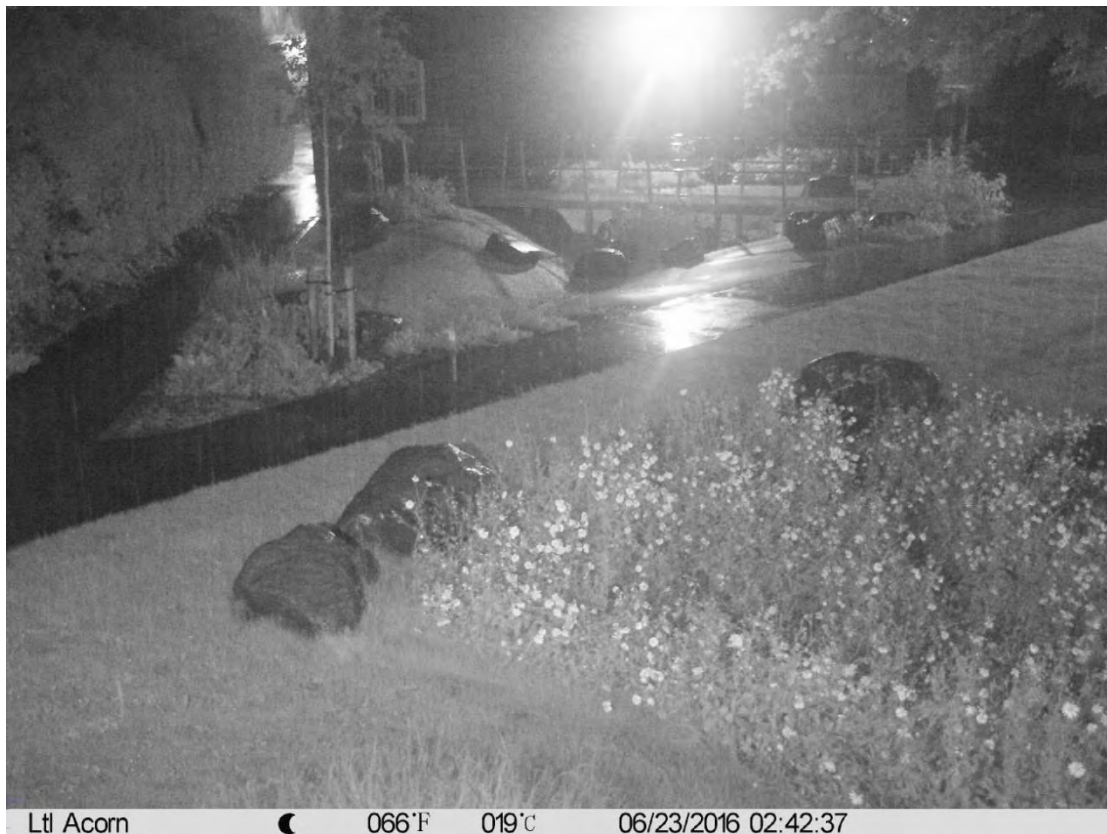
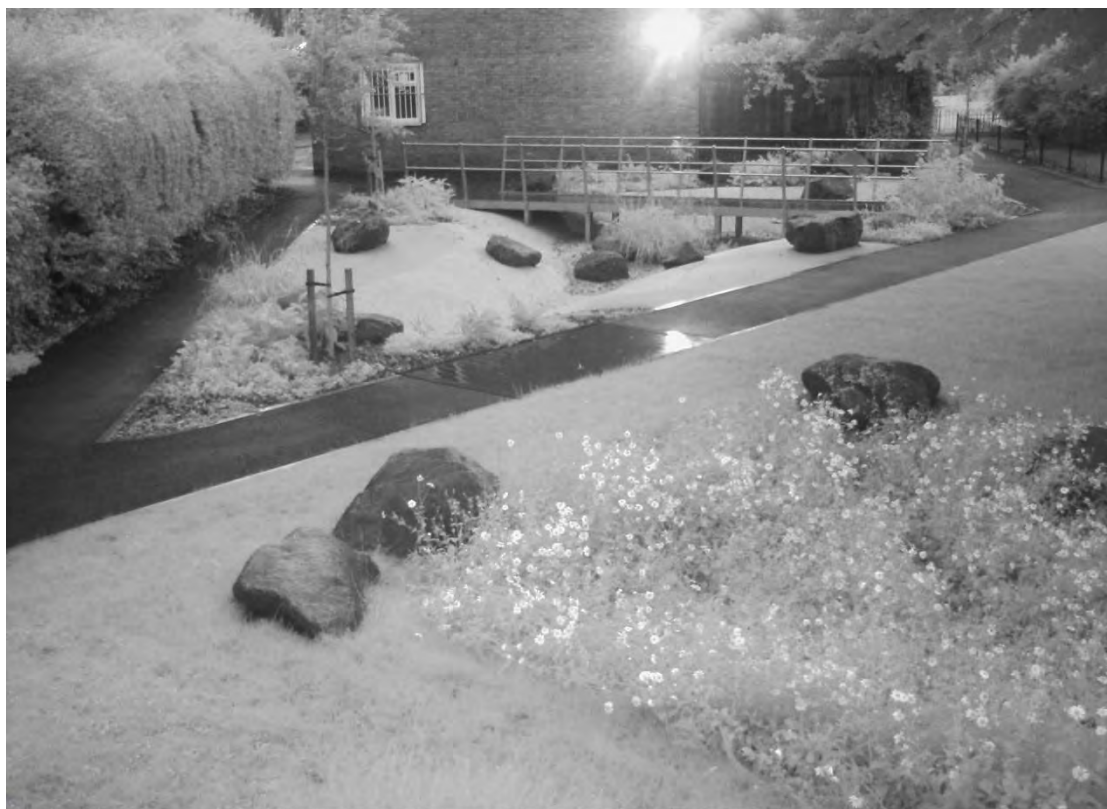
**Figure 21. Time-lapse camera images from Adella House basin (FPC3).** Images show no sign of excessive pooling in the basin i) during the period of intense rainfall or ii) following the cessation of the most intense period of the rain event.

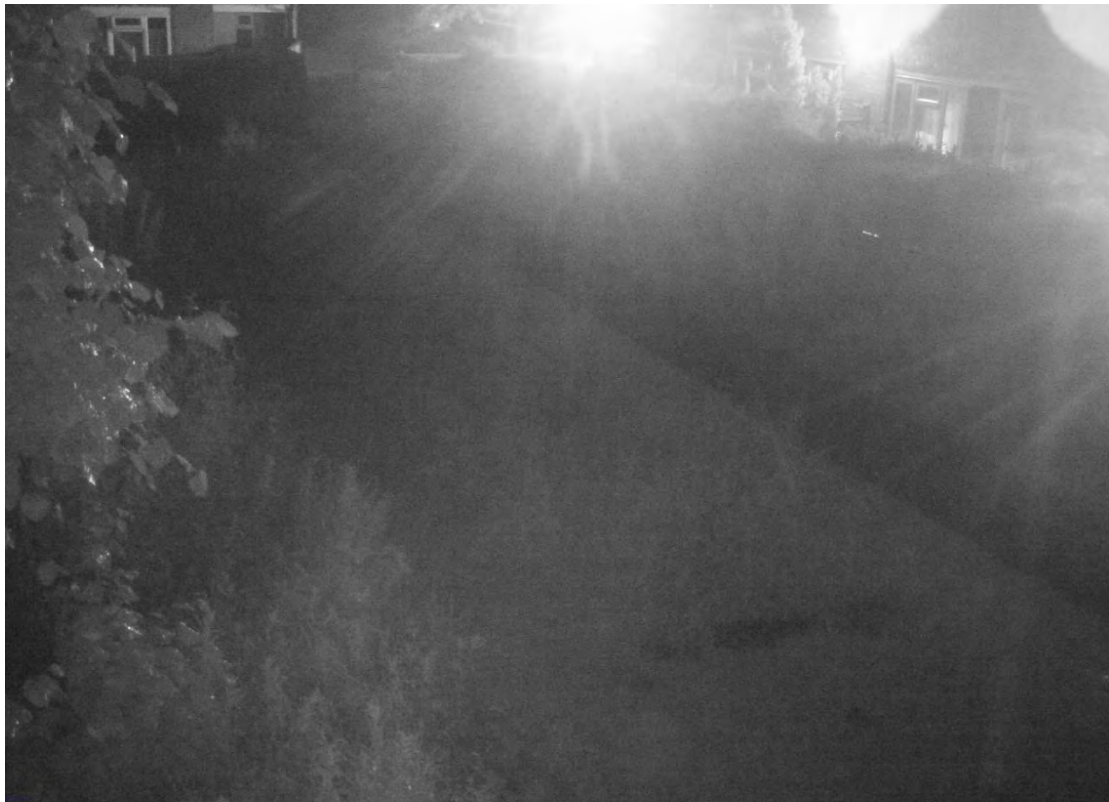
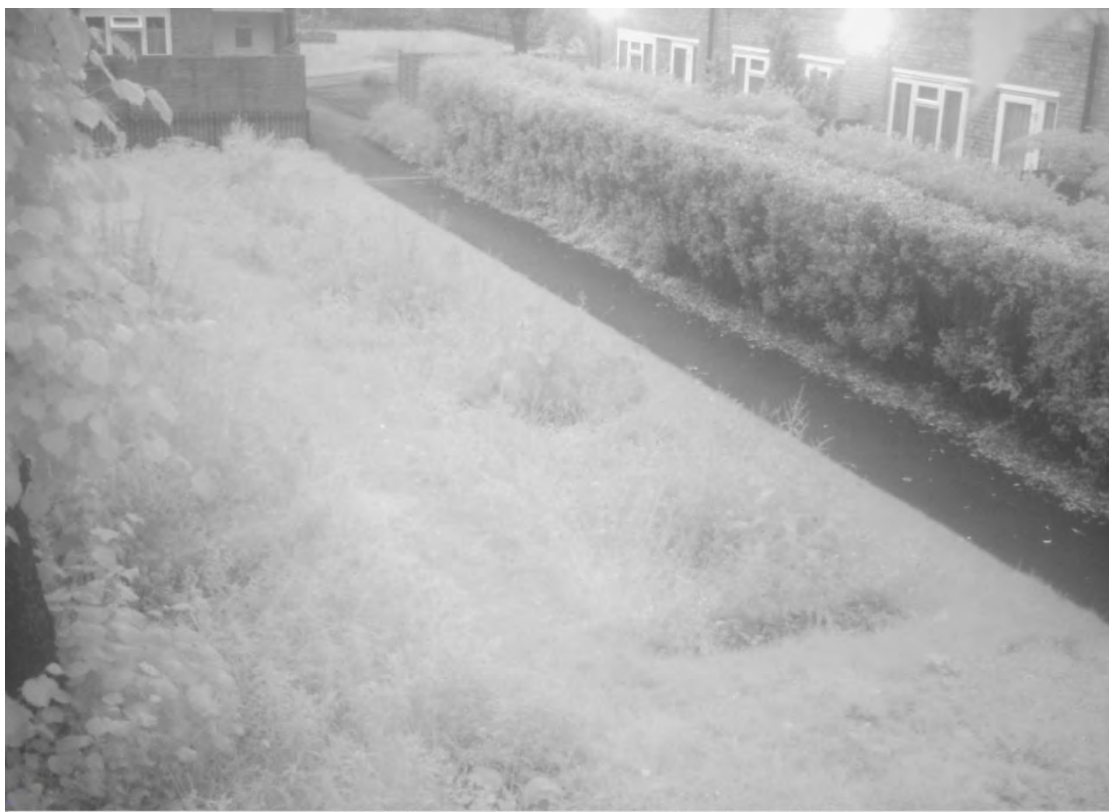
**Figure 22. Time-lapse camera images from Alexandra House swale (FPC1).** Images show no sign of excessive pooling in the swale i) during the period of intense rainfall or ii) following the cessation of the most intense period of the rain event.

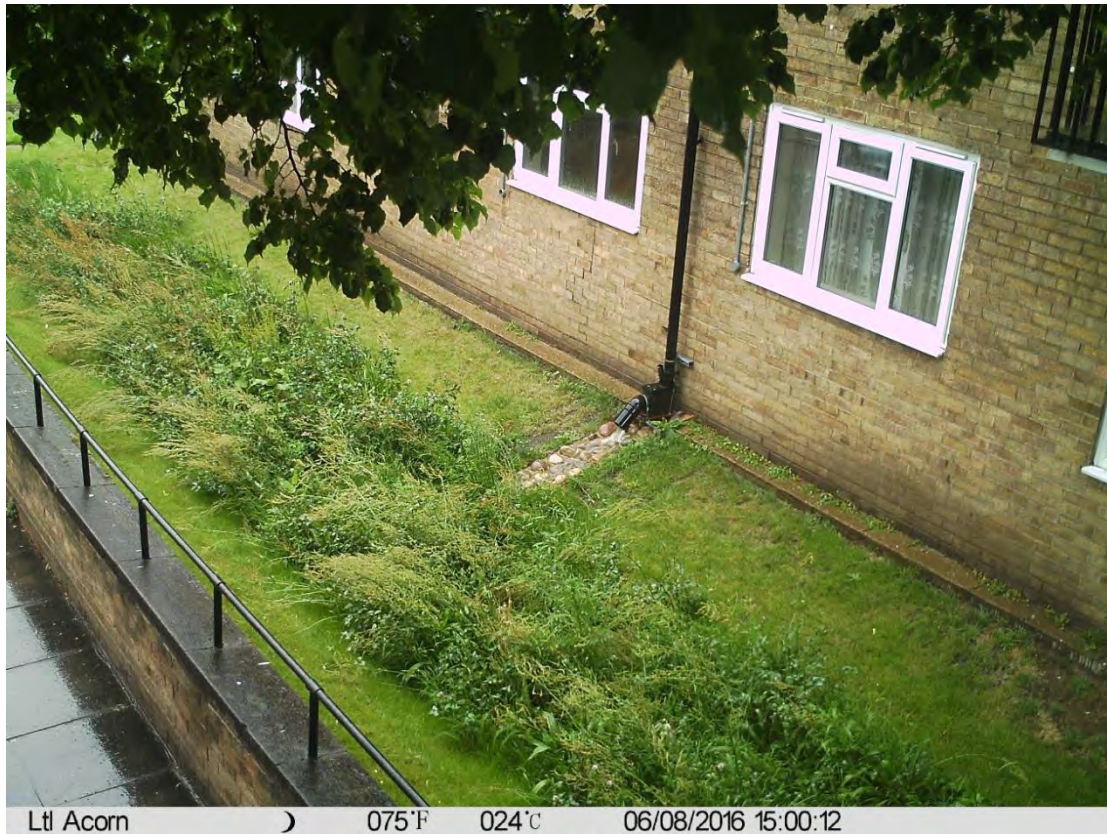
**Figure 24. Time-lapse camera images from Beatrice House swale (FPC4).** Images show no sign of excessive pooling in the swale i) during the period of intense rainfall or ii) following the cessation of the most intense period of the rain event.
