**Climate Proofing Housing Landscapes:  
Monitoring Report 2**

**June 2016 to September 2016**

Authors: Connop, S., Clough, J., Gunawardena, D. and Nash, C.

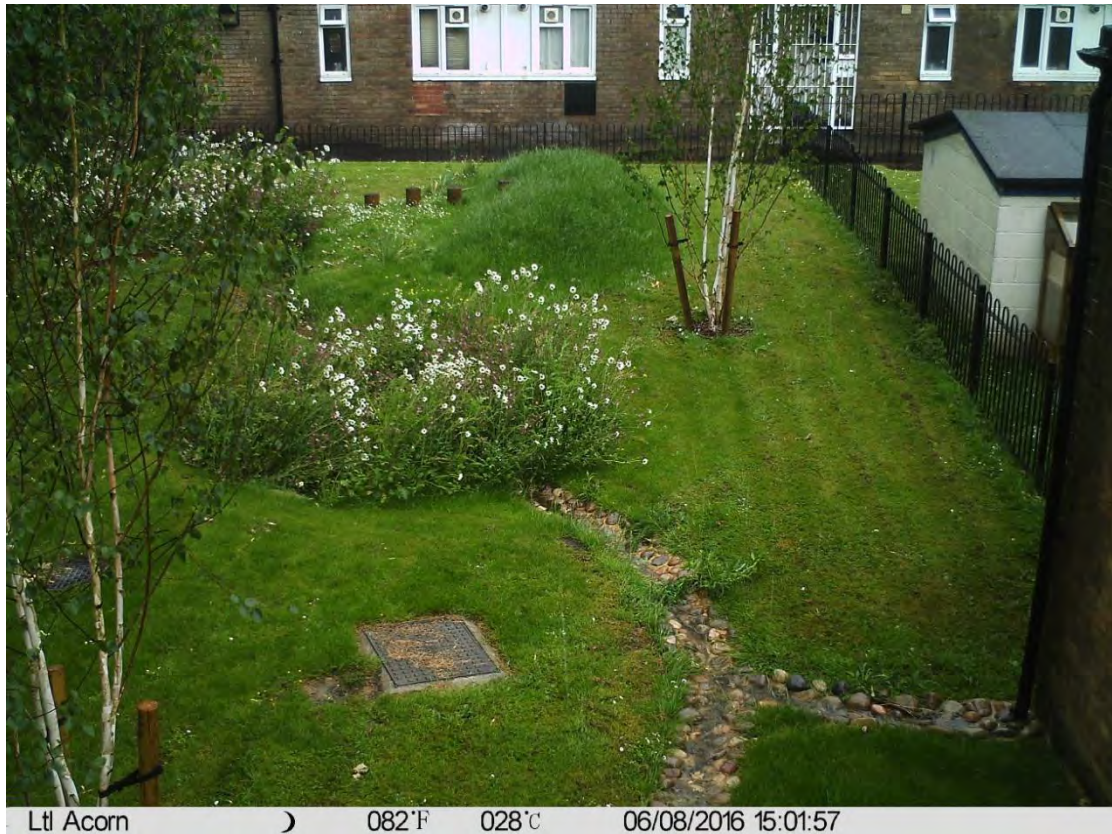
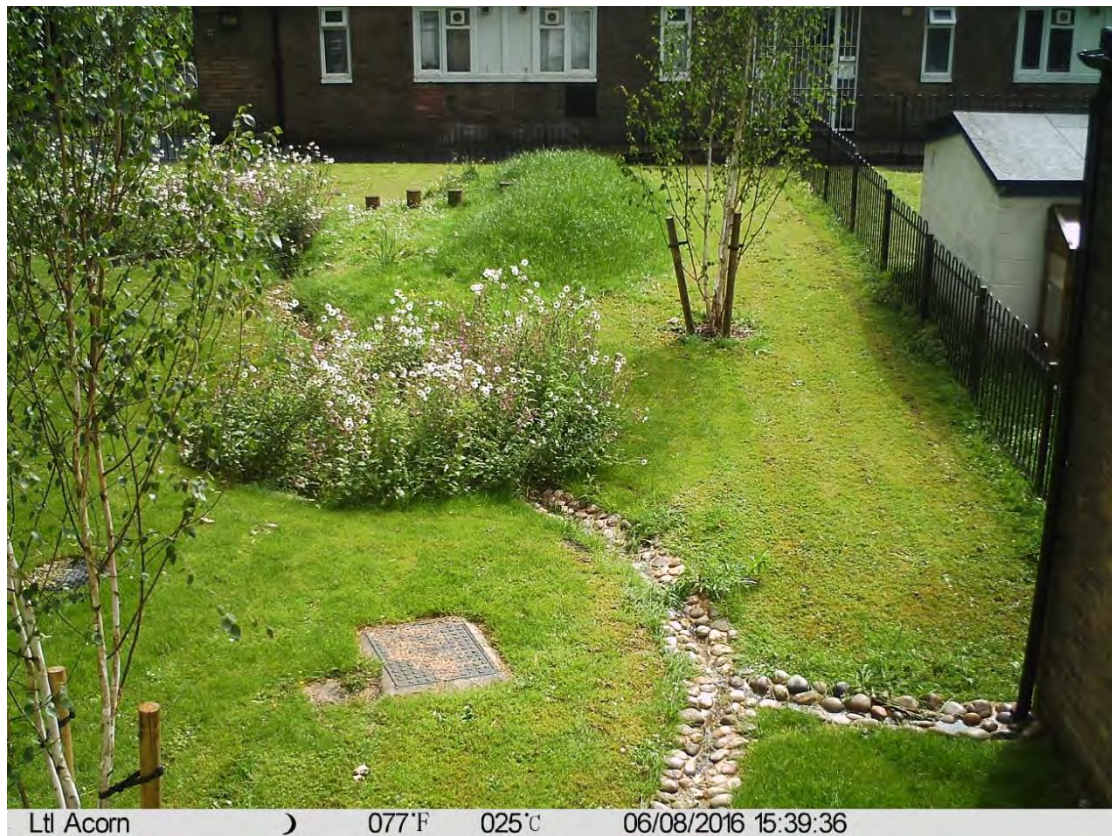
**Figure 25. Time-lapse camera images from Adella House basin (FPC2).** Images show no sign of excessive pooling in the basin i) during the period of intense rainfall or ii) following the cessation of the most intense period of the rain event.

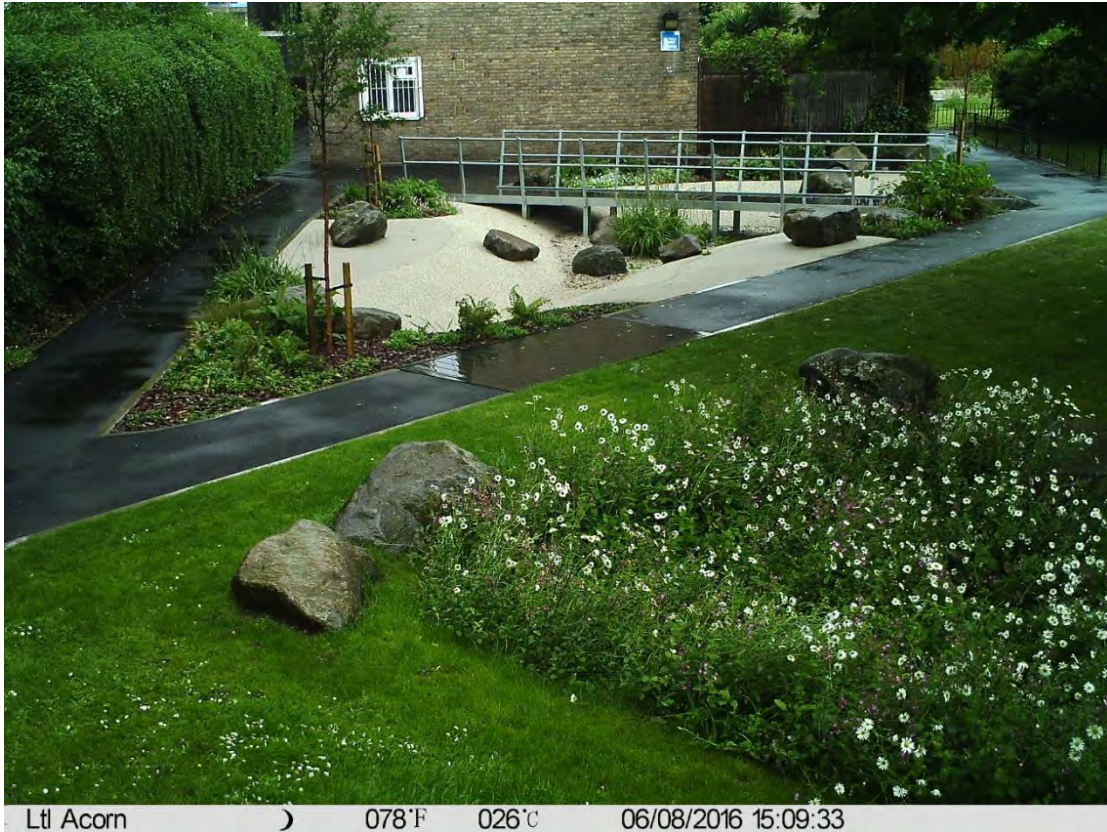
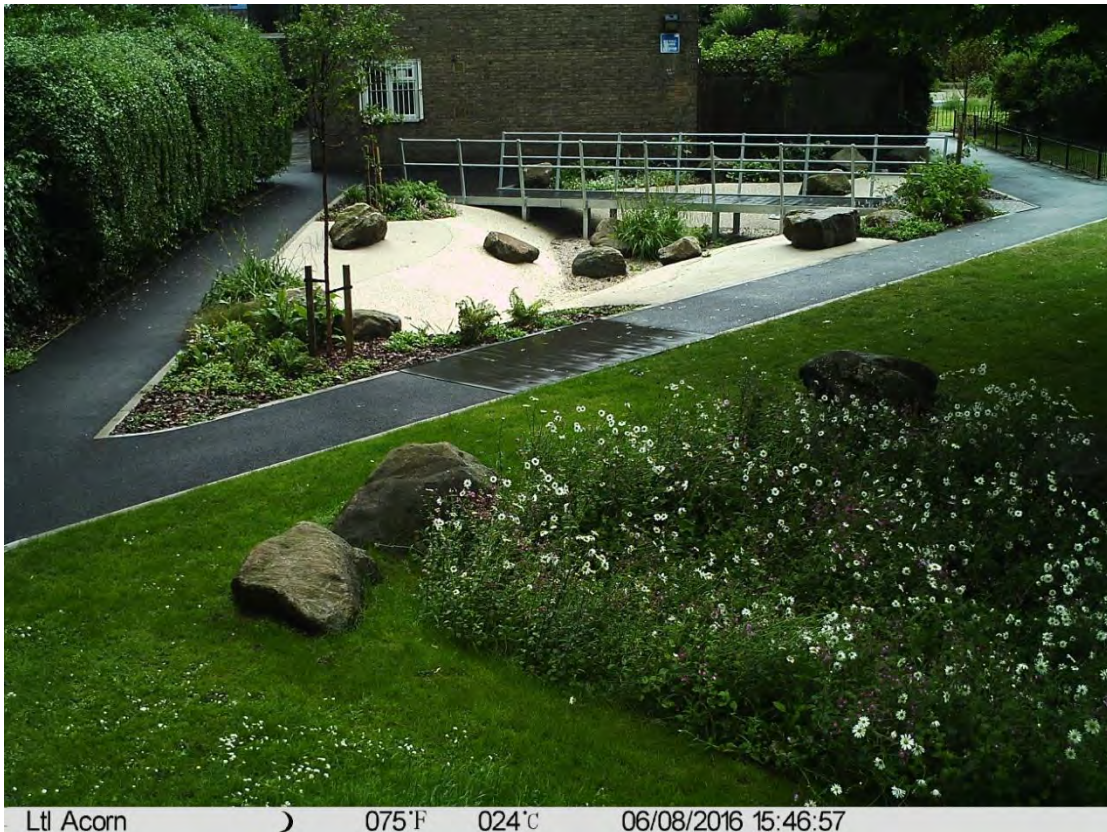
**Figure 26. Time-lapse camera images from Adella House basin (FPC3).** Images show no sign of excessive pooling in the basin i) during the period of intense rainfall or ii) following the cessation of the most intense period of the rain event.

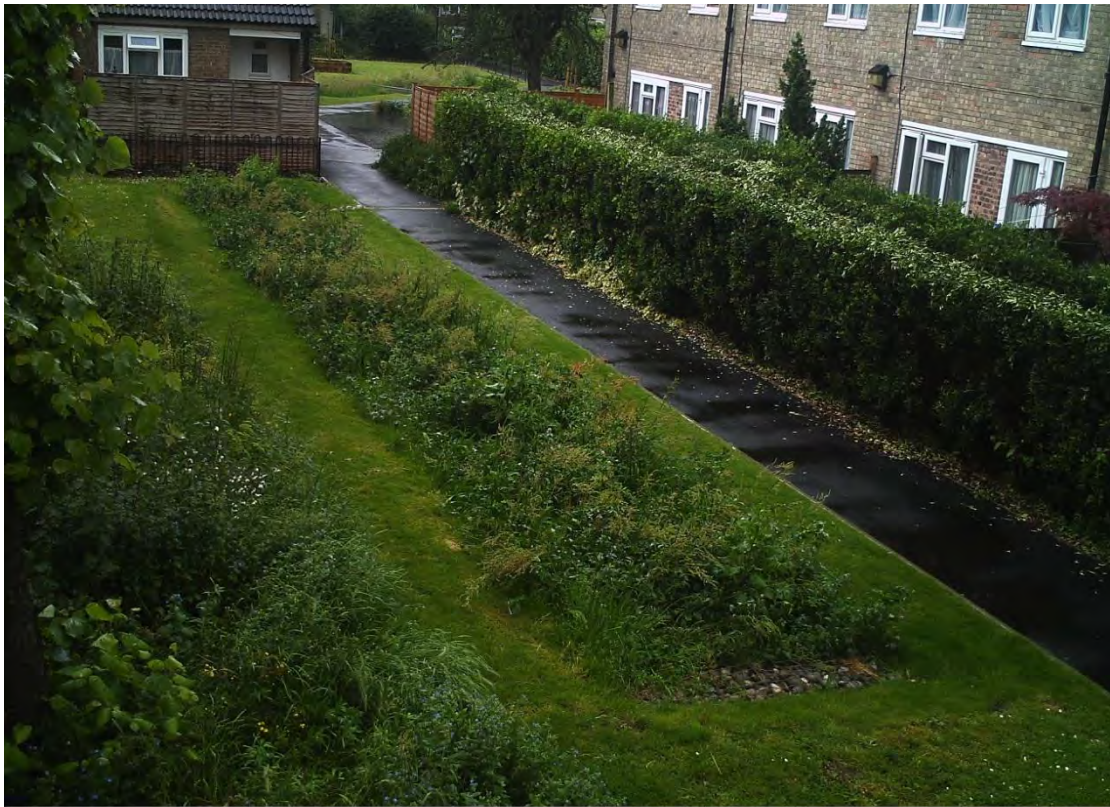
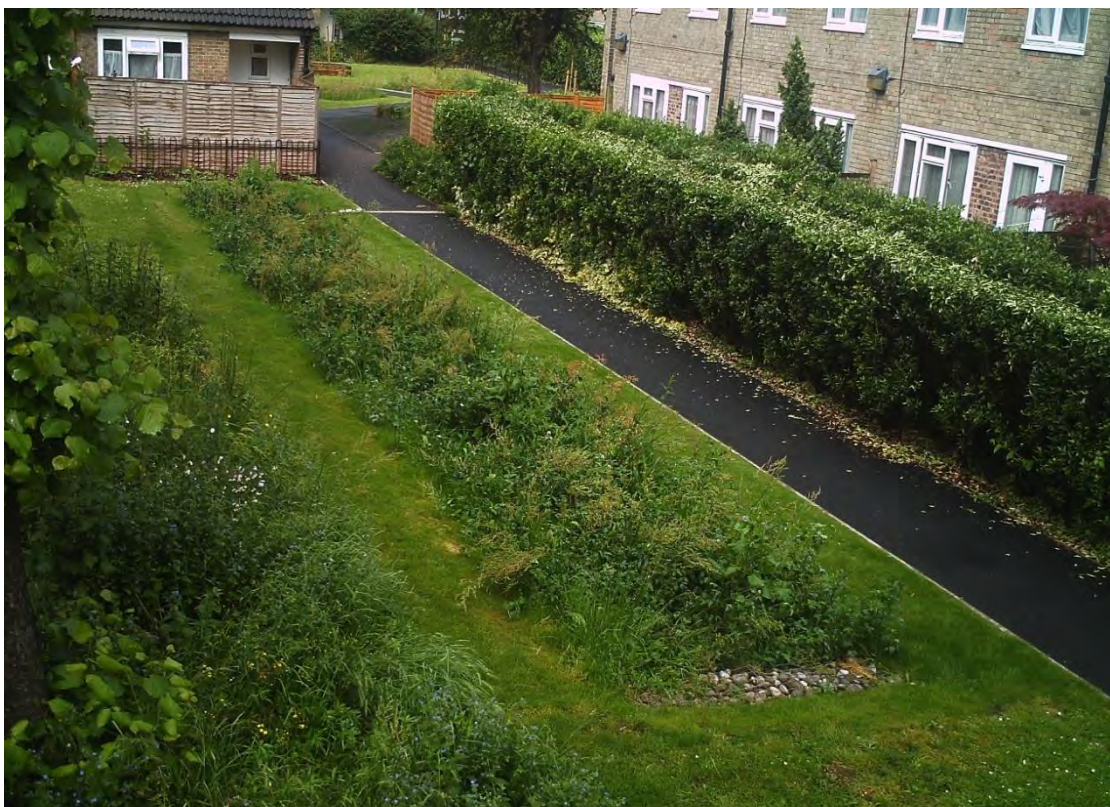
**Figure 27. Time-lapse camera images from Alexandra House swale (FPC1).** Images show no sign of excessive pooling in the swale i) during the period of intense rainfall or ii) following the cessation of the most intense period of the rain event.

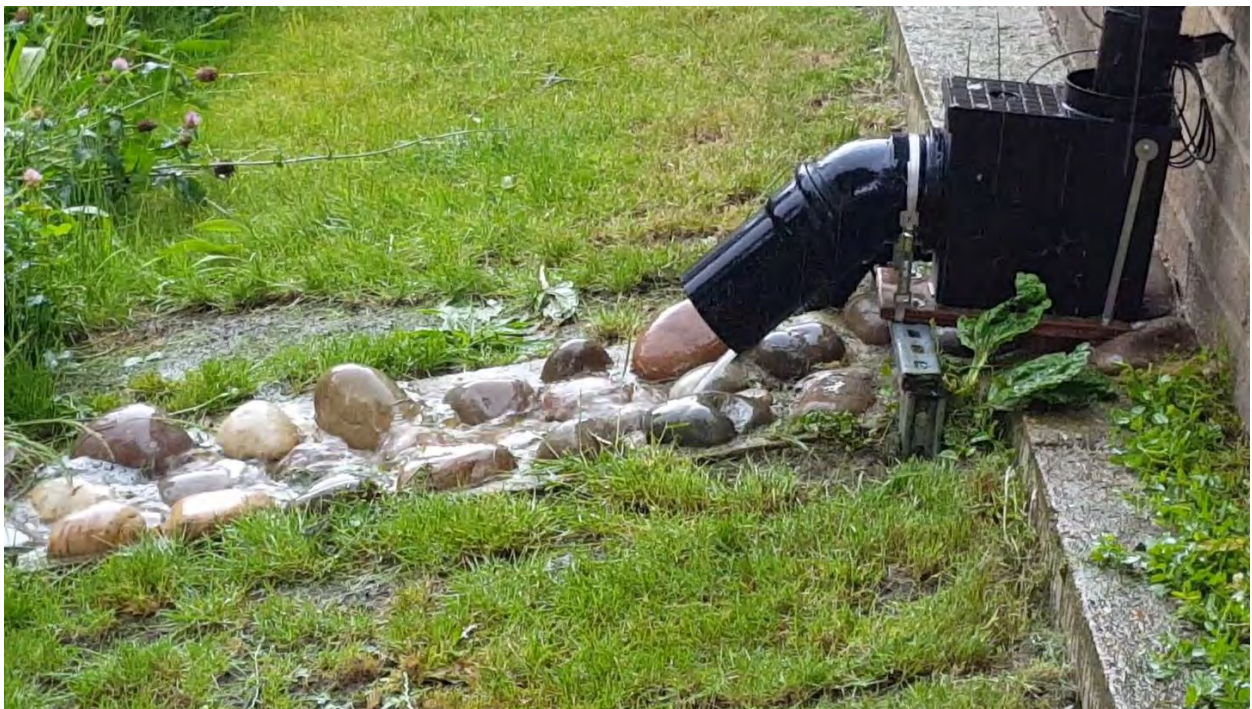
**Figure 28. Beatrice House downpipe outflow.** Image shows runoff from downpipe to ground level swale during a storm event on the 16th June 2016.

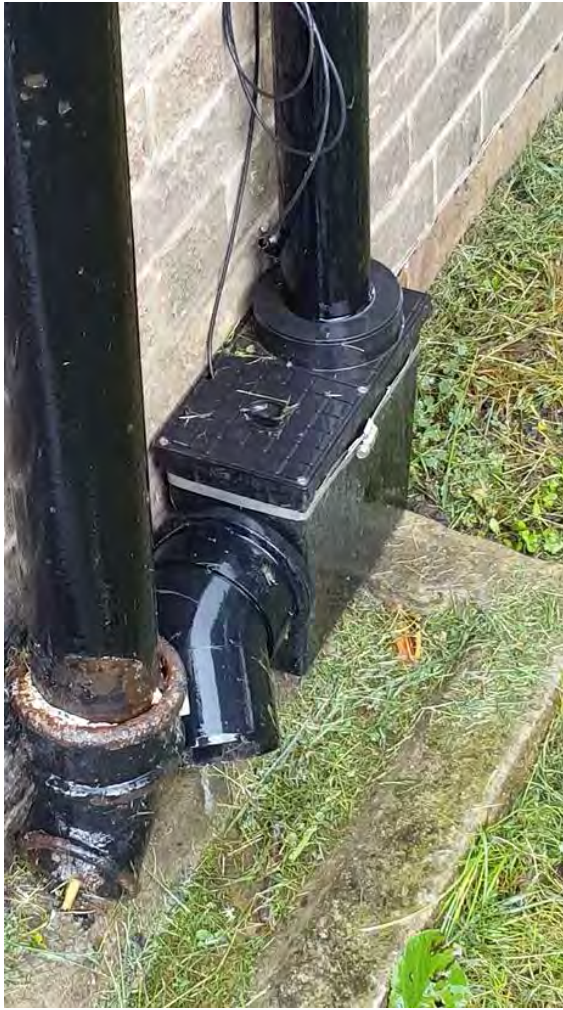
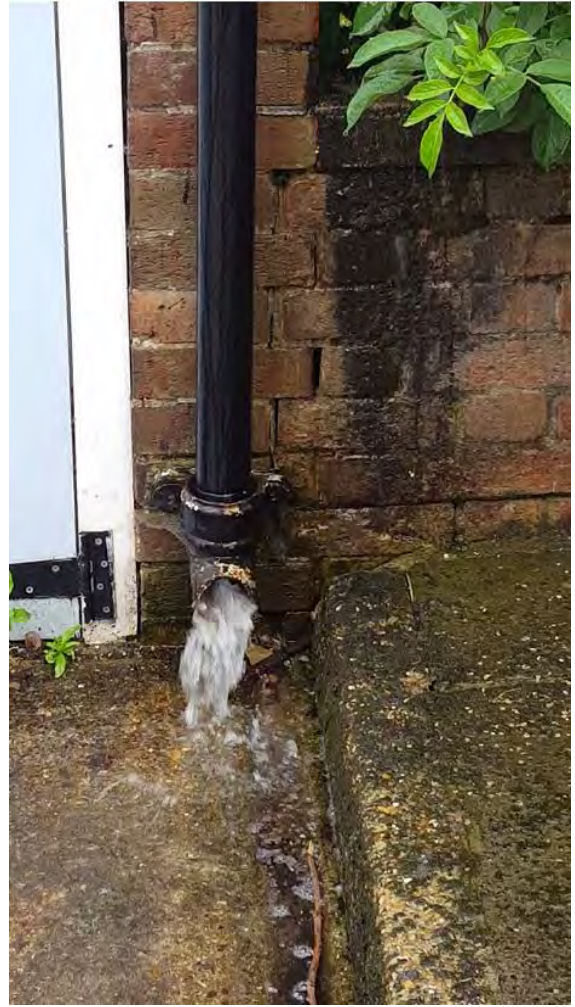
**Figure 29. Queen Caroline Estate pramshed roof downpipe outflows.** Images show runoff from downpipe to ground level drainage during a storm event on the 16th June 2016 for i) a pramshed with a green roof installed, and ii) a pramshed with no green roof installed.

In addition to the fixed-point time-lapse camera data from the 37.2 mm rain event on the 16th June 2016, SRI staff were on site downloading data from the cameras and in-line flowmeter dataloggers when one of this day's downpours occurred. Whilst not during the highest intensity rainfall during the day, the SRI researchers were present for a period when 2 mm of rain fell within the space of 30 minutes with an intensity of 36.8 mm/hr. The SRI researchers were able to take photographs (Figure 28) and videos to record this event. A video showing the outflow from one of the pramshed roofs without a green roof and another with a green roof during the intense period of this rainfall is available on YouTube on the UEL SRI channel ([https://www.youtube.com/watch?v=srAZW5v-\\_WA](https://www.youtube.com/watch?v=srAZW5v-_WA)). It must be noted that the areas of the roofs draining into each downpipe were not exactly equal. Nevertheless, both were fairly large catchments and the stark difference in terms of the rate of runoff from each roof is demonstrative of the effect that installation of green roofs can have on stormwater runoff. Stills taken from this video are presented as Figure 29.

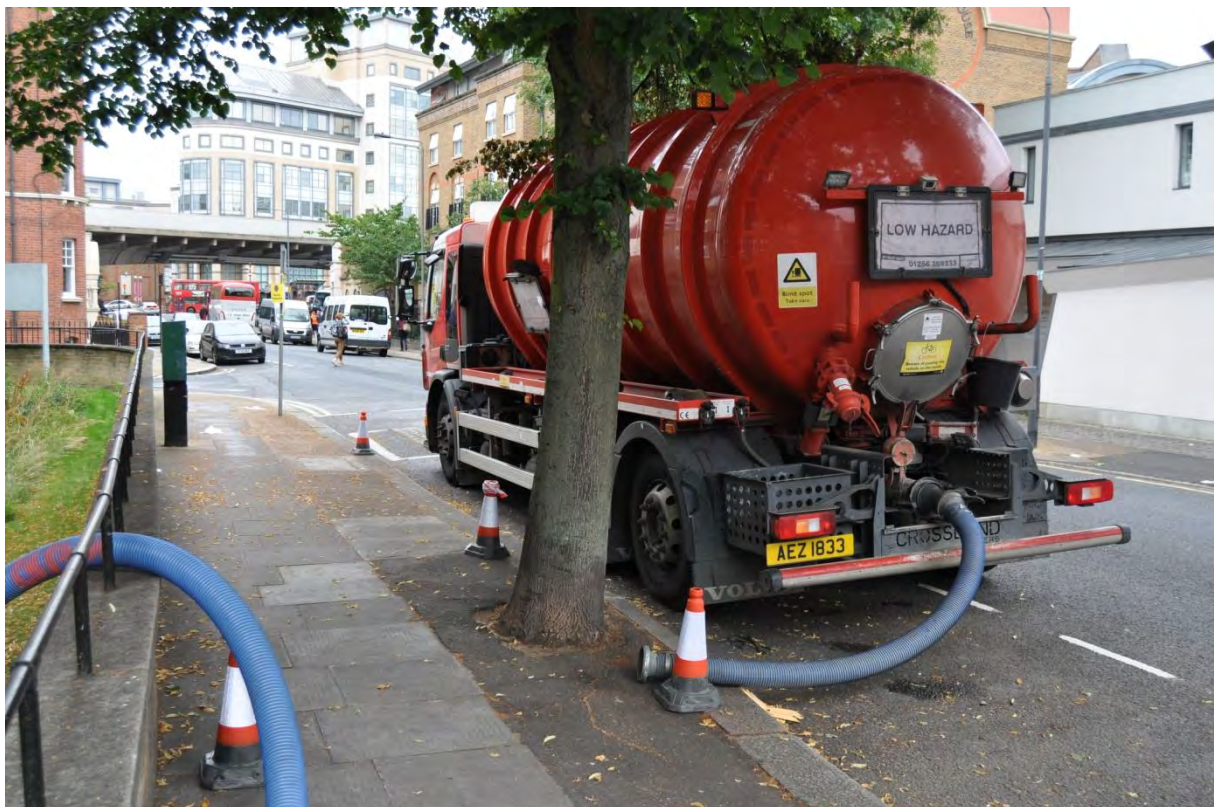
**Figure 30. Water tanker delivering 10,000 Litres of non-potable water for the storm simulation event at Beatrice House swale.** Storm simulation was carried out over the course of an hour on the 29th July 2016.

In order to create a simulation of a 1 in 100 year event it was therefore necessary to pump 10,000 L of water into the swale over the course of an hour. In order to achieve this it was necessary (with the support of Thames Water Ltd) to hire a tanker capable of transporting and delivering such a quantity of water (Figure 30).

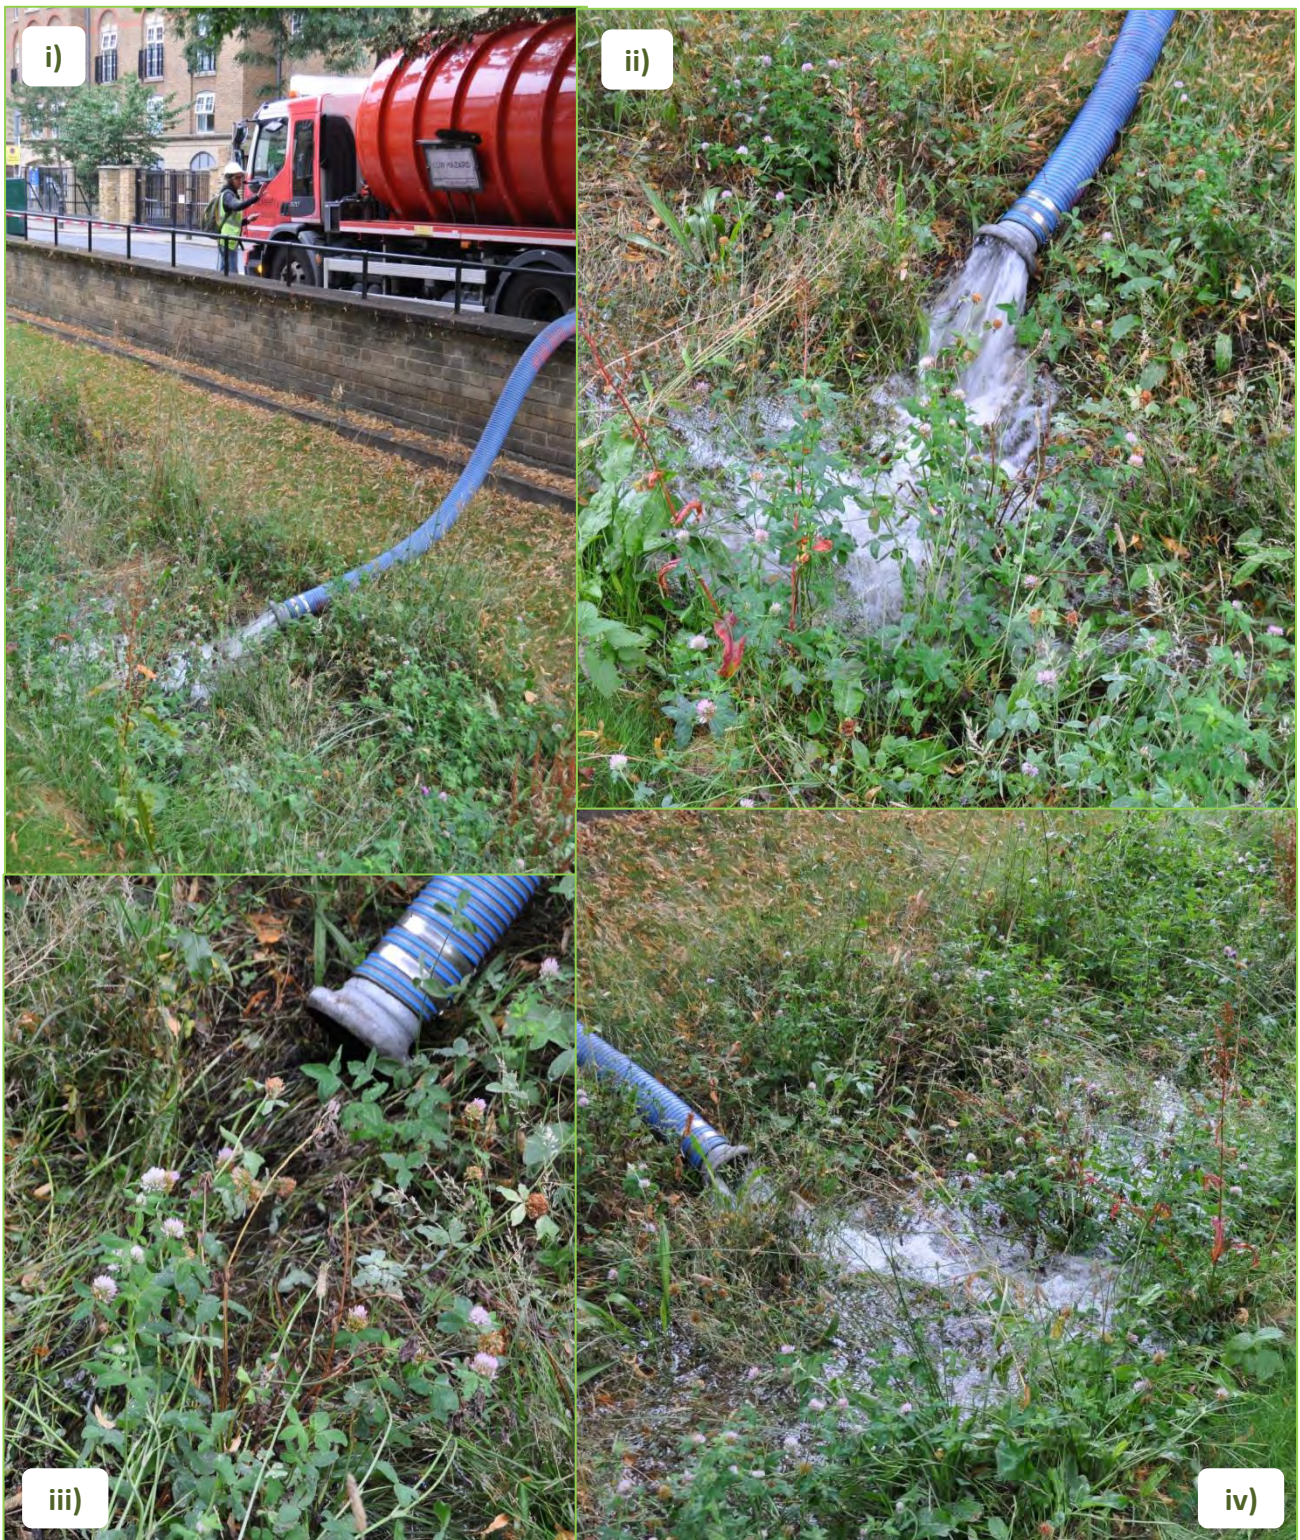
**Figure 32. Images from the storm simulation event at Beatrice House swale, Queen Caroline Estate, 29th July 2016.** Images show i) water release from tanker being timed to release 1000 Litres every six minutes; ii) 1000 Litres entering the centre of the swale; iii) condition of the swale after the first 1000 Litres; iv) condition of the swale as it starts to fill after several 1000 Litres releases.

Photographs documenting the storm simulation process are presented in Figures 32 to 34.

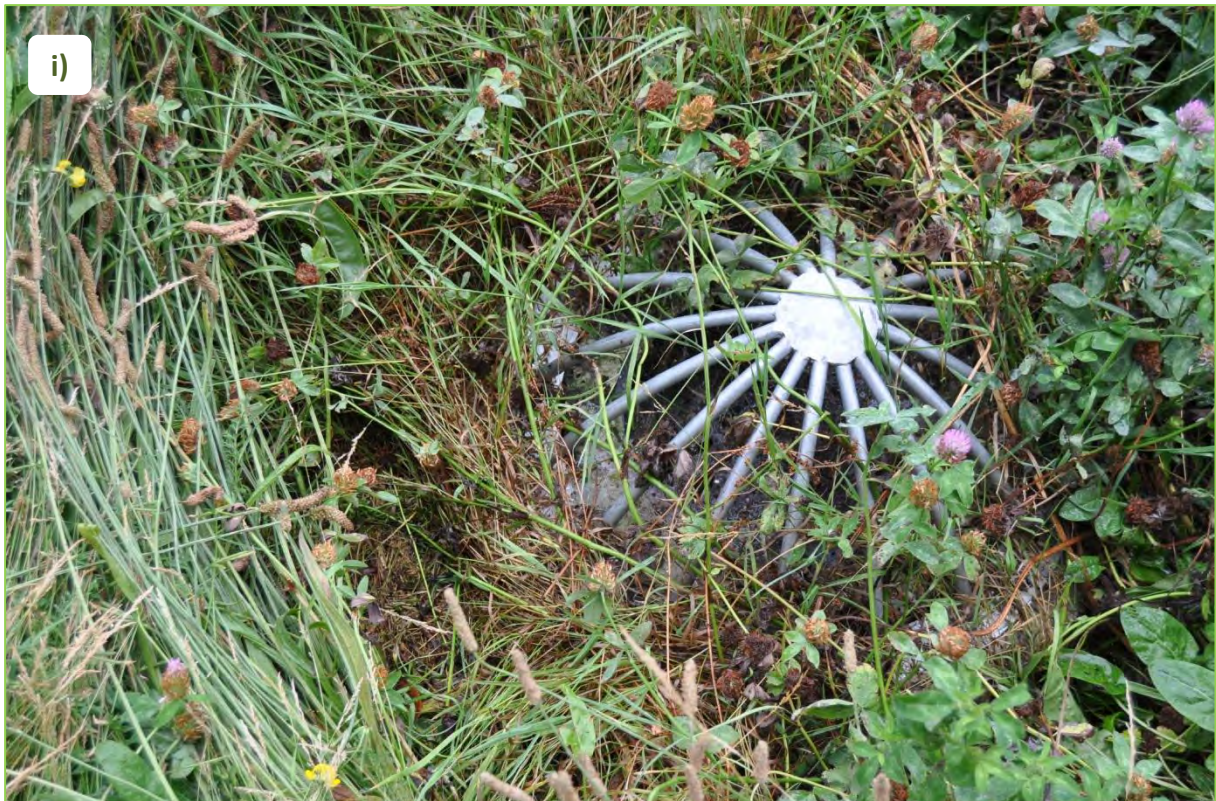
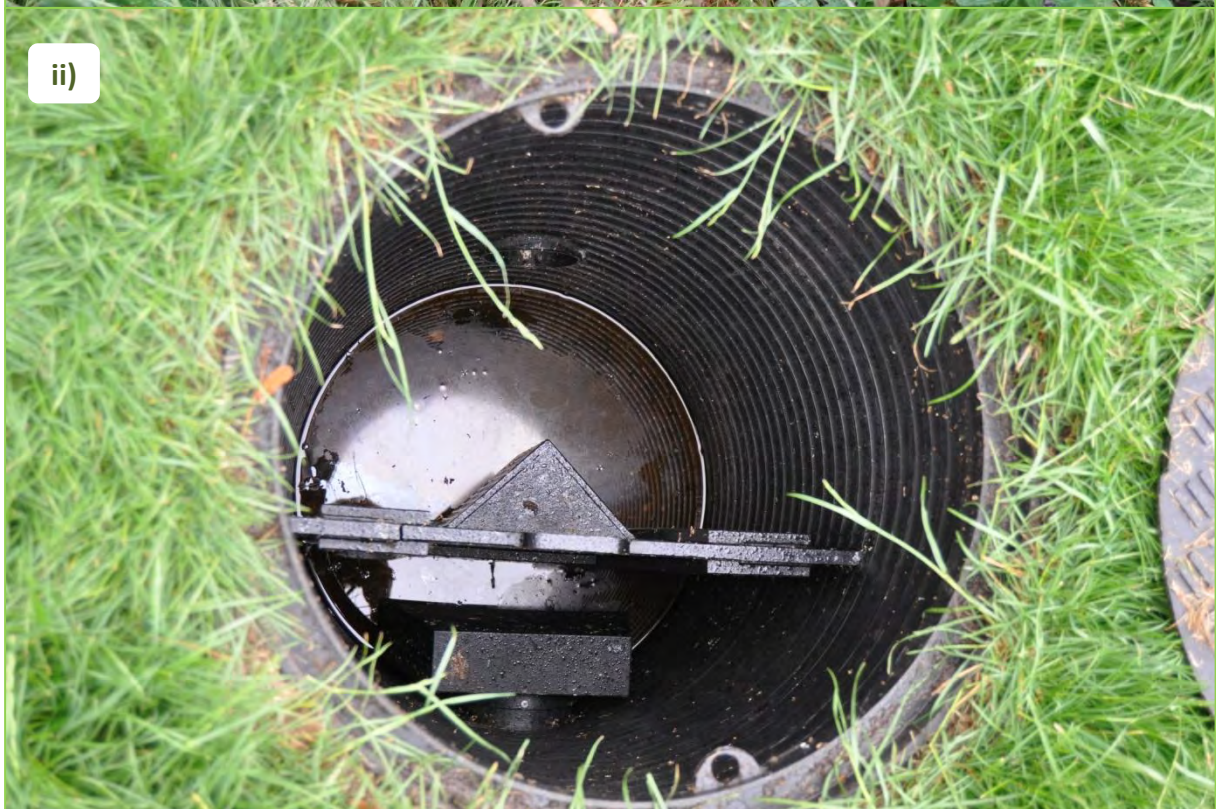
**Figure 33. Images from the storm simulation event at Beatrice House swale, Queen Caroline Estate, 29th July 2016. Images show that no water was released to the i) swale overflow or ii) the control flow chamber, after the 10,000 Litres of water were pumped into the swale to simulate a 1 in 100 year storm event.**

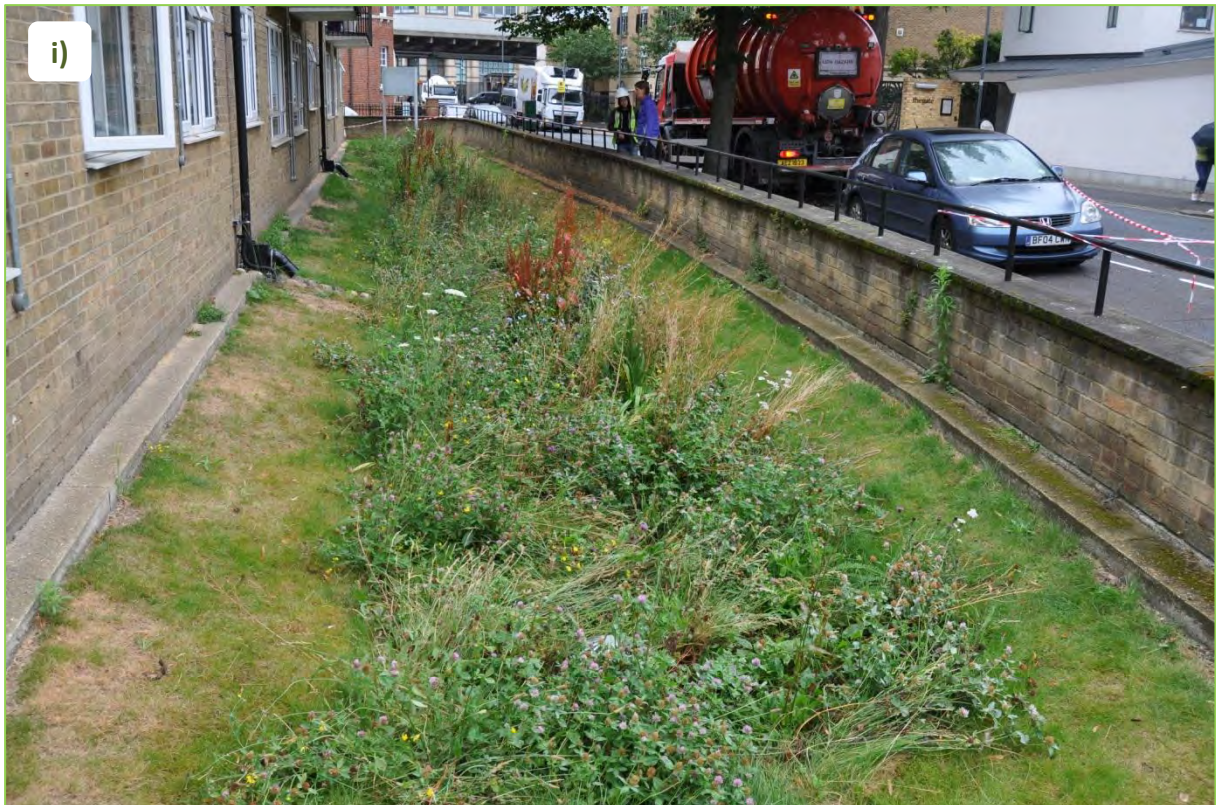
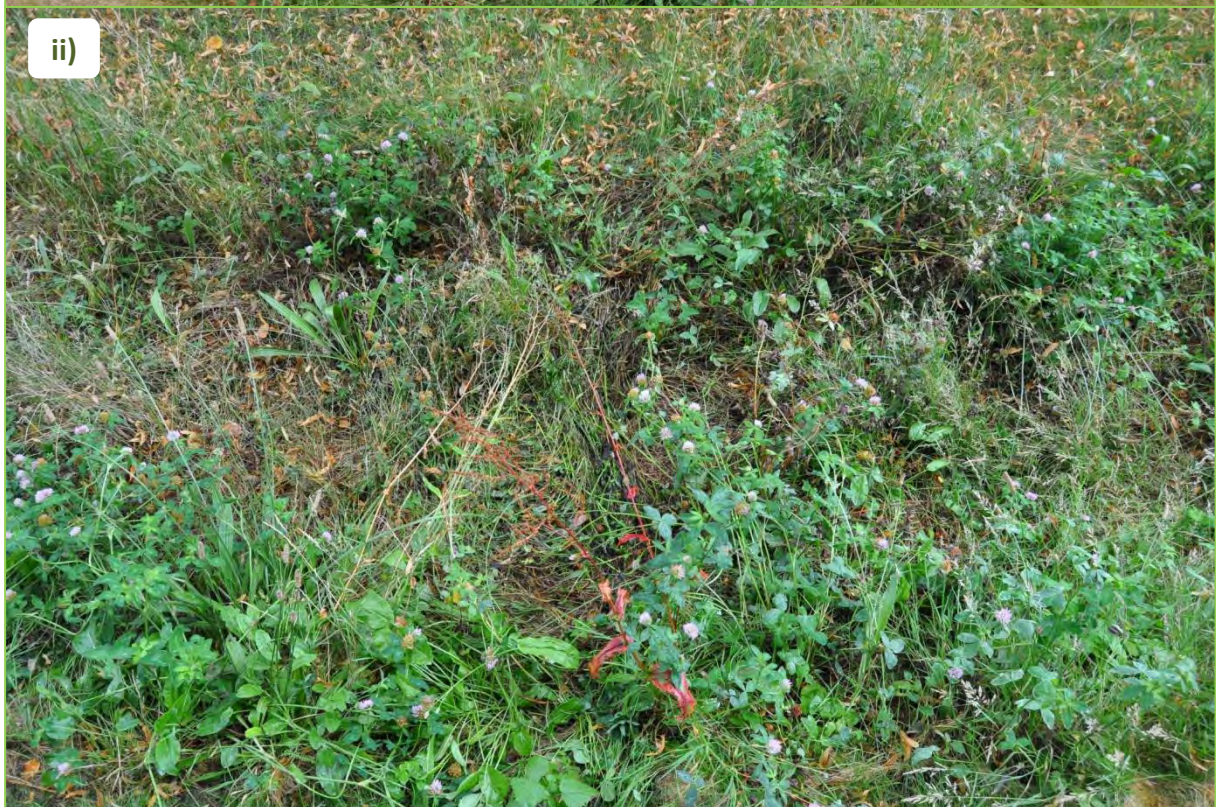
**Figure 34. Images from the storm simulation event at Beatrice House swale, Queen Caroline Estate, 29th July 2016. Images show i) the Beatrice House swale immediately after the last of the 10,000 Litres of water was released and ii) the centre of the swale where the water was pumped in 15 minutes after the last of the water was released.**

Using visual monitoring of the swale during the storm simulation event, it was possible to confirm that the Beatrice House swale was able to retain all of the 10,000 Litres of stormwater that was pumped into the basin. Moreover, at no point during the storm simulation did water pooling in the swale reach the swale's stormwater overflow. This was evidenced with the photographs taken during the simulation. This result indicated that, during dry summer periods, the swale had additional storage capacity that could be used. That could include additional capacity so that a storm greater than a 1 in 100 year event could be retained, or that additional catchment area could be diverted into the existing swale for retention of a 1 in 100 year 1 hour rain event.

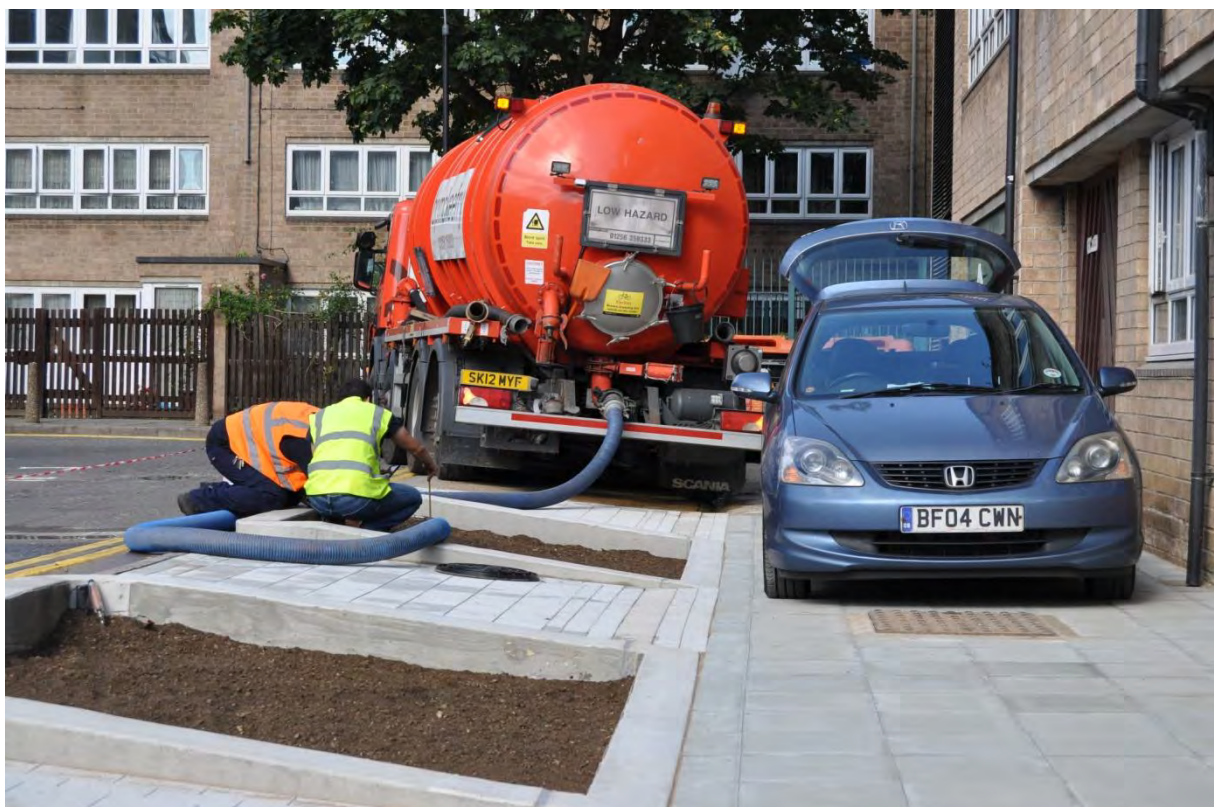
**Figure 36. Water tanker delivering 6000 Litres of non-potable water for the storm simulation event at Cheeseman Terrace Estate.** Storm simulation was carried out over the course of an hour on the 23rd September 2016.

In order to create a simulation of a 1 in 5 year event it was therefore necessary to pump 5580 L of water into the swale over the course of an hour. In order to achieve this it was necessary to hire a tanker capable of transporting and delivering such a quantity of water (Figure 36).

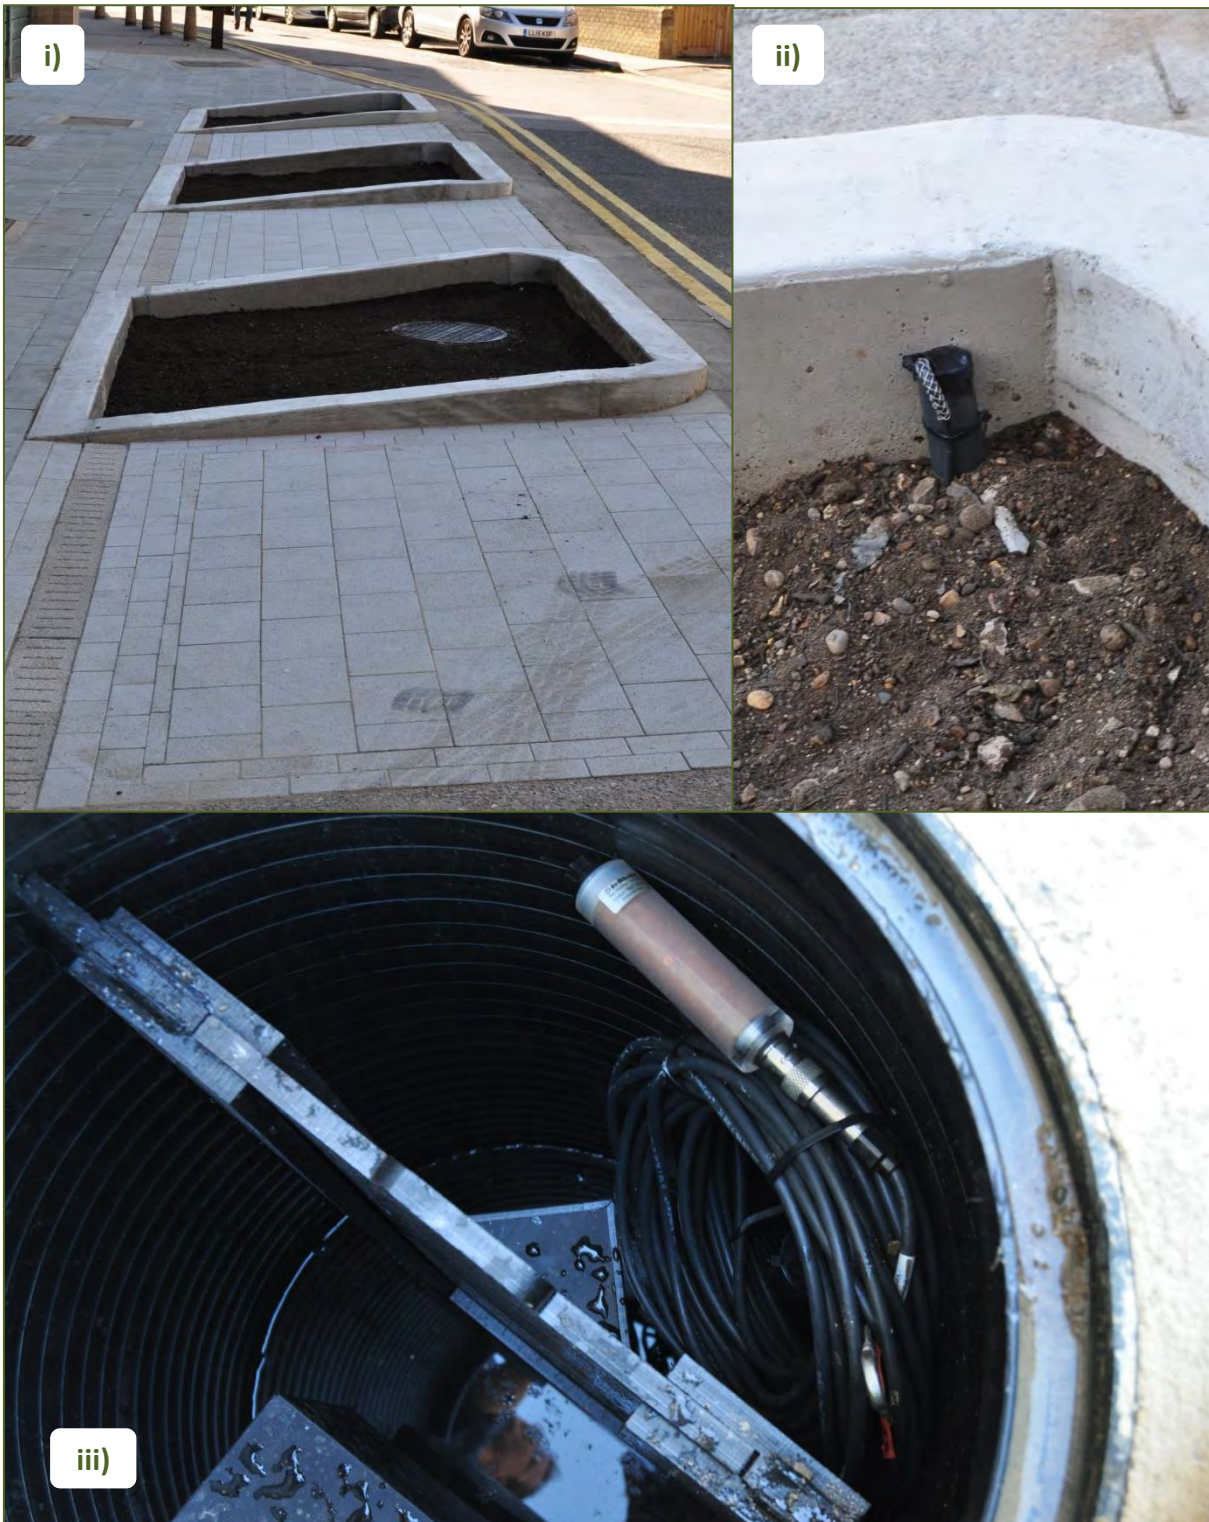
**Figure 38. Images from the storm simulation event at the Sun Road rain gardens, Cheeseman Terrace Estate, 23rd September 2016.** Images show i) Cheeseman Terrace Estate rain gardens before rain simulation; ii) pressure sensor installed in the corner of one of the rain gardens; iii) pressure sensor installed in the control flow chamber in the outlet from the rain garden.

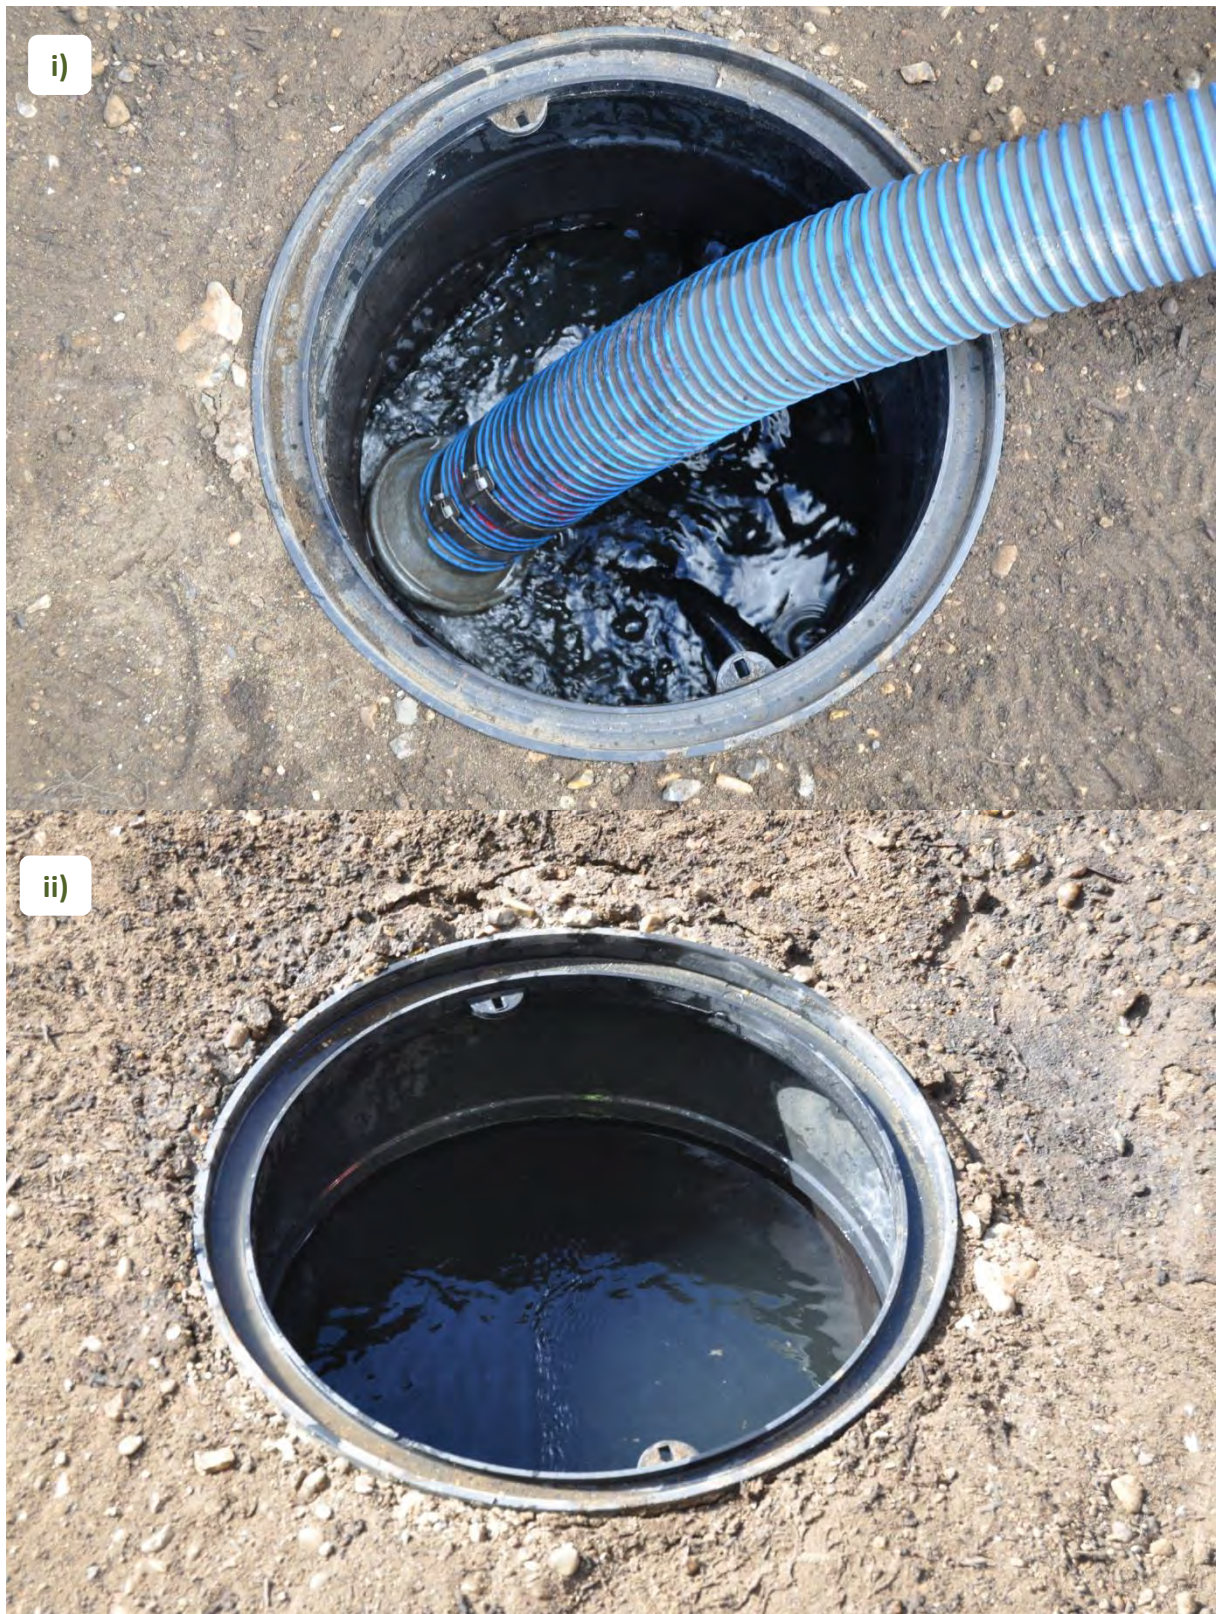
**Figure 39. Images from the storm simulation event at the Sun Road rain gardens, Cheeseman Terrace Estate, 23rd September 2016. Images show i) water being pumped into the inspection chamber of the rain garden; ii) inlet chamber full after the stormwater was pumped in.**

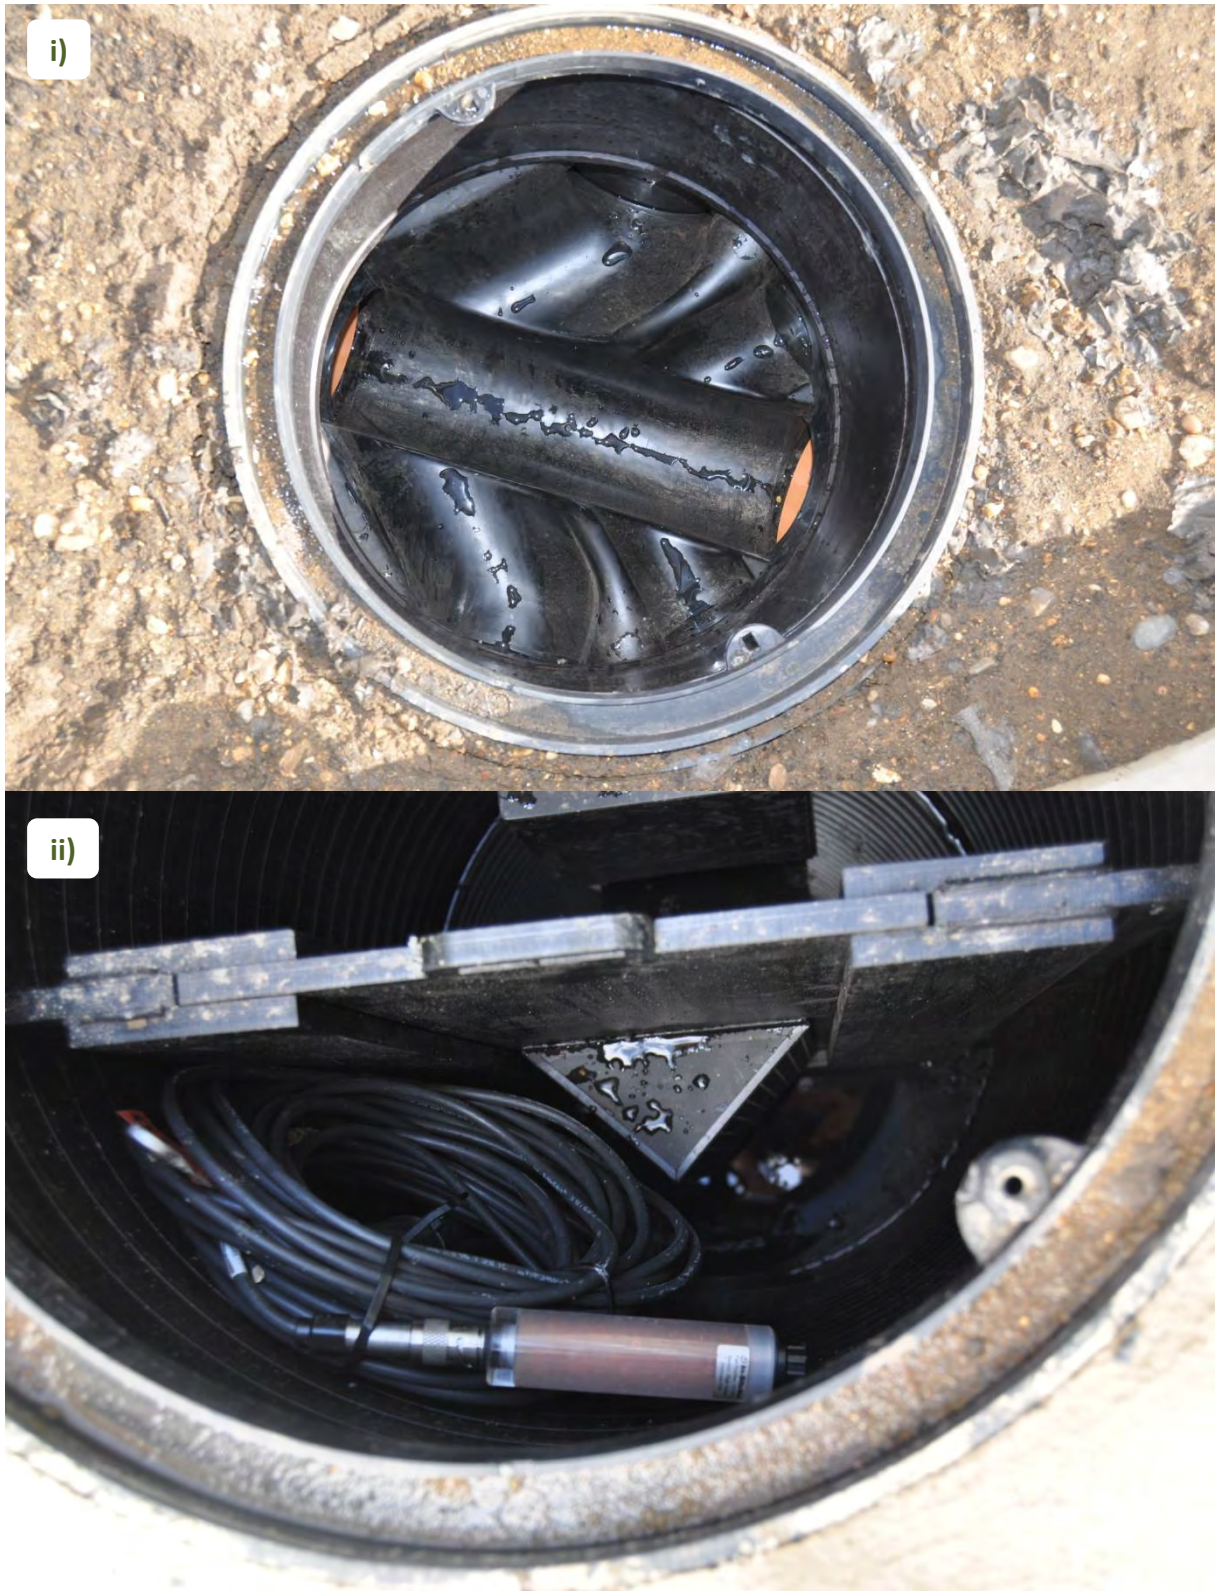
**Figure 40. Images from the storm simulation event at the Sun Road rain gardens, Cheeseman Terrace Estate, 23rd September 2016. Images show i) the rain garden inspection chamber 30 minutes after the last of the 6,000 Litres of water was released and ii) the control flow chamber showing no release of water from the rain gardens following the 1 in 5 year storm event simulation.**
