**Climate Proofing Housing Landscapes:  
Monitoring Report 2**

**June 2016 to September 2016**

Authors: Connop, S., Clough, J., Gunawardena, D. and Nash, C.

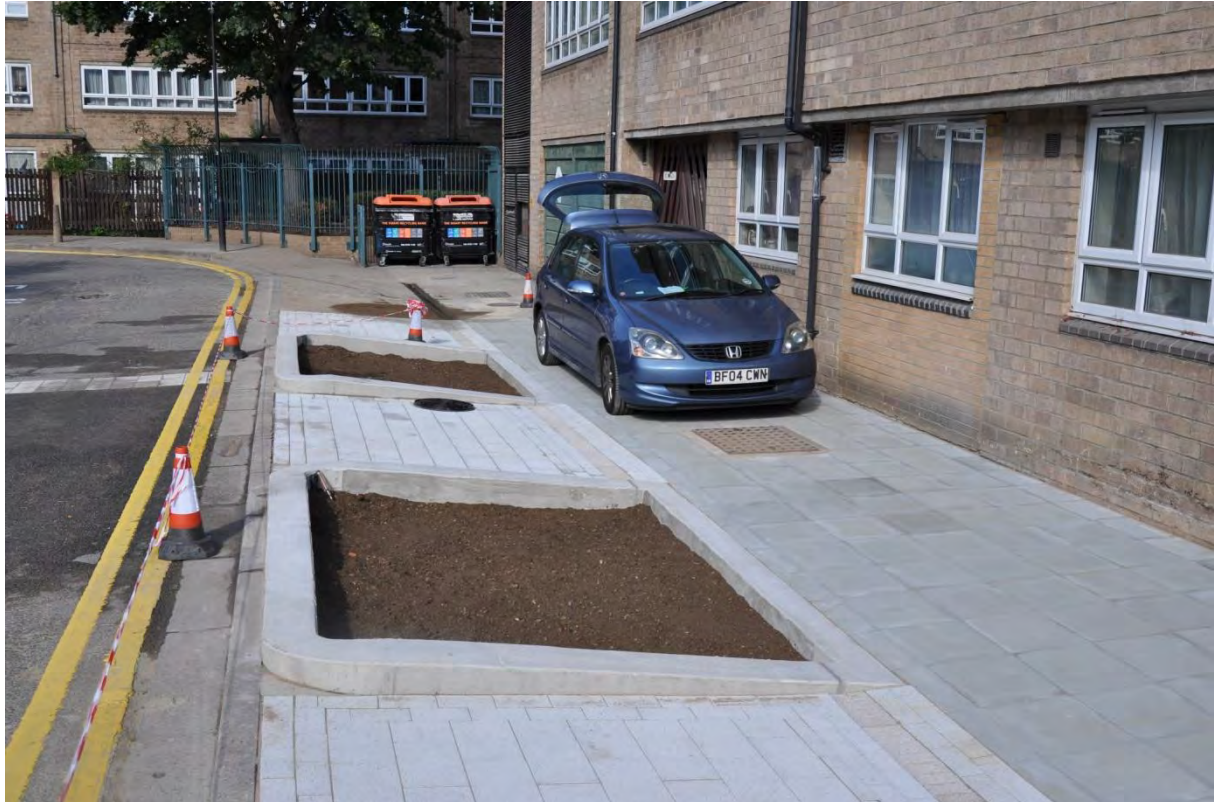
**Figure 41. Image from the storm simulation event at the Sun Road rain gardens, Cheeseman Terrace Estate, 23rd September 2016.** Image shows the rain gardens after the end of the stormwater simulation test with no signs of water pooling on any of the rain gardens.

Using visual monitoring of the rain gardens during the storm simulation event, it was possible to confirm that the Cheeseman Terrace rain gardens were able to retain all of the 6,000 Litres of stormwater that was pumped into the inspection chambers. Moreover, at no point during the storm simulation did water pumped into the rain gardens reach the stormwater control flow chamber within the rain garden outlet. This was evidenced with the photographs taken during the simulation. This result indicated that, during dry summer periods, the rain gardens had additional storage capacity that could be used. That could include additional capacity so that a storm greater than a 1 in 5 year event could be retained, or that additional catchment area could be diverted into the existing rain gardens for retention of a 1 in 5 year 1 hour rain event.

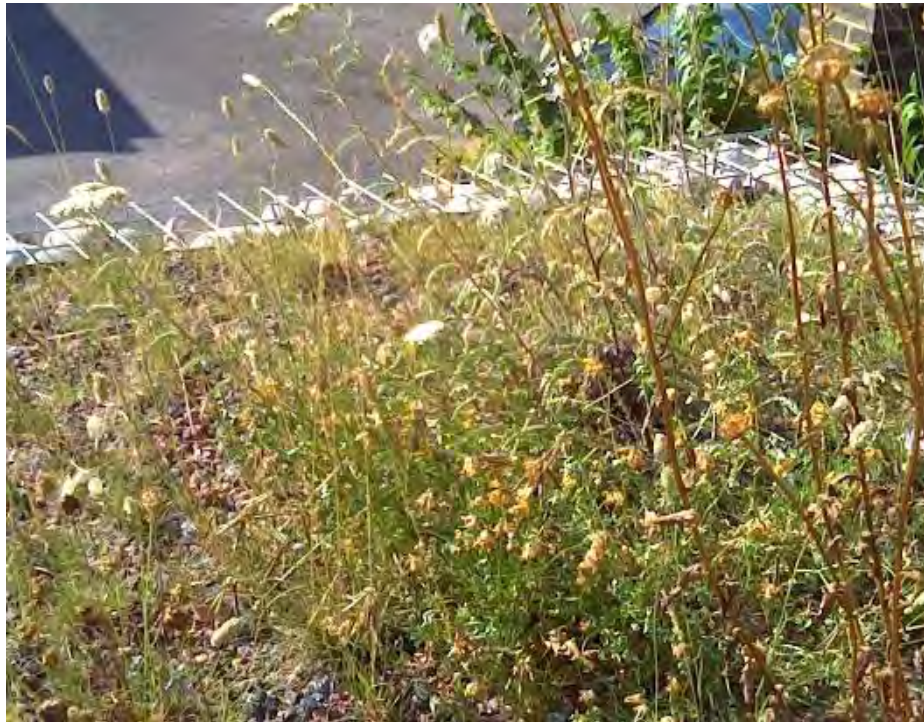
**Figure 44. Photo and infrared image of pramshed green roof and surrounding grey infrastructure on the 19th July 2016.** Infrared image reveals a temperature difference of 27.3 °C between the hottest and coolest areas within the field of view. A FLIR QuickReport spotmeter was used to identify individual temperatures within the field of view. Hottest temperatures (>45 °C) were associated with the surrounding tarmac and some areas of bare substrate on the green roof. These areas were recorded as being substantially hotter than the maximum daily temperature recorded by the nearby weather station (33.3 °C). Coolest temperatures were associated with vegetated areas of the green roof (with temperatures from 35.5 °C to 36.2 °C) and surrounding vegetation (34.0 °C).

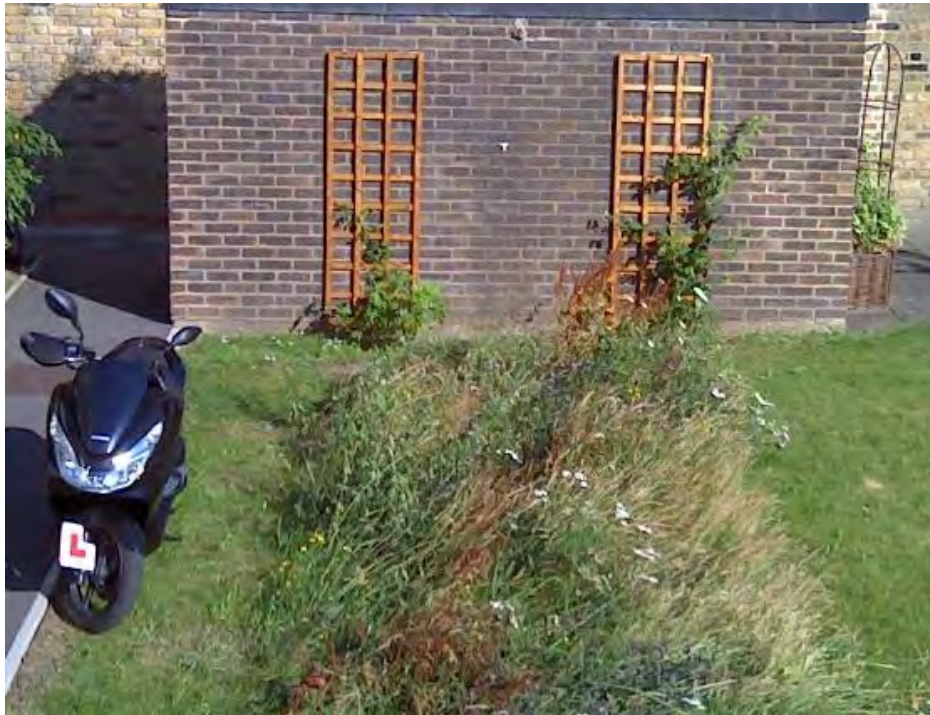
**Figure 45. Photo and infrared image of the Richard Knight House swale and surrounding grey infrastructure, 19th July 2016.** Infrared image reveals a temperature difference of 36.5 °C between the hottest and coolest areas within the field of view. A FLIR QuickReport spotmeter was used to identify individual temperatures within the field of view. Hottest temperatures (>51 °C) were associated with the neighbouring pramshed wall. These areas were recorded as being substantially hotter than the maximum daily temperature recorded by the nearby weather station (33.3 °C). Coolest temperatures were associated with the tall vegetated areas of the swale (with temperatures from 33.3 °C to 33.8 °C). Surrounding areas of amenity turf vegetation were warmer than those in the swale (35.8 °C).

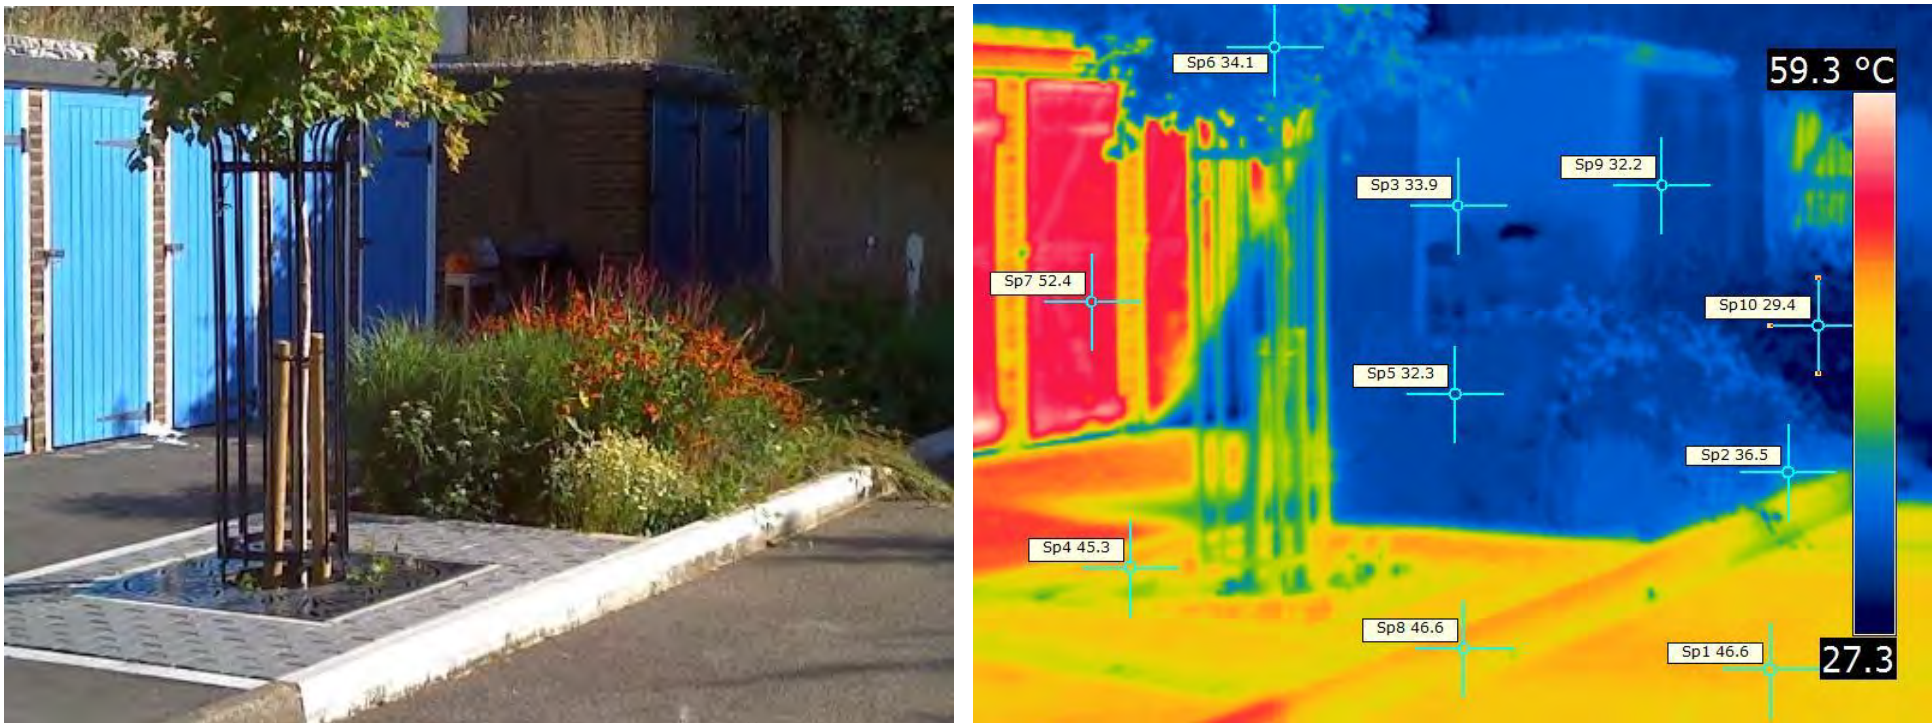
**Figure 46. Photo and infrared image of the Richard Knight House rain garden and surrounding grey infrastructure on the 19th July 2016.** Infrared image reveals a temperature difference of 32.3 °C between the hottest and coolest areas within the field of view. A FLIR QuickReport spotmeter was used to identify individual temperatures within the field of view. Hottest temperatures (>45 °C) were associated with the neighbouring pramshed doors and surrounding tarmac areas. These areas were recorded as being substantially hotter than the maximum daily temperature recorded by the nearby weather station (33.3 °C). Coolest temperatures were associated with the tall vegetated areas of the rain garden (with temperatures from 29.4 °C to 36.5 °C). The tree canopy as part of the SuDS feature also showed cooling potential with a temperature of 34.1 °C.

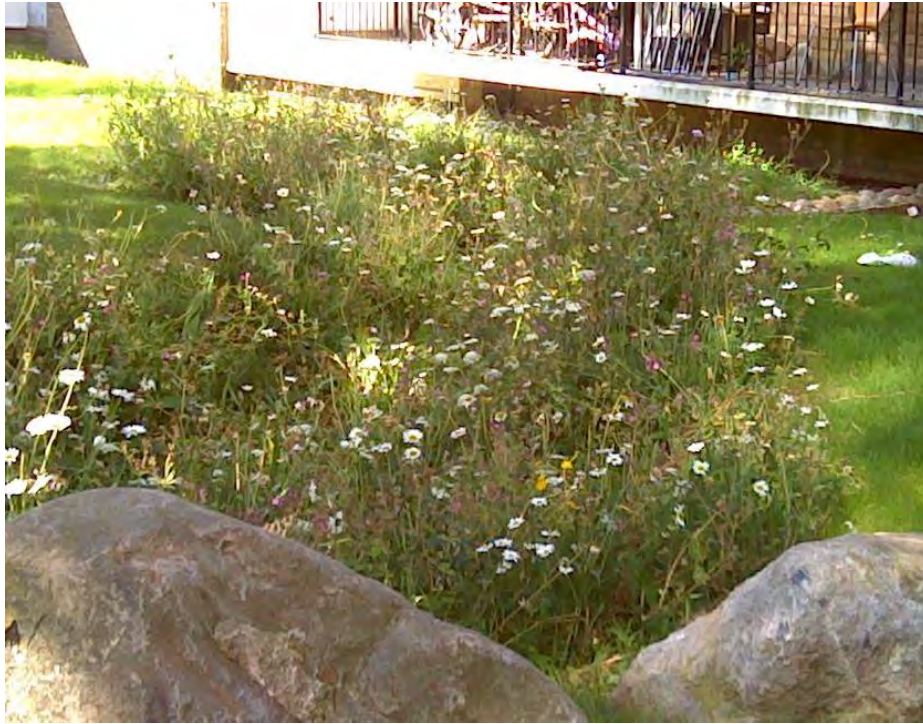
**Figure 47. Photo and infrared image of Adella rain basin at Queen Caroline Estate 19th July 2016.** Infrared image reveals a temperature difference of 30.1 °C between the hottest and coolest areas within the field of view. A FLIR QuickReport spotmeter was used to identify individual temperatures within the field of view. Hottest temperatures (>40 °C) were associated with the neighbouring walls. These areas were recorded as being substantially hotter than the maximum daily temperature recorded by the nearby weather station (32.6 °C). Coolest temperatures were associated with the tall vegetated areas of the rain garden (with temperatures from 28.2 °C to 31.0 °C) although these areas were in the shade compared to surrounding walls. Nevertheless, boulders at the edge of the rain basin were warmer than the vegetation in the basin (32.2 °C to 35.5 °C).

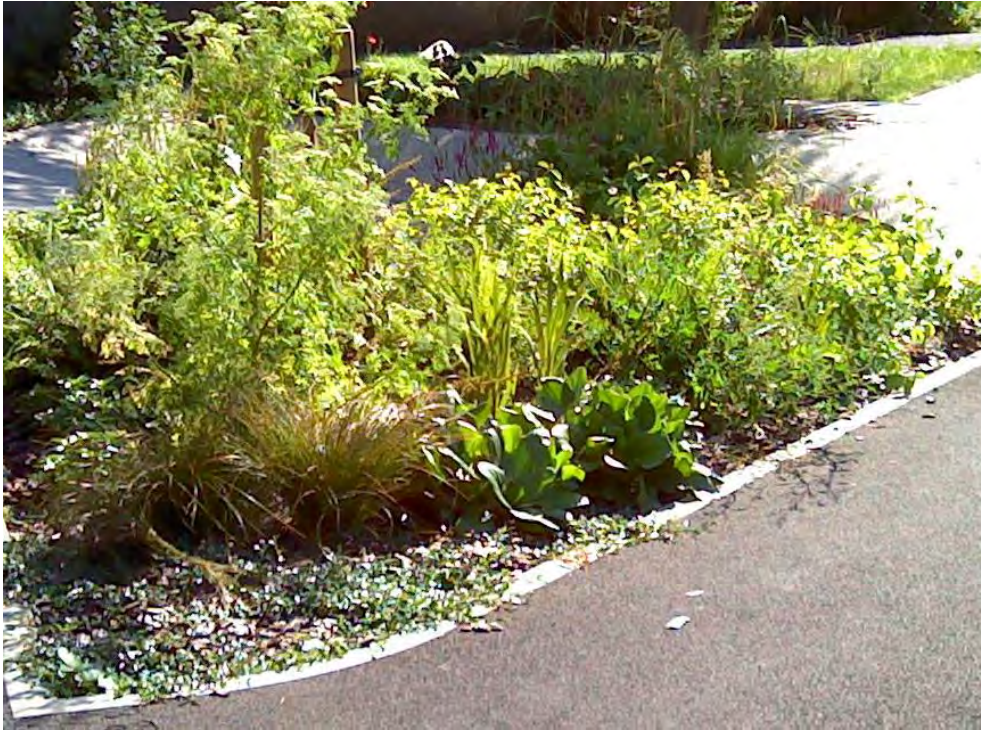
**Figure 48. Photo and infrared image of SuDS planting features at Queen Caroline Estate, 19th July 2016.** Infrared image reveals a temperature difference of 30.0 °C between the hottest and coolest areas within the field of view. A FLIR QuickReport spotmeter was used to identify individual temperatures within the field of view. Hottest temperatures (>55 °C) were associated with the neighbouring tarmac paths. These areas were recorded as being substantially hotter than the maximum daily temperature recorded by the nearby weather station (32.6 °C). Coolest temperatures were associated with the tall vegetated areas of the SuDS feature (with temperatures from 33.9 °C to 35.7 °C).

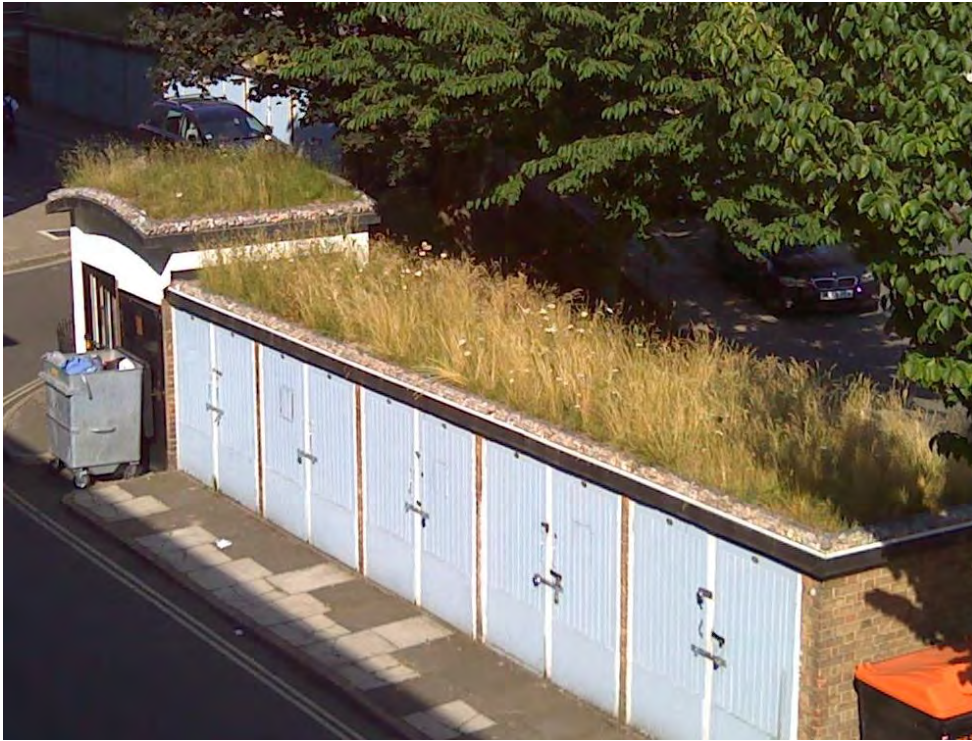
**Figure 49. Photo and infrared image of pram shed roofs at Queen Caroline Estate 19th July 2016.** Infrared image reveals a temperature difference of 37.3 °C between the hottest and coolest areas within the field of view. A FLIR QuickReport spotmeter was used to identify individual temperatures within the field of view. Hottest temperatures (>52 °C) were associated with the neighbouring paving and bins. These areas were recorded as being substantially hotter than the maximum daily temperature recorded by the nearby weather station (32.6 °C). Coolest temperatures were associated with the tall vegetated areas of the pramshed green roofs (with temperatures from 34.0 °C to 38.1 °C). The surrounding tree canopy was also cooler than paved areas (35.0 °C to 35.7 °C).

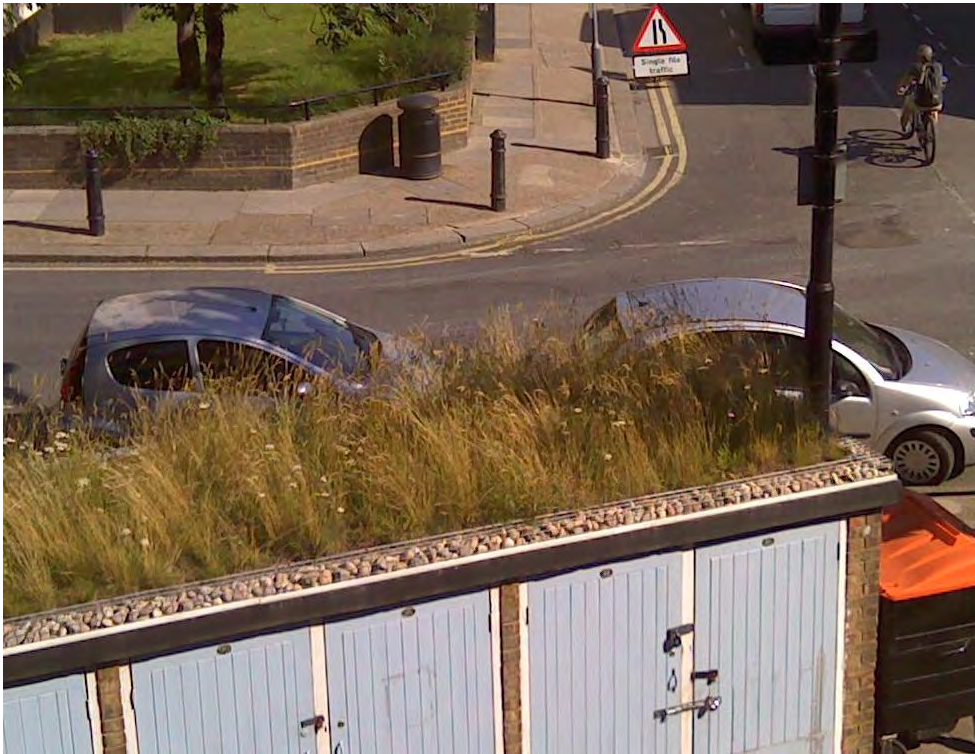
**Figure 50. Photo and infrared image of pram shed roofs at Queen Caroline Estate 19th July 2016.** Infrared image reveals a temperature difference of 36.0 °C between the hottest and coolest areas within the field of view. A FLIR QuickReport spotmeter was used to identify individual temperatures within the field of view. Hottest temperatures (>47 °C) were associated with the road and neighbouring paving areas. These areas were recorded as being substantially hotter than the maximum daily temperature recorded by the nearby weather station (32.6 °C). Coolest temperatures were associated with the tall vegetated areas of the pramshed green roofs (with temperatures from 33.9 °C to 35.9 °C). The roof edges were also hot (45.7 °C and 50.3 °C).

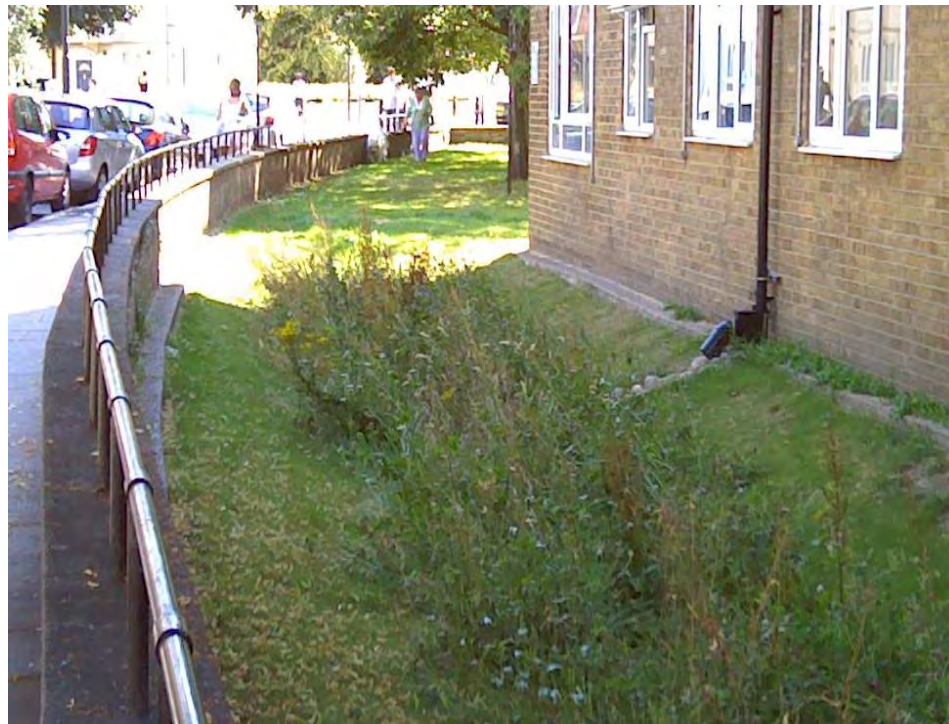
**Figure 53. Photo and infrared image of Beatrice House Swale, 19th July 2016.** Infrared image reveals a temperature difference of 23.6 °C between the hottest and coolest areas within the field of view. A FLIR QuickReport spotmeter was used to identify individual temperatures within the field of view. Hottest temperatures (>35 °C) were associated with the walls of Beatrice House surrounding the rain garden. These areas were recorded as being hotter than the maximum daily temperature recorded by the nearby weather station (32.6 °C). Coolest temperatures were associated with the tall vegetated areas of the swale (with temperatures from 26.8 °C to 30.0 °C).

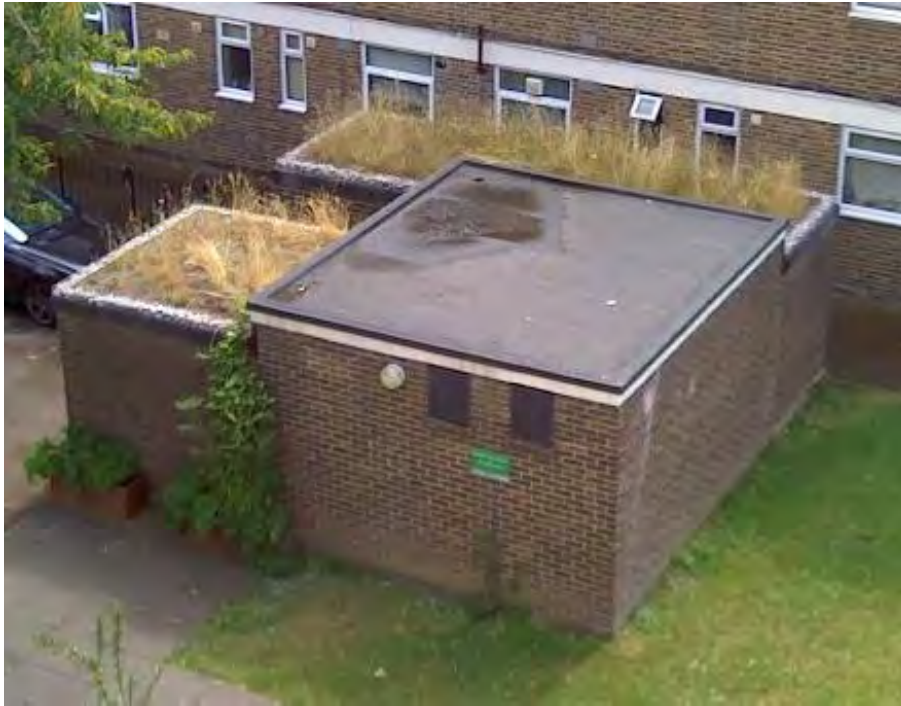
**Figure 54. Photo and infrared image of Pramshed standard and green roofs at Richard Knight House, 27th July 2016.** Infrared image reveals a temperature difference of 15.9 °C between the hottest and coolest areas within the field of view. A FLIR QuickReport spotmeter was used to identify individual temperatures within the field of view. Hottest temperatures (>32 °C) were associated with the standard flat pramshed roofs. These areas were recorded as being hotter than the maximum daily temperature recorded by the nearby weather station (24.3 °C). Temperatures on the greened roofs were substantially lower (22.0 °C). These temperatures were even lower than those associated with pooled water on the standard flat roof (26.4 °C).

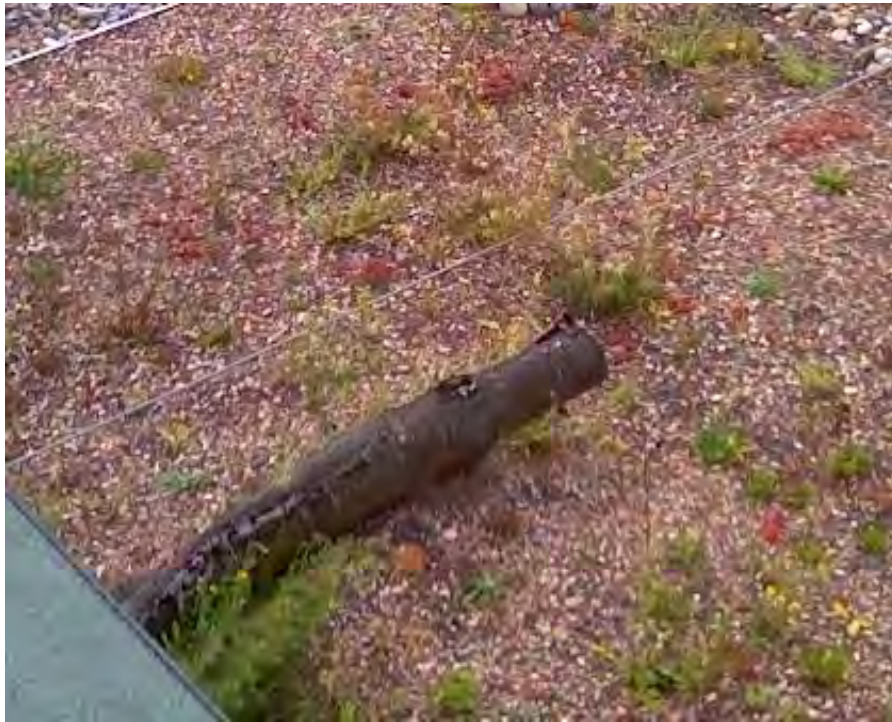
**Figure 56. Photo and infrared image of habitat pile on the Richard Knight House green roof 27th July 2016.** Infrared image reveals a temperature difference of 19.7 °C between the hottest and coolest areas within the field of view. A FLIR QuickReport spotmeter was used to identify individual temperatures within the field of view. Hottest temperatures (>38 °C) were associated with the non-greened edges of the flat roof. These areas were recorded as being hotter than the maximum daily temperature recorded by the nearby weather station (24.3 °C). Temperatures on sparsely vegetated areas of the greened roof were substantially lower than the roof edges (30.8 to 33.6 °C). The coolest areas were associated with the log habitat pile (23.4 °C to 24.9 °C) and the vegetated areas of the green roof (24.4 to 25.6 °C). This provided additional evidence that habitat piles can provide refugia on green roofs and cooling benefits when other areas of the roof are drought stressed and thus have sparse vegetation.

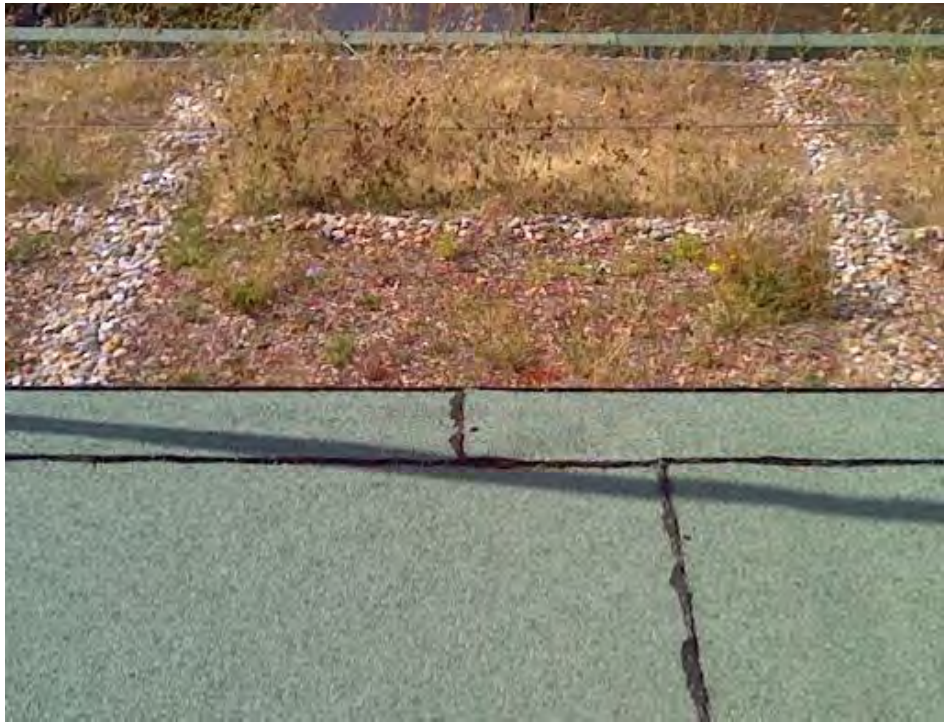
**Figure 57. Photo and infrared image of green roof and neighbouring standard roof on Richard Knight House 27th July 2016.** Infrared image reveals a temperature difference of 19.1 °C between the hottest and coolest areas within the field of view. A FLIR QuickReport spotmeter was used to identify individual temperatures within the field of view. Hottest temperatures (>33 °C) were associated with the non-greened areas of the flat roof. These areas were recorded as being hotter than the maximum daily temperature recorded by the nearby weather station (24.3 °C). Temperatures on sparsely vegetated areas of the greened roof were slightly lower than the non-greened roof area (31.6 to 32.7 °C). The coolest areas were associated with the vegetated areas of the green roof (24.9 to 26.4 °C).

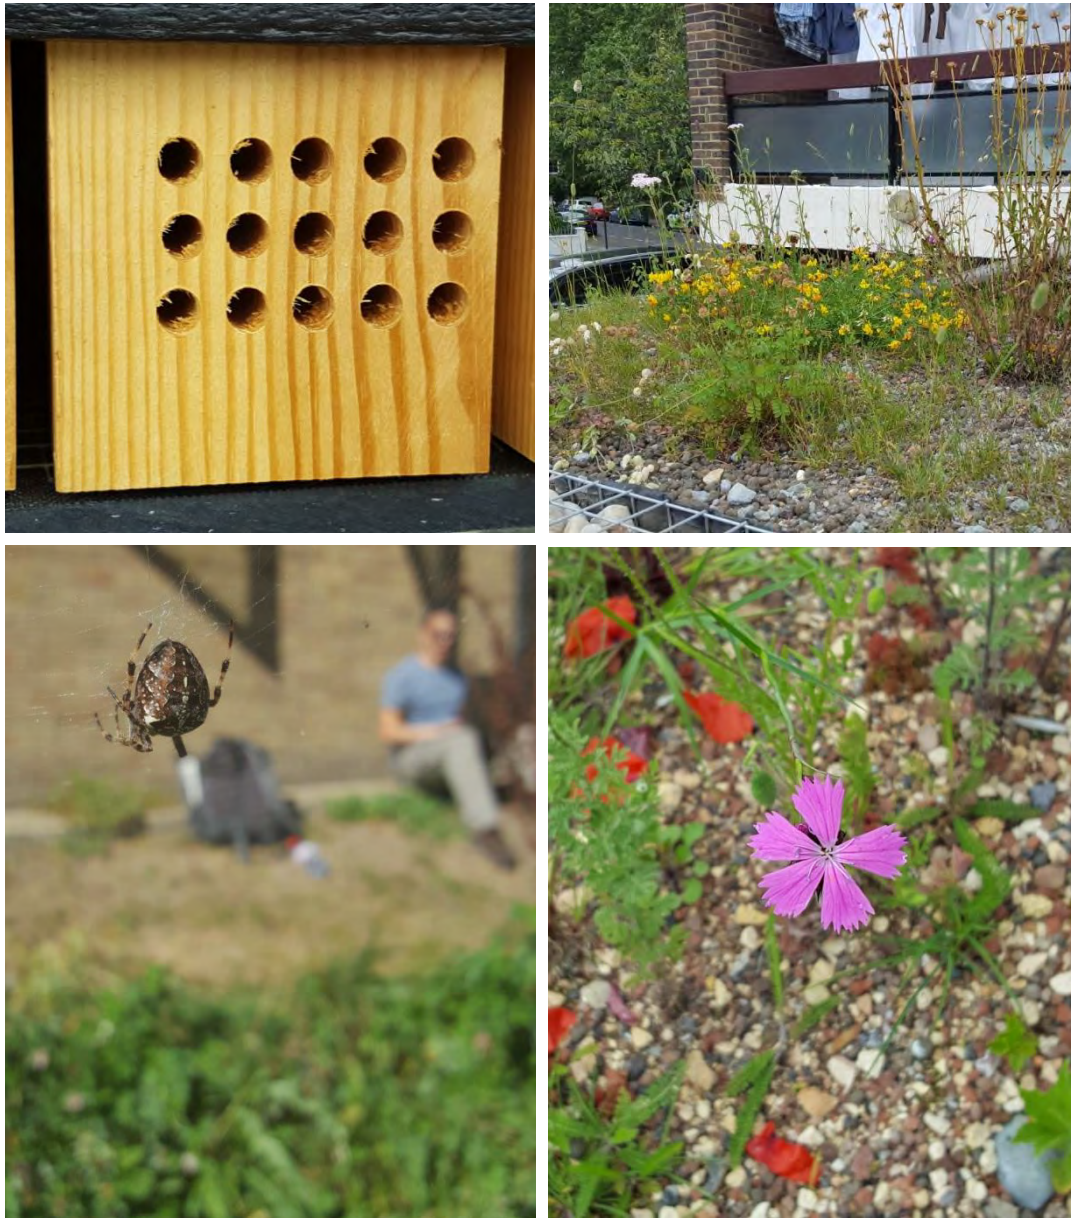
**Figure 67. Images from green infrastructure retrofit project in Hammersmith.** Clockwise from top left: cavity nesting bee habitat installed on Richard Knight House green roof; bird's-foot trefoil (*Lotus corniculatus*) growing on pramshed green roof; The European garden spider (*Araneus diadematus*) making use of the habitat structure in the Beatrice House swale; and Pink (*Dianthus spp*) flower on the Richard Knight House green roof.

In addition to the specific vegetation monitoring of the retrofitted green infrastructure, photos were taken to capture the development of the vegetation and wildlife visiting the sites. Below are a small selection of these images (Figures 67 and 68):

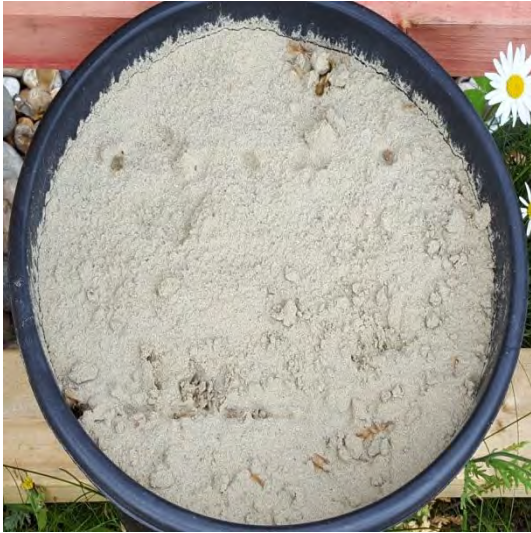
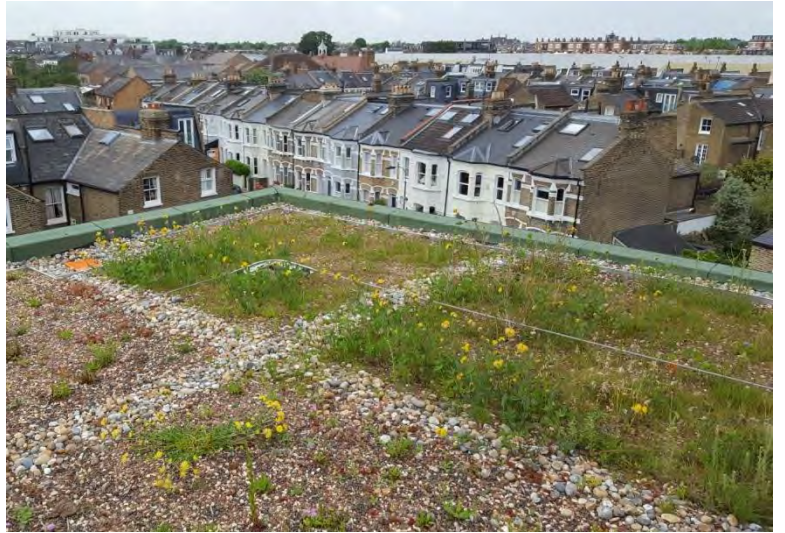
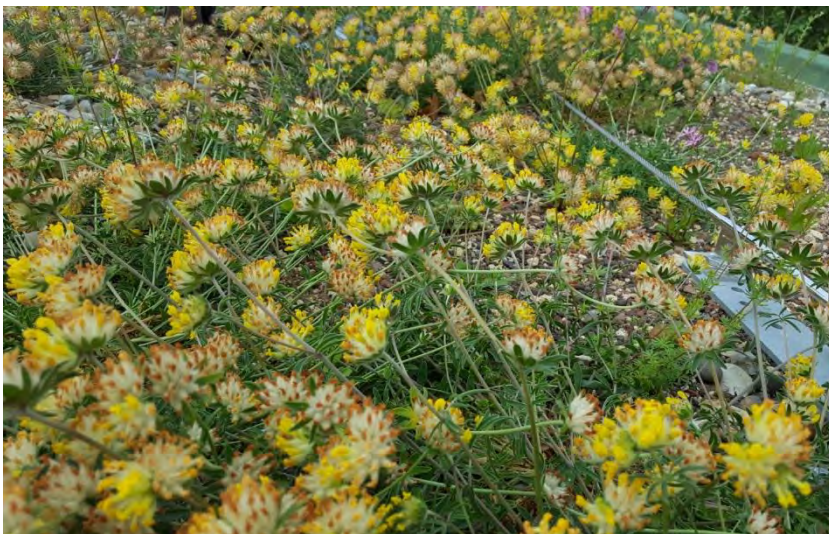
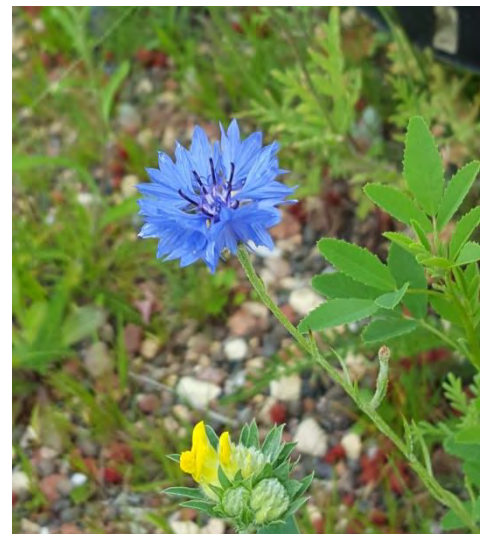
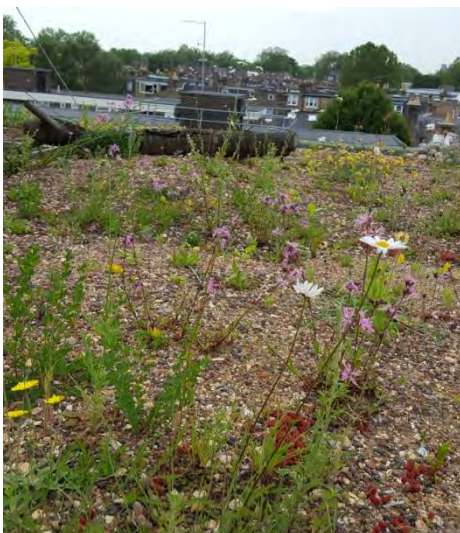
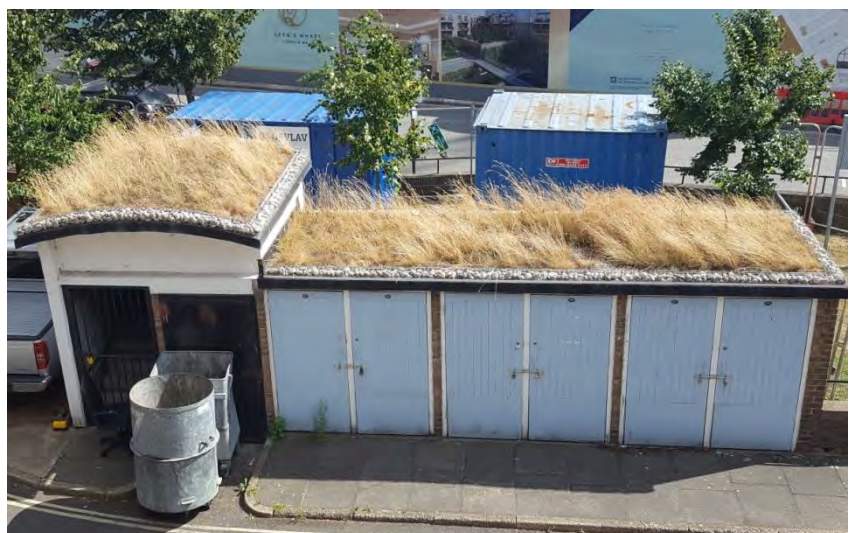
**Figure 68.** Images from green infrastructure retrofit project in Hammersmith. Clockwise from top left: Thanet sand habitat for ground nesting bees; experimental plots greening differently on the Richard Knight House green roof; Kidney vetch (*Anthyllis vulneraria*) sprawling across a green roof; Cornflower (*Centaurea cyanus*) providing a pollen resource for bees; Habitat pile and diverse wildflowers on the Richard Knight House green roof; a 'golden' green roof (drought stressed vegetation ready to burst in to life again once it rains).
